ARBORICULTURAL REPORT

9 Castle Drive Lennox Head

PREPARED FOR:
Mr. Jason Vidler
Shire of Ballina

Re: Arboriculture report on Ficus macrophylla at Castle Drive and Ficus macrophylla at Pine Avenue.

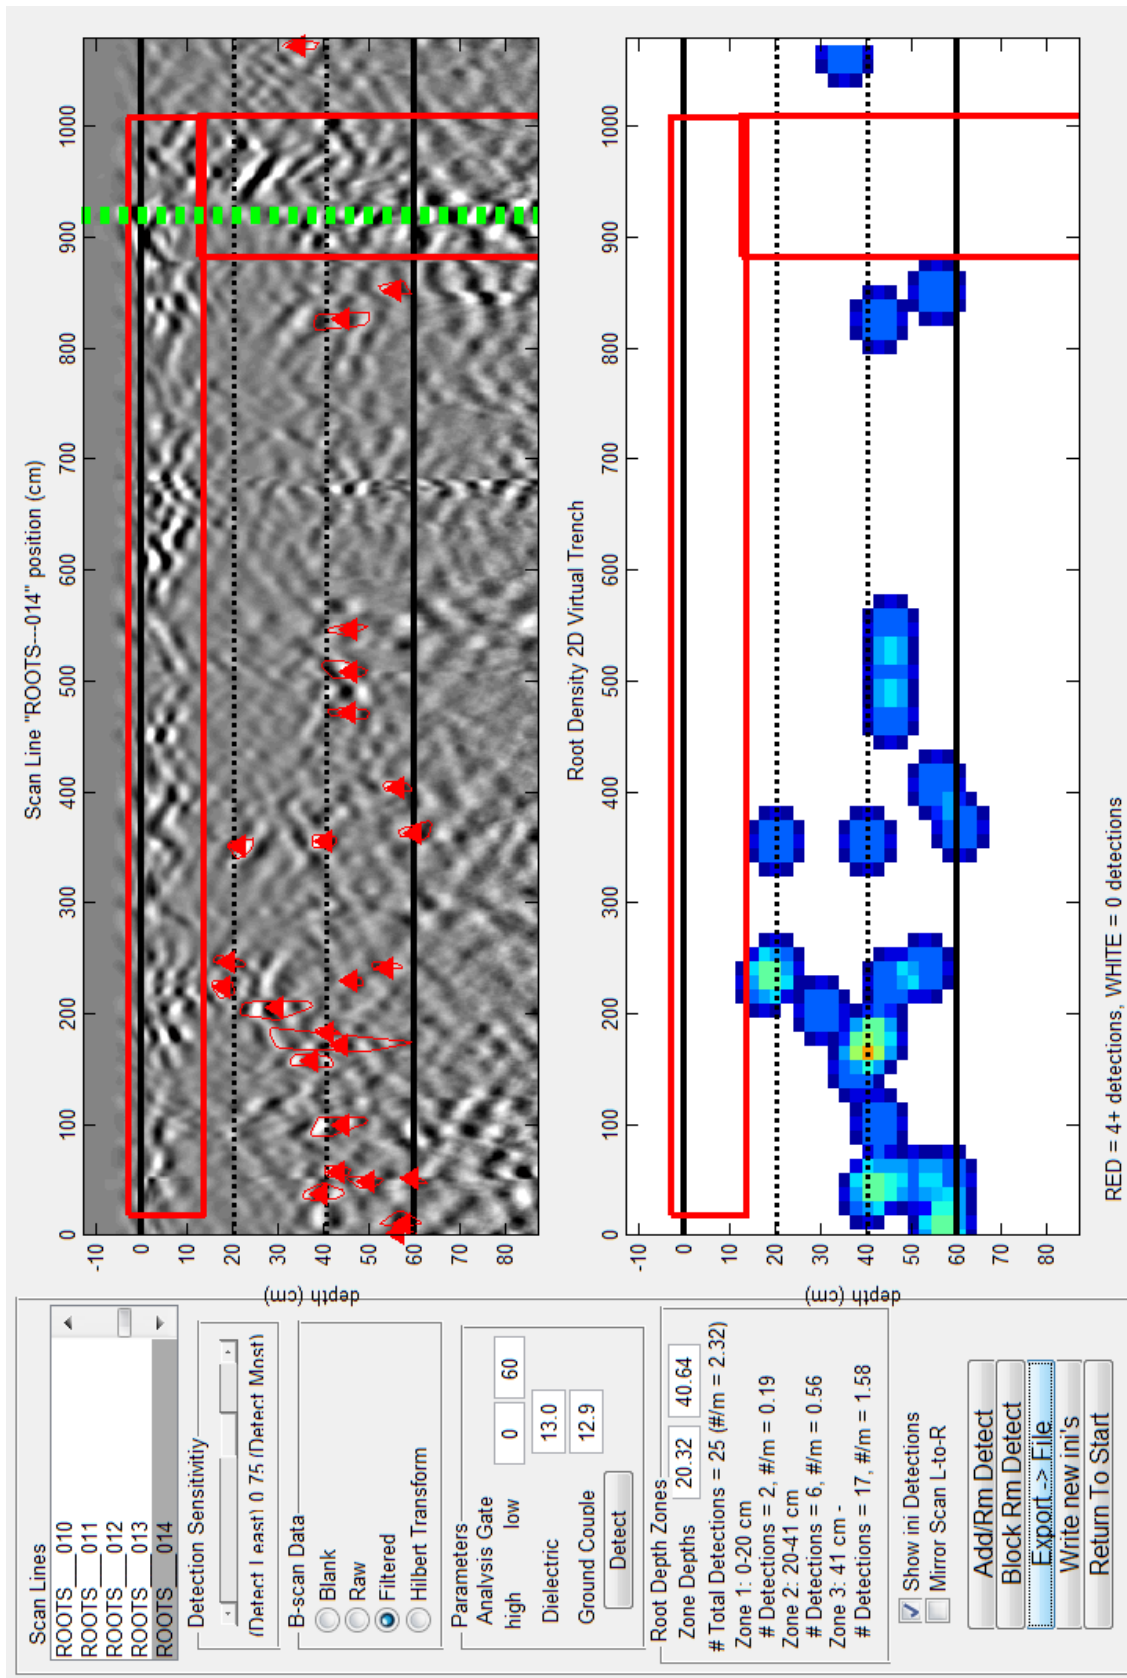
Red squares appear in the graphs and these are abnormal soil conditions such as excavation or rocks. This is particular in scan 14 taken on the excavated driveway.

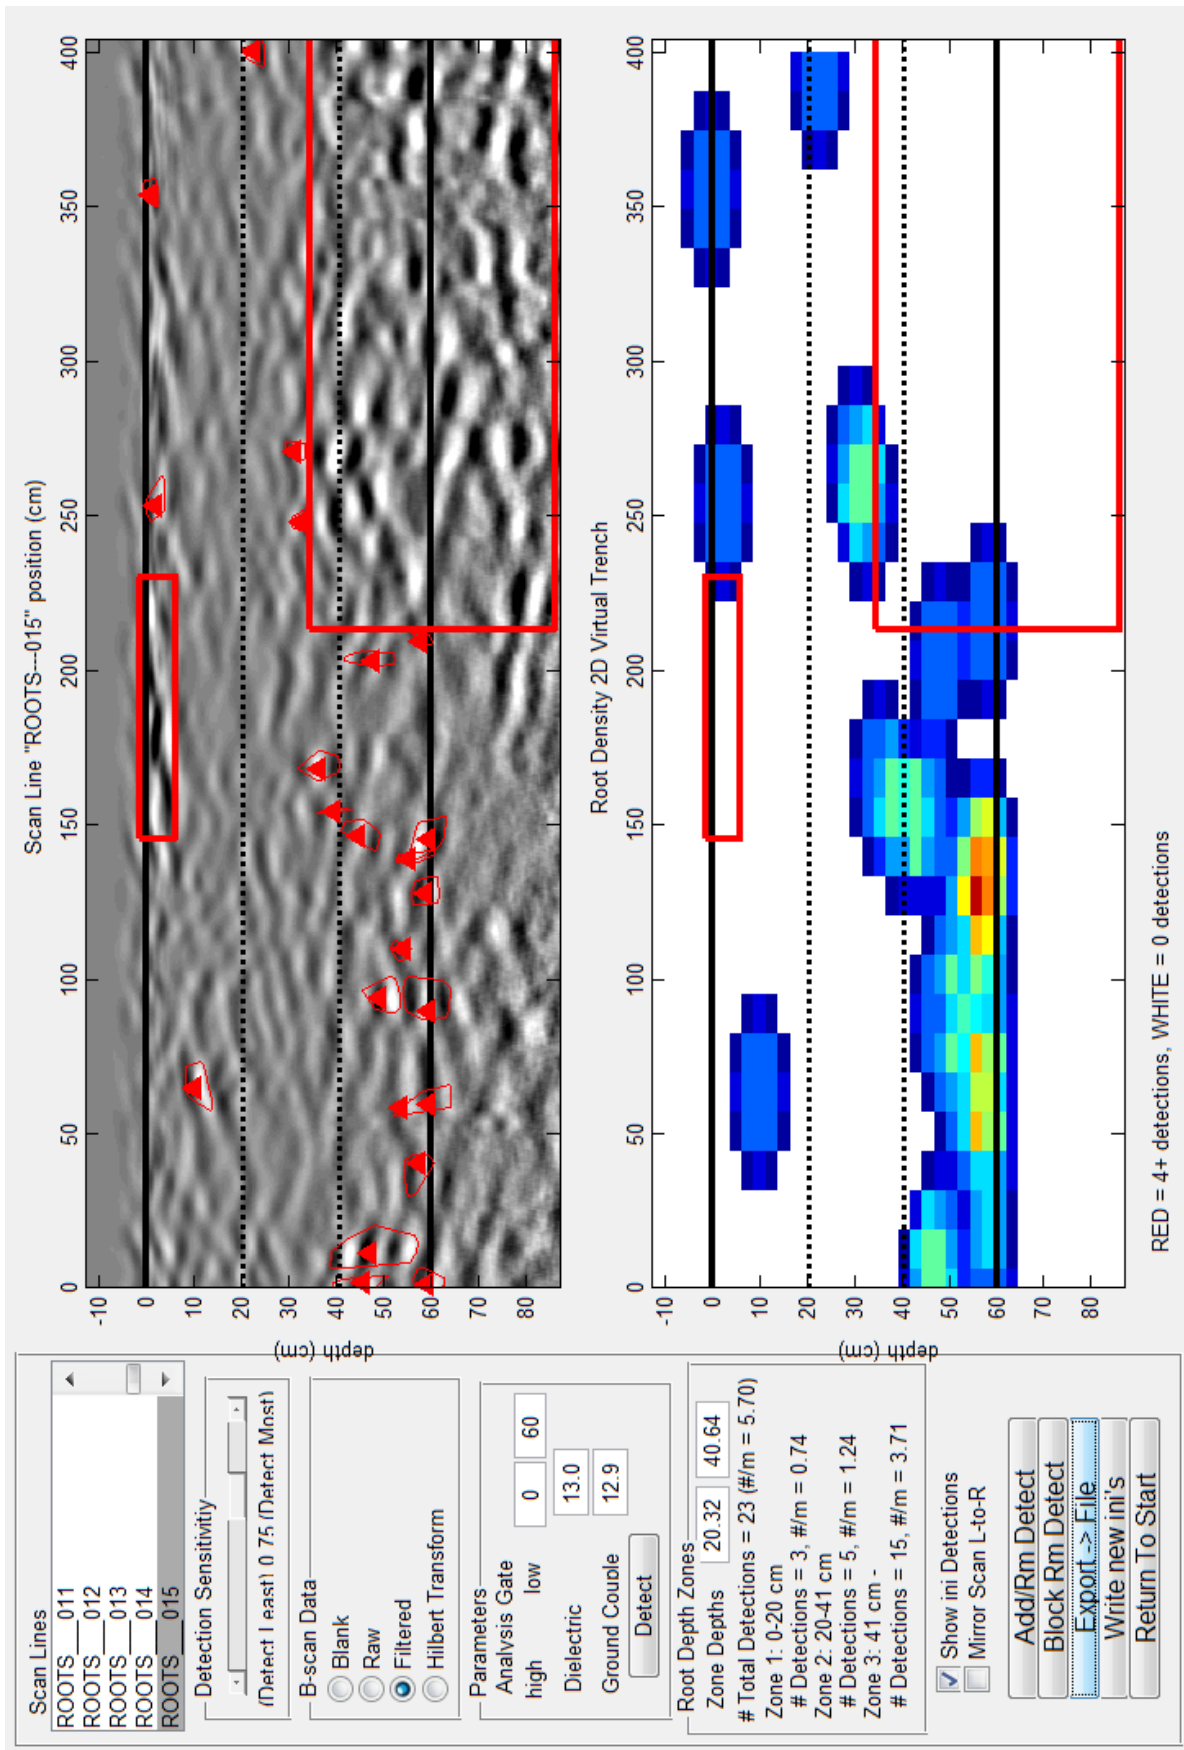
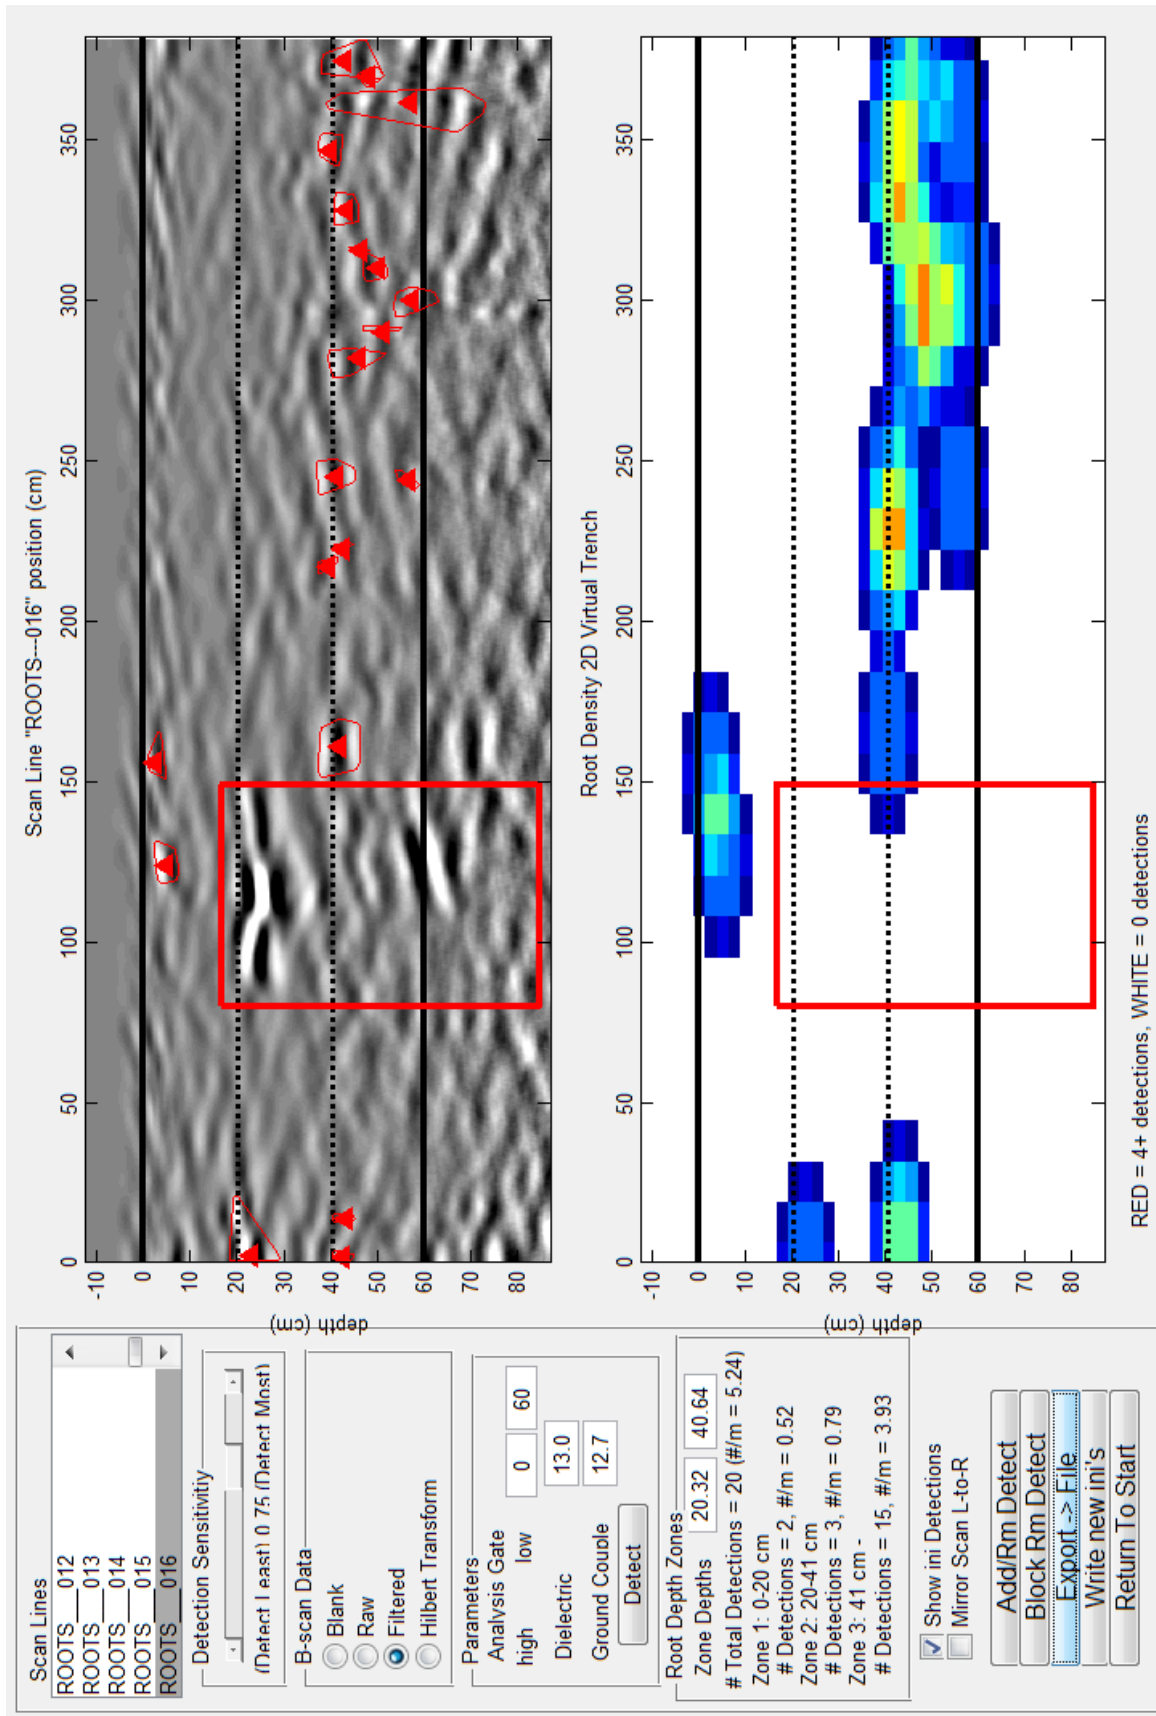
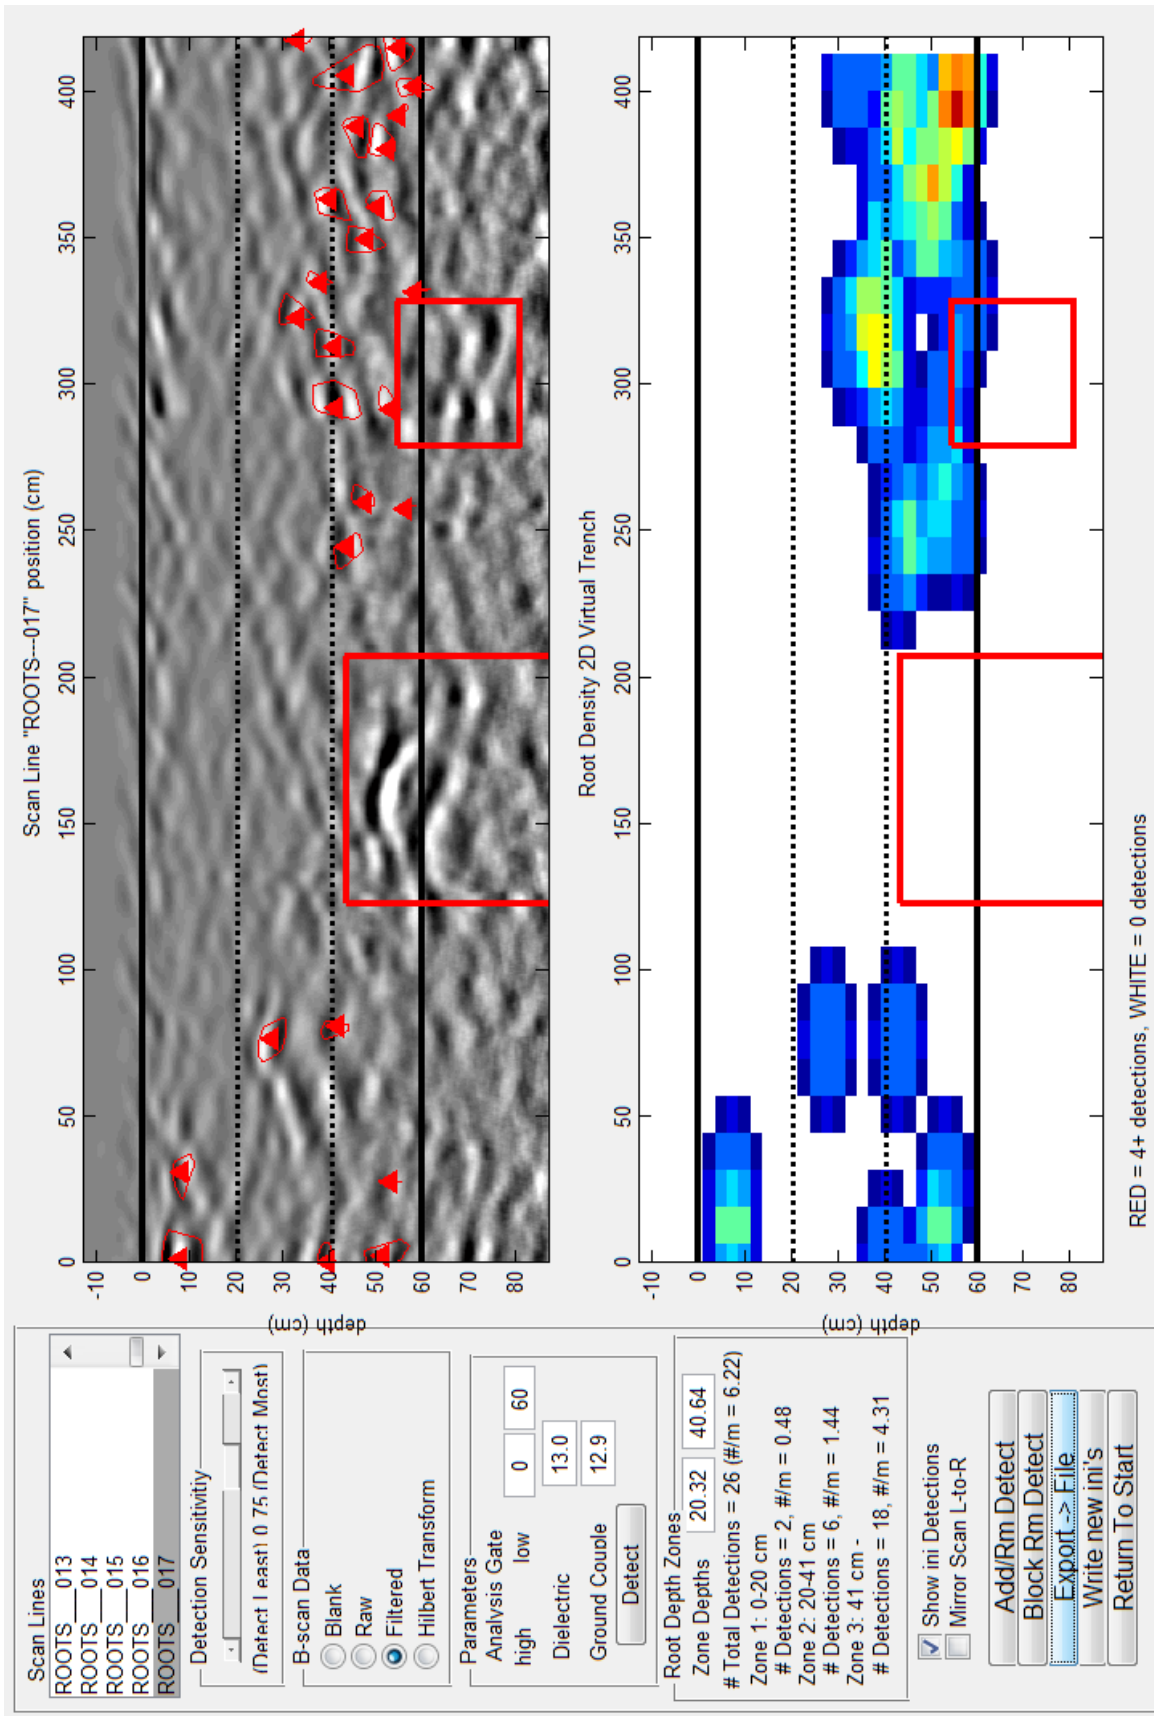
Scans 15, 16 and 17 were short linear scans taken beside the house and show plenty of root matter. There were some smaller shrubs in this vicinity but not all of the roots detected belong to these smaller plants.

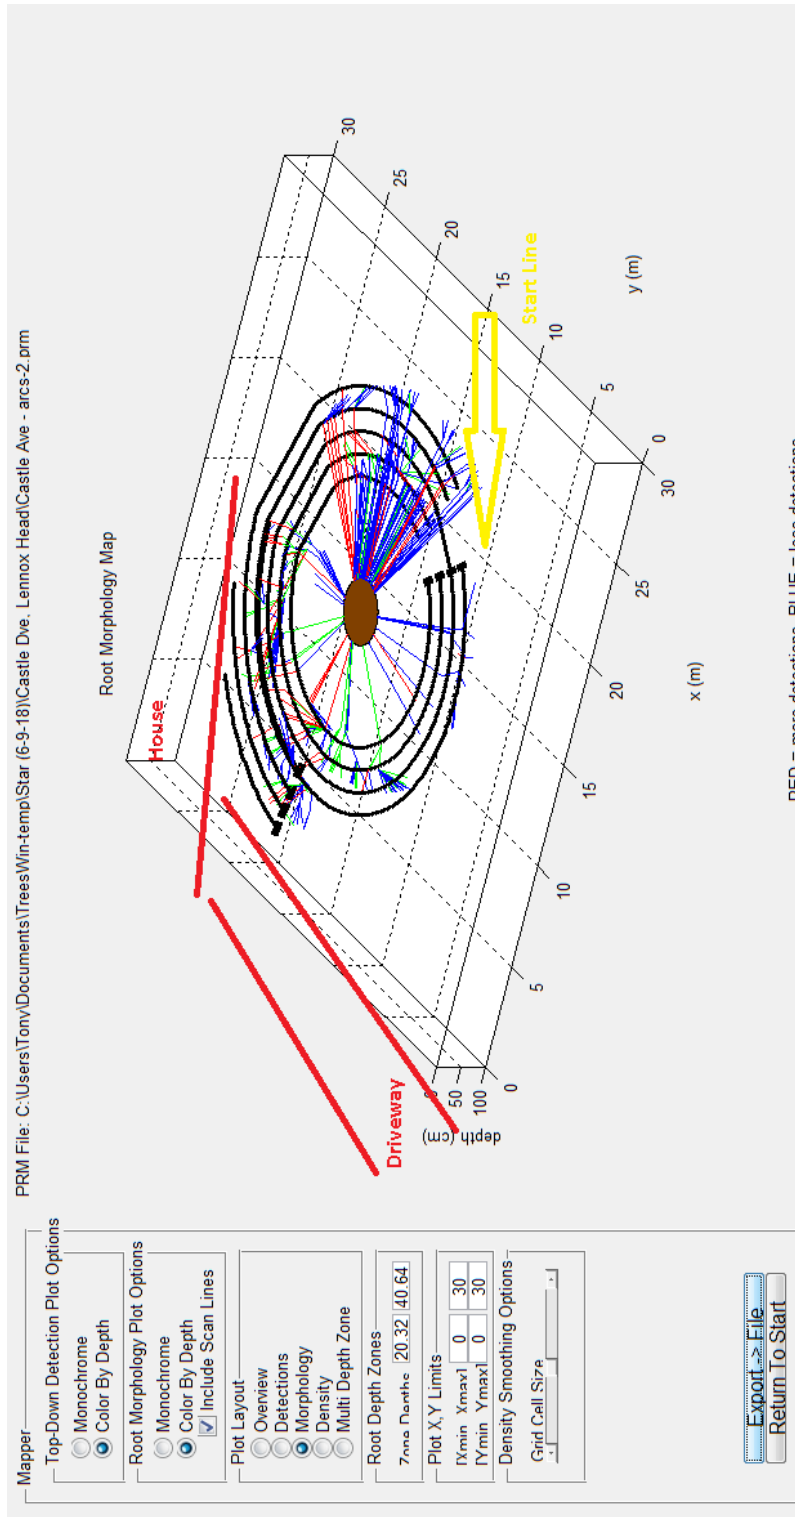
3d imaging of the projected root system.

The final graph shows a 3d projected plan of the trees root system. The greater concentration of roots appear to be on the east side of the tree but much of the larger, near surface roots appear on the house side and the scans show a fair amount of roots directly in front of the house.
