27 April 2018
Ref No. 914108

Further Assessment of Damage to Property at 7 Castle Drive, Lennox Head

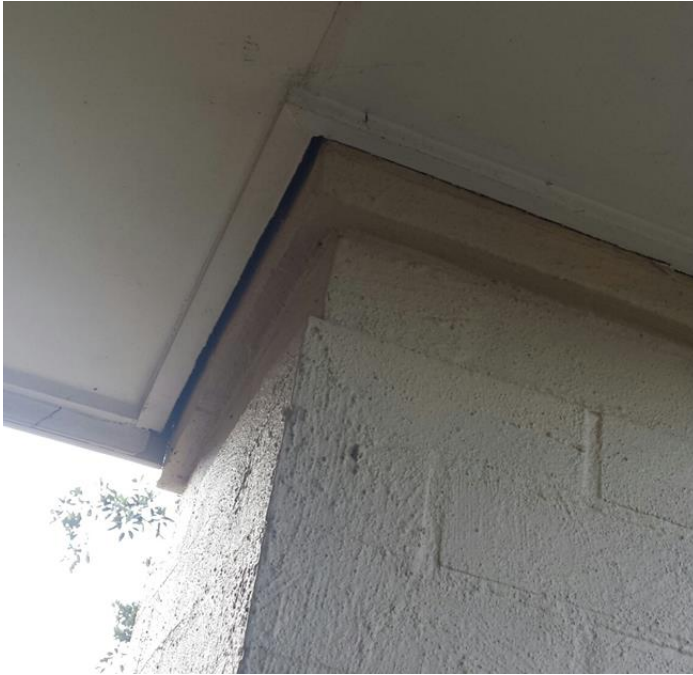
Photo No. 1 – Leaning brick pillar at the entry to the house as photographed on 6 April 2017.

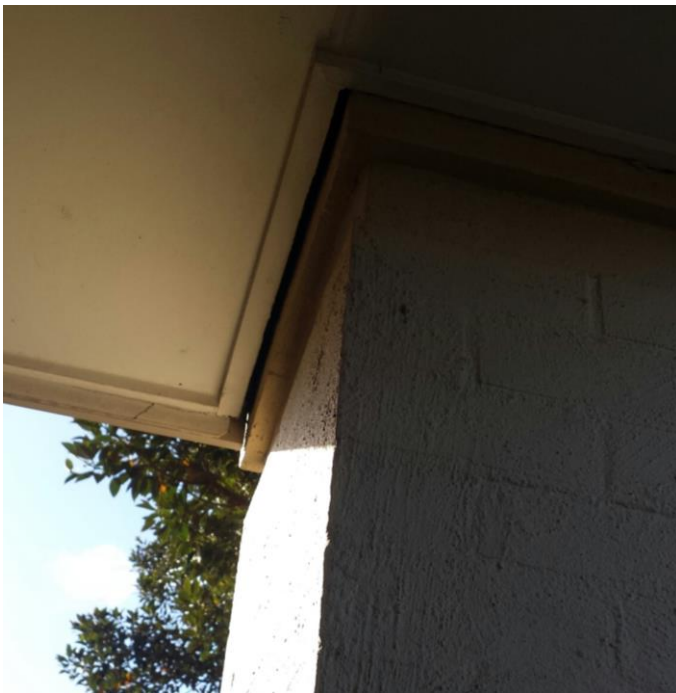
Photo No. 2 – The leaning in the brick pillar at the entry as photographed on 27 April 2018. The lean does not appear to have deteriorated over the past 12 months.

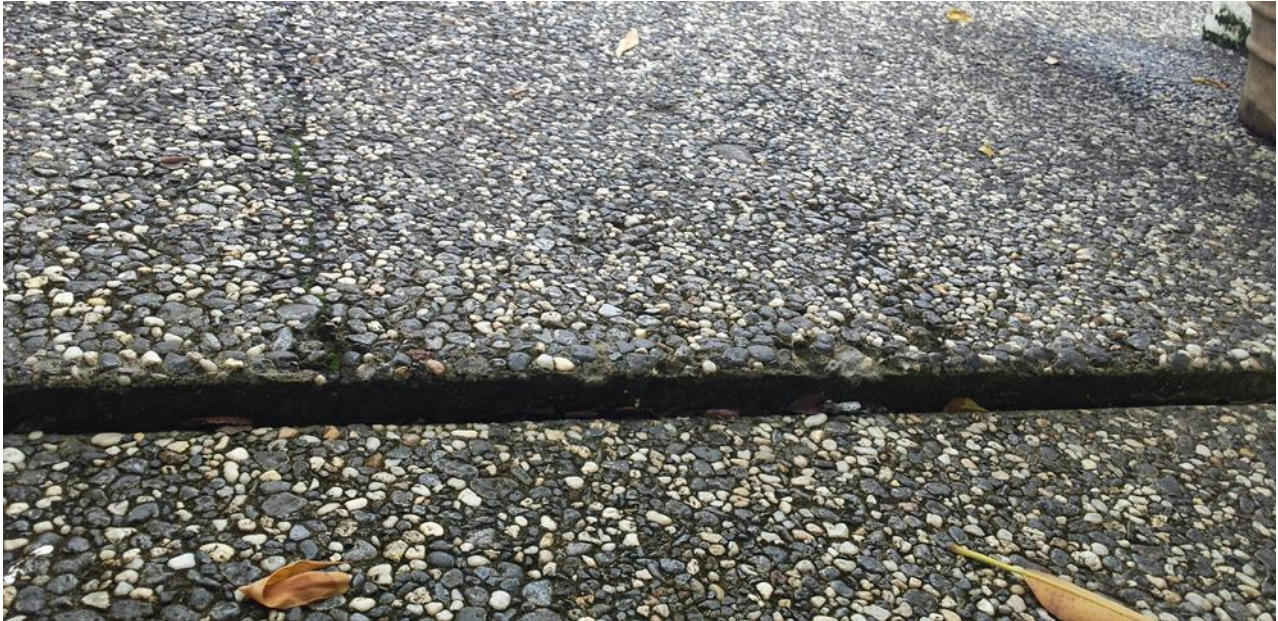
Photo No. 3 – Lifted concrete driveway slab abutting the garage floor slab as photographed on 6 April 2017. At the time the step at the joint was measured at 25mm high.

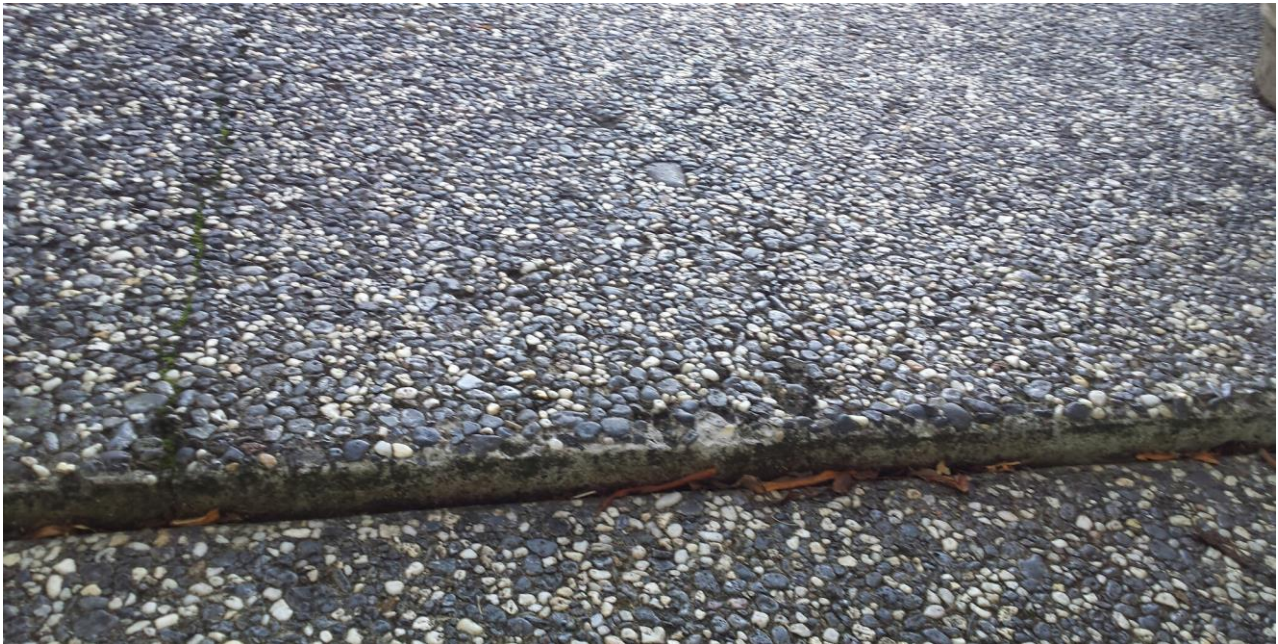
It can be concluded that between 6 April 2017 and 27 April 2018 the extent of damage to the driveway and masonry screen fence at the front of the dwelling at 7 Castle Drive has increased. This has most likely resulted from the continued growth of the root system of the adjoining fig tree. However no other significant increase in movement within the structure of the dwelling was observed.

Photo No. 4 – Lifted concrete driveway slab abutting the garage floor slab as photographed on 27 April 2018 when the step at the joint was measured at 35mm high.

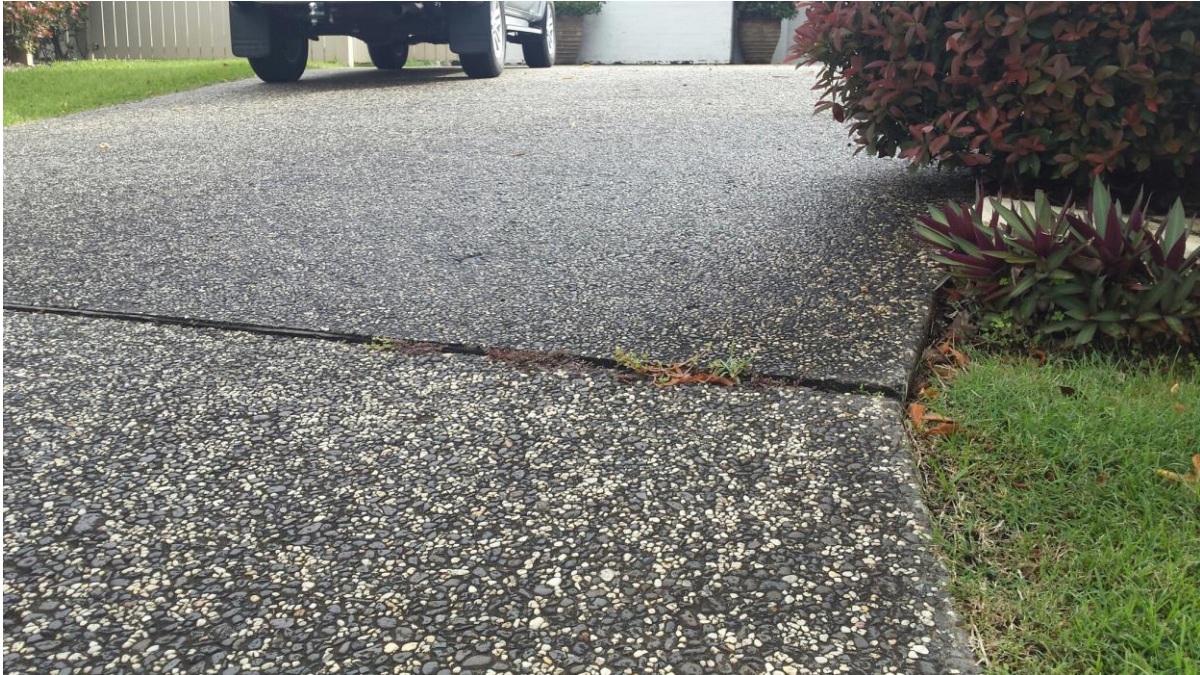
Photo No. 5 – A step in a contraction joint in the driveway slab at the property boundary as photographed on 6 April 2017.

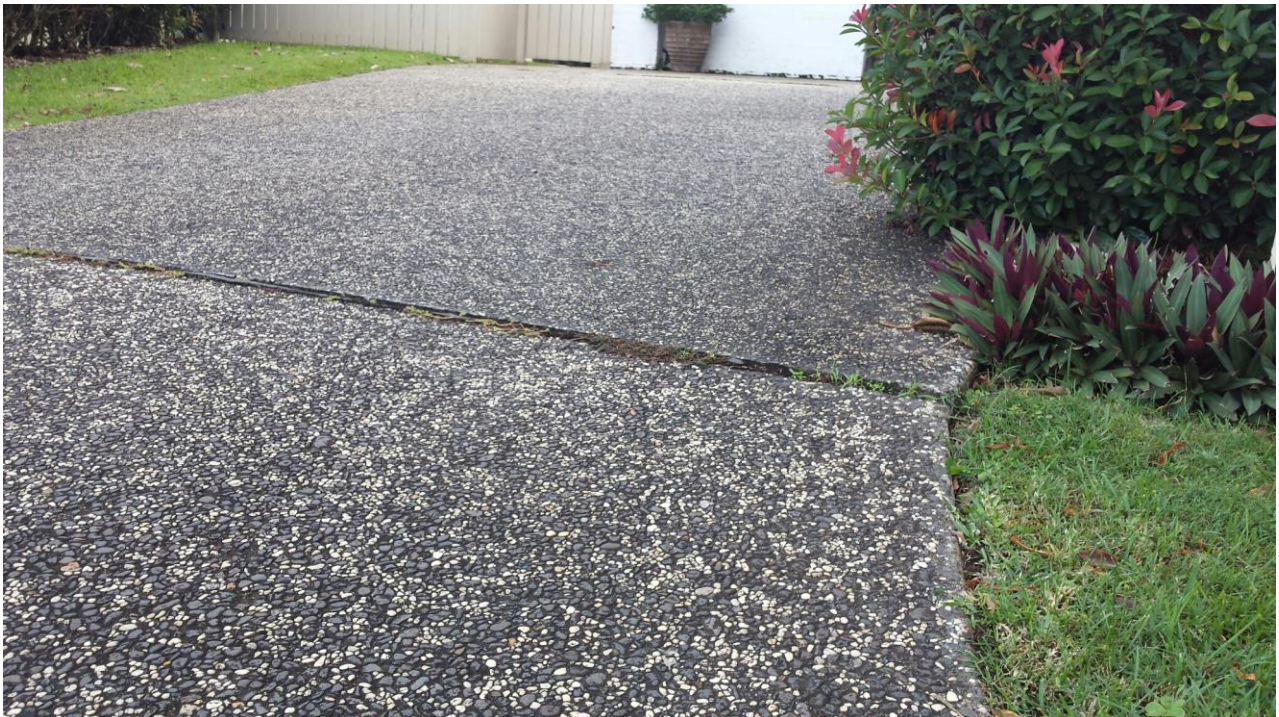
Photo No. 6 – The step in the contraction joint in the driveway slab at the property boundary as photographed on 27 April 2018 did not exhibit any significant change over the past 12 months.

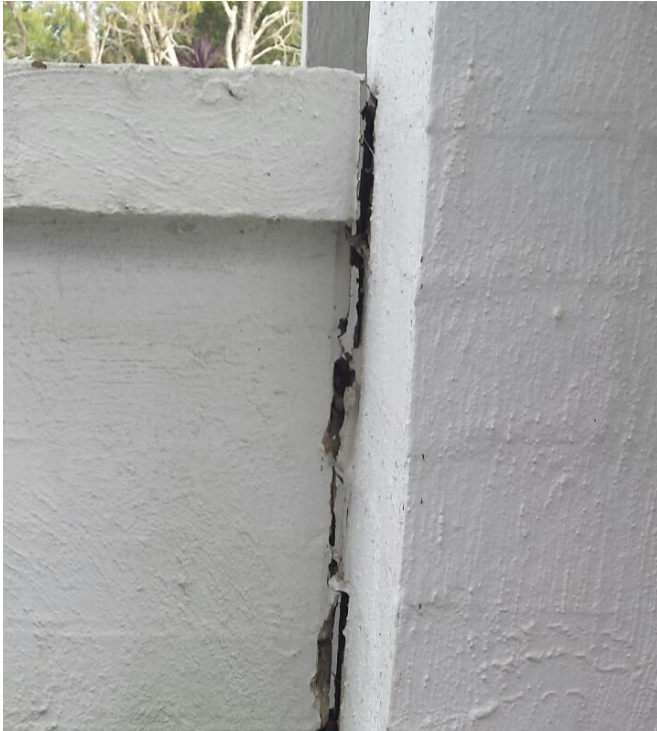
Photo No. 7 – As photographed on 6 April 2017, lifting and rotation of the brick privacy wall on the western side of the garage had opened up a gap in the vertical joint with the house.

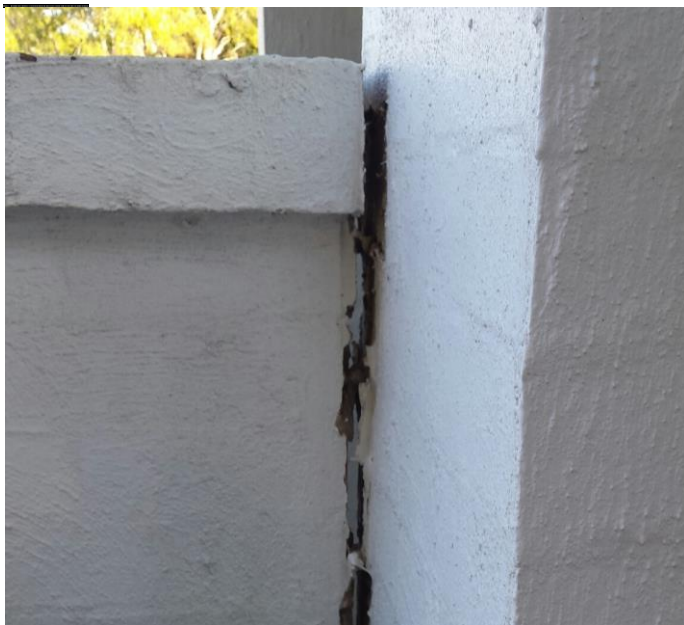
Photo No. 8 –The vertical joint between the brick privacy screen and the house as photographed on 27 April 2017. This joint has widened by about 4mm and the privacy screen has lifted by about 10mm over the past 12 months.

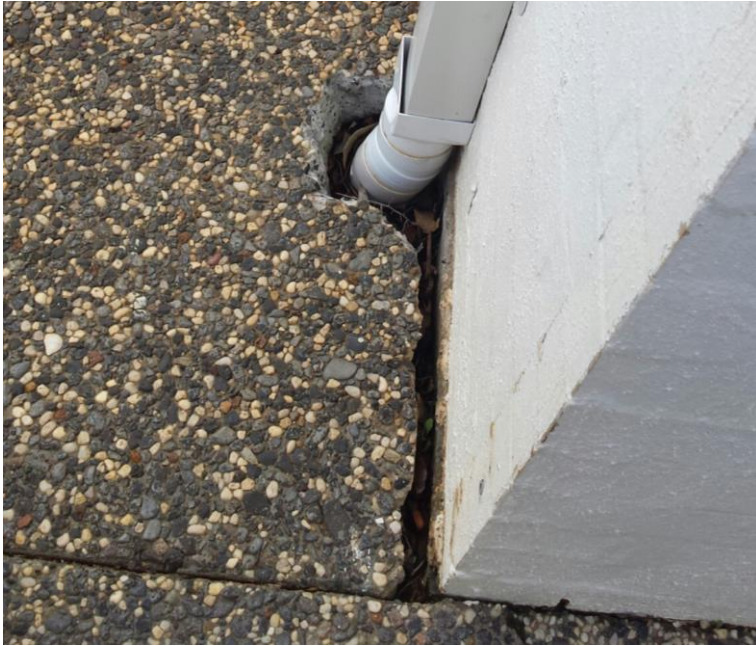
Photo No. 9 – Separation of the 1.3metre wide path from the wall on the western side of the house as photographed on 6 April 2017

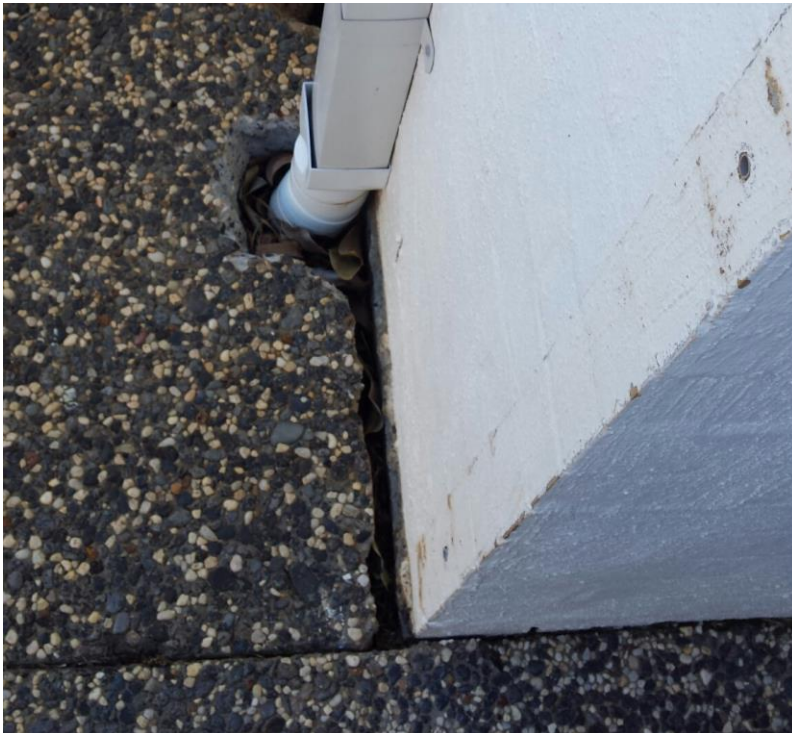
Photo No. 10 – Separation of the 1.3metre wide path from the wall on the western side of the house as photographed on 27 April 2018. The does not appear to have been any significant change since April 2017.

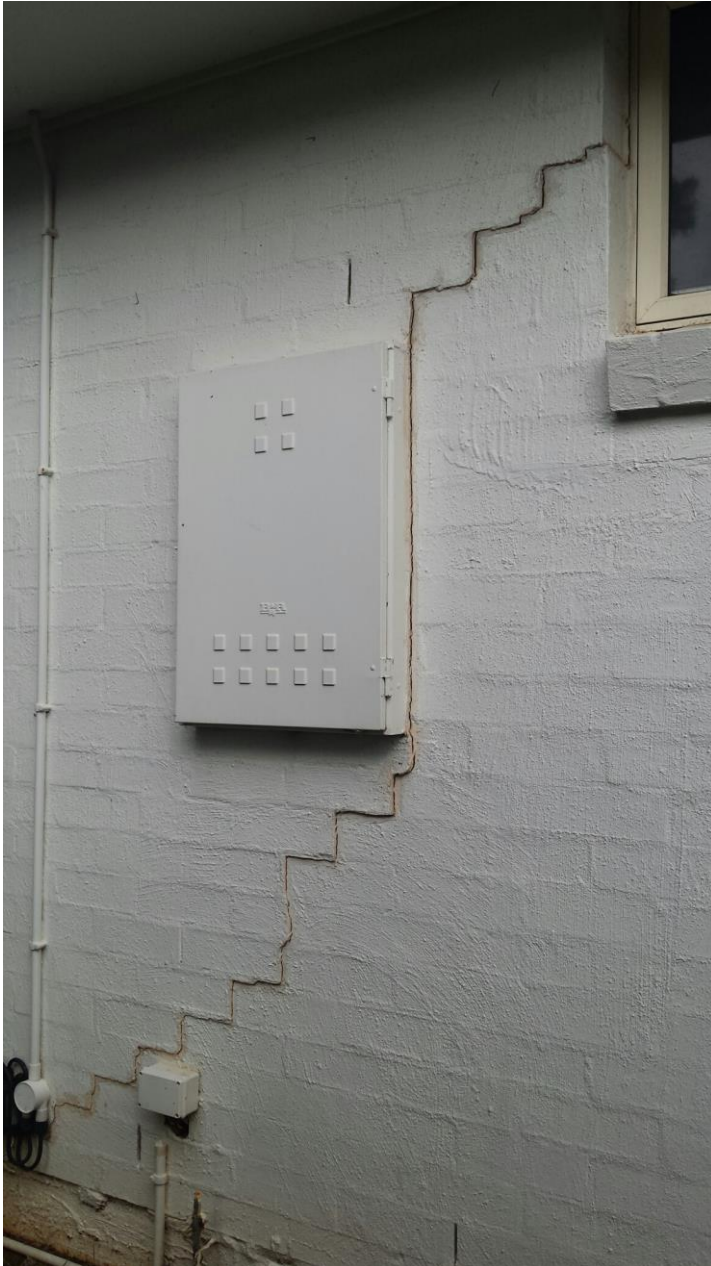
Photo No. 11 – Cracking in the brick wall at the south-eastern corner of the house as photographed on 6 April 2017.

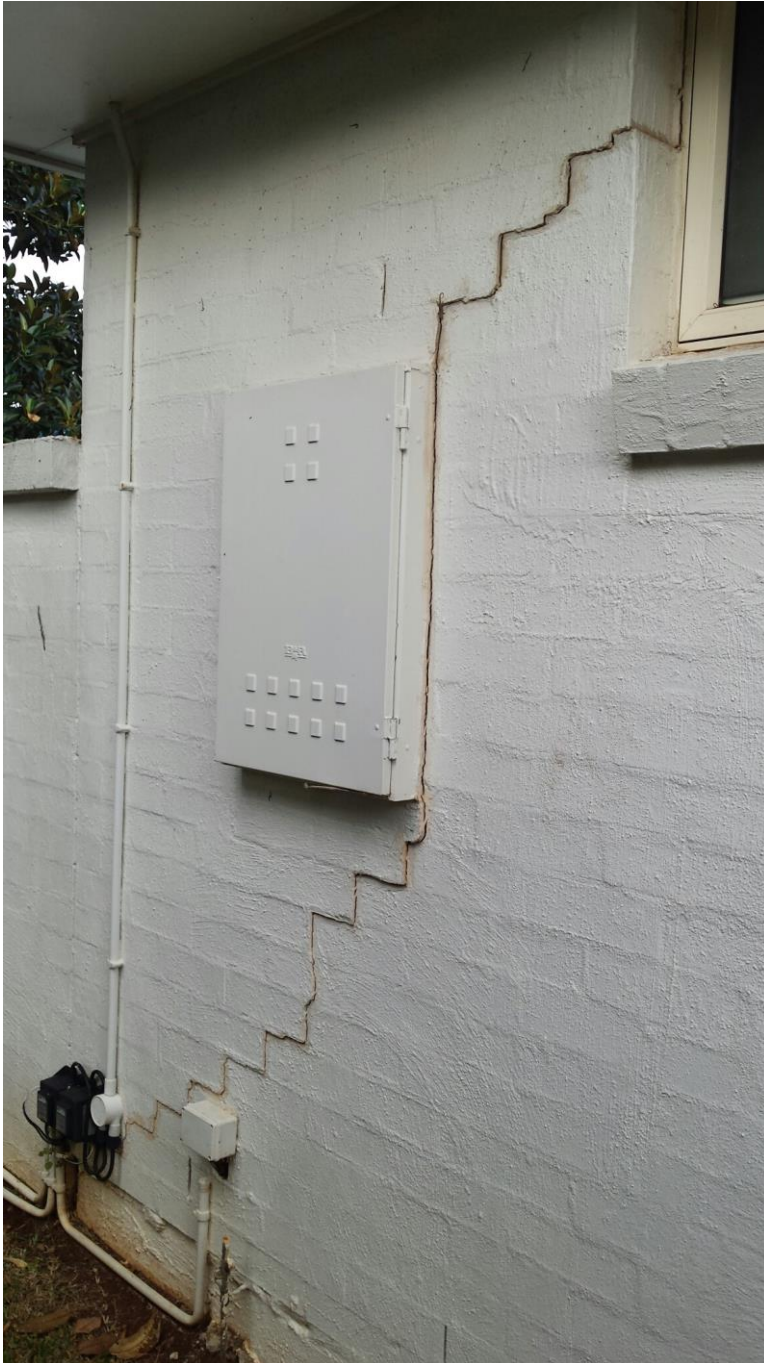
Photo No. 12 – Cracking in the brick wall at the south-eastern corner of the house as photographed on 27 April 2018. This crack does not appear to have deteriorated over the past 12 months.
