General Manager
Ballina Shire Council
PO Box 450
BALLINA NSW 2478

20 April 2017
Ref No. 770108

Assessment of Damage to Property at 7 Castle Drive, Lennox Head

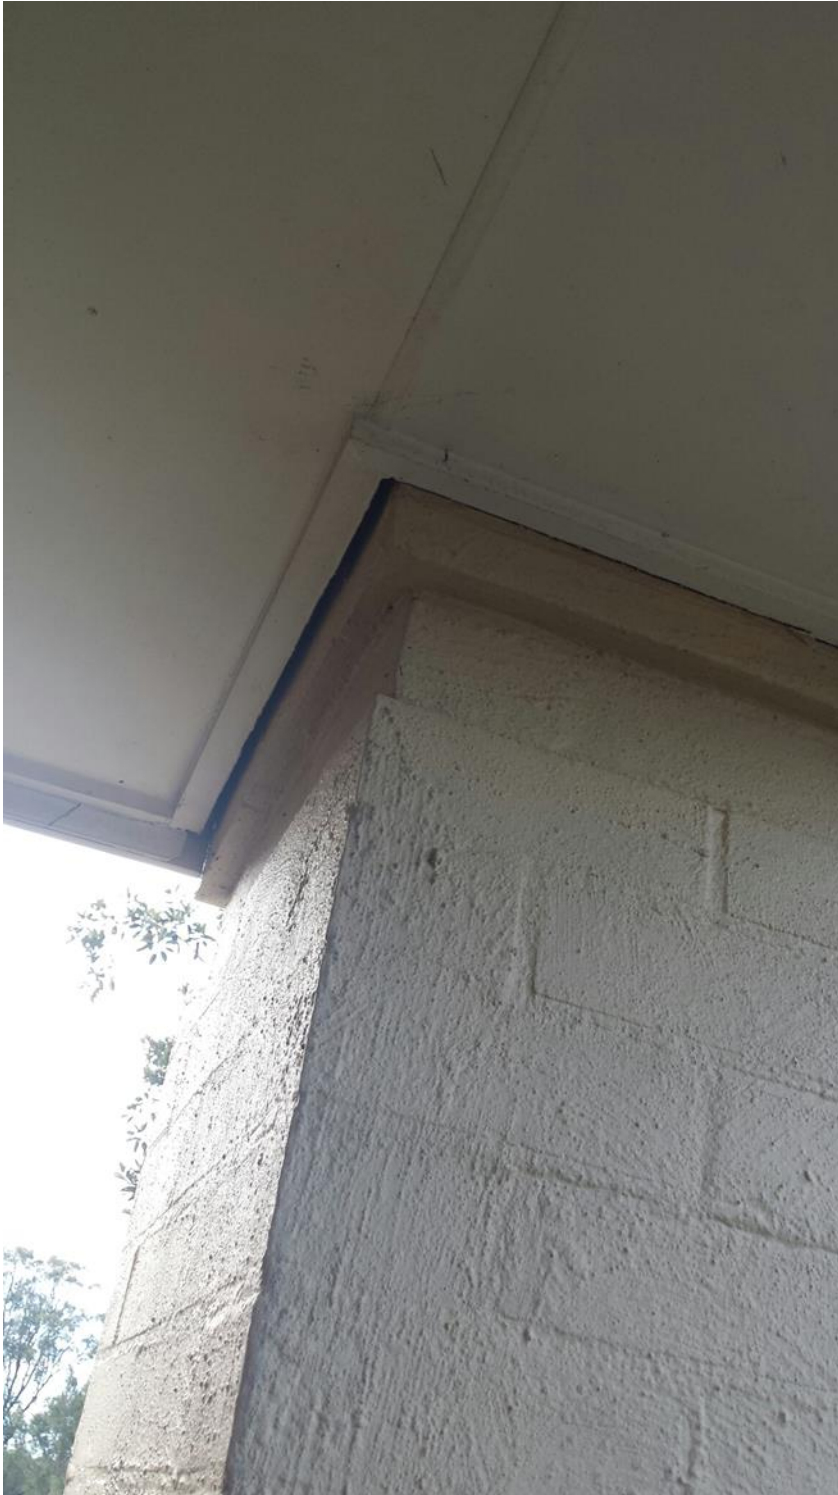
The Lucena report makes note of evidence that the soffit lining around the top of this pillar on the eastern side of the house has been repaired in the past. There is a gap in the edge trimming around the soffit which indicates that the top of the pillar has rotated outwards from the dwelling by about 15 millimetres (refer to Photo No. 1). This lean in the pillar however is otherwise not perceptible to the naked eye.

Comparison of the photographs taken in 2015 and 2017 indicate that the degree of rotation of the pillar may have increased slightly over the past 20 months.

Photo No. 1 – Leaning brick pillar at the entry to the house.

- d) Re-lay the 1.3metre wide footpath on the western side of the house and the driveway slab between the garage and the front boundary.
- e) Remove and replace the cracked brickwork at the south-eastern corner of the house.
- f) Re-construct the brick privacy screen on the western side of the garage.
- g) Bag and paint the restored brickwork.
- h) Provide new painted timber trimming around the top of the brick pillar at the entry to the house.

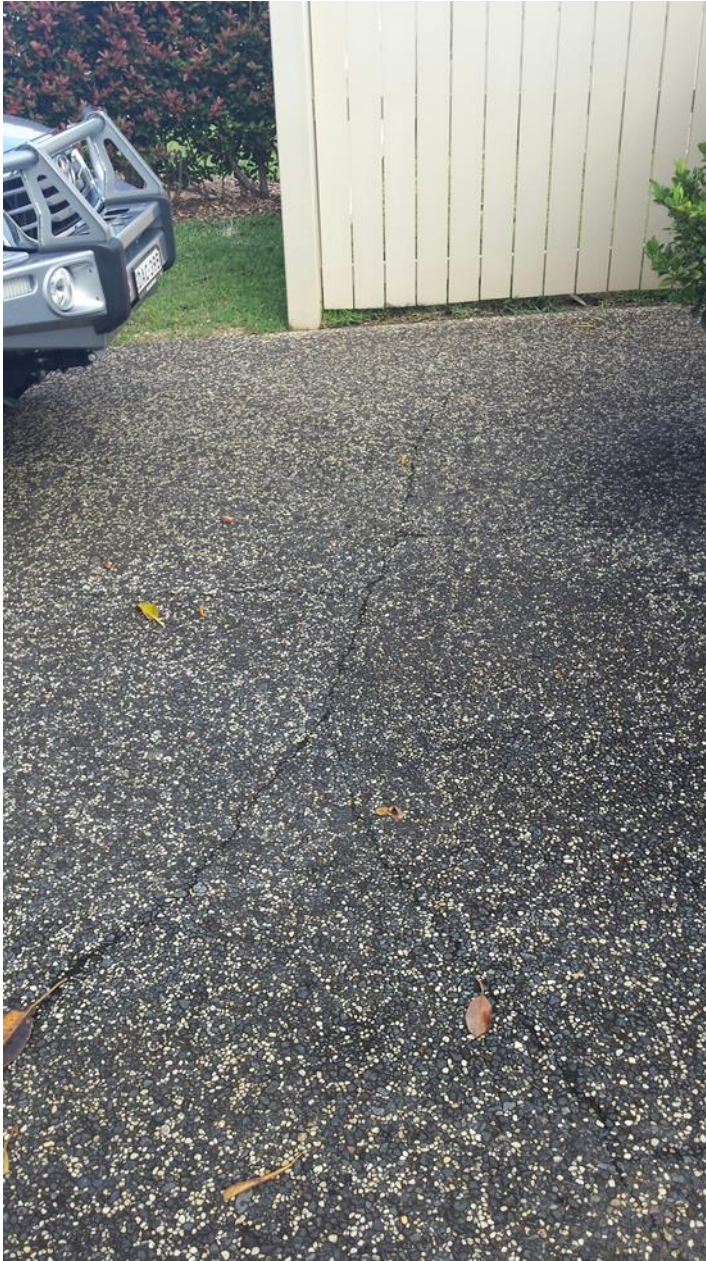
As noted in the Lucena report, the driveway slab has lifted at the construction joint against the garage slab and this has induced significant cracking within the panels of concrete slab that adjoin the garage (Refer to Photo No. 2). At the junction with the garage, the driveway slab has now lifted by up to 30mm (Refer to Photo No. 3) and comparison of the photographs taken in 2015 and 2017 indicate that the amounts of movement and cracking in the slab appear to have increased over the past 20 months.

Photo No. 2 – Typical cracking of the concrete driveway slab abutting the garage floor slab.

- a) Remove the privacy screen on the western side of the garage.
- b) Remove the 1.3metre wide footpath on the western side of the house and all of the driveway slab between the garage and the contraction joint at the front boundary.
- c) Locate and remove the subject tree root and backfill the excavation with granular material.

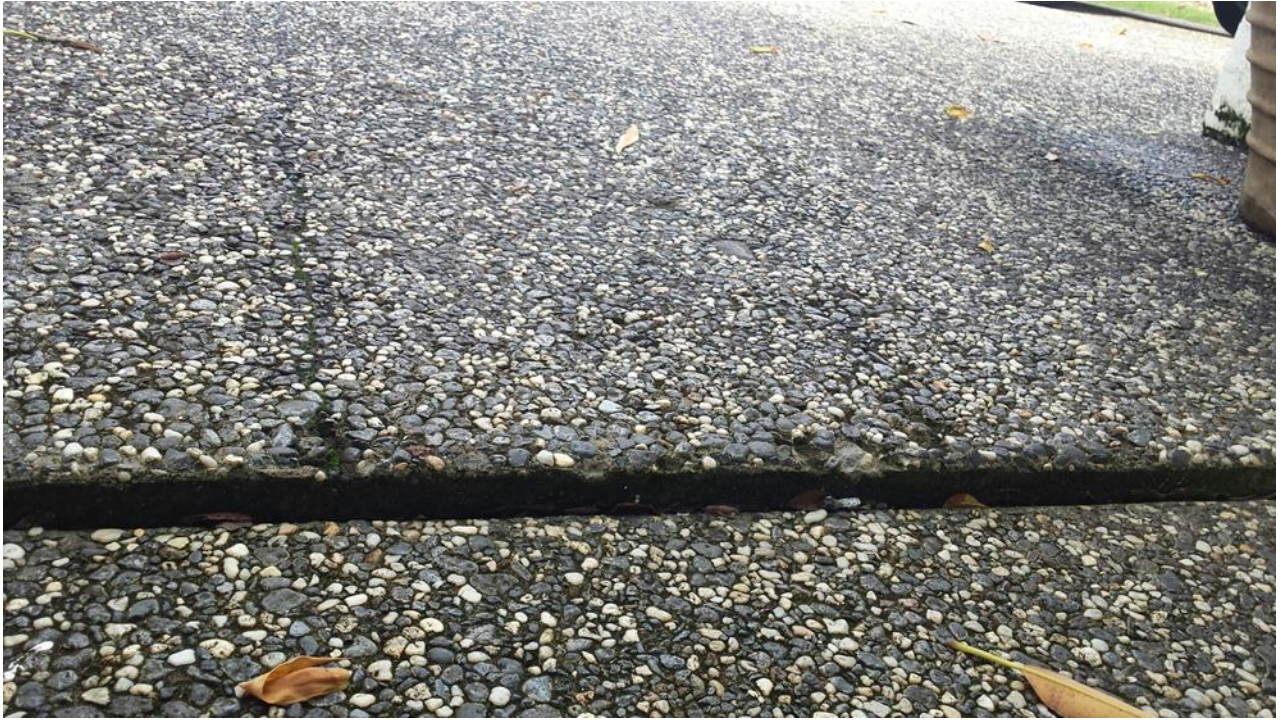
Photo No. 3 – Lifted concrete driveway slab abutting the garage floor slab. Note the presence of cracks.

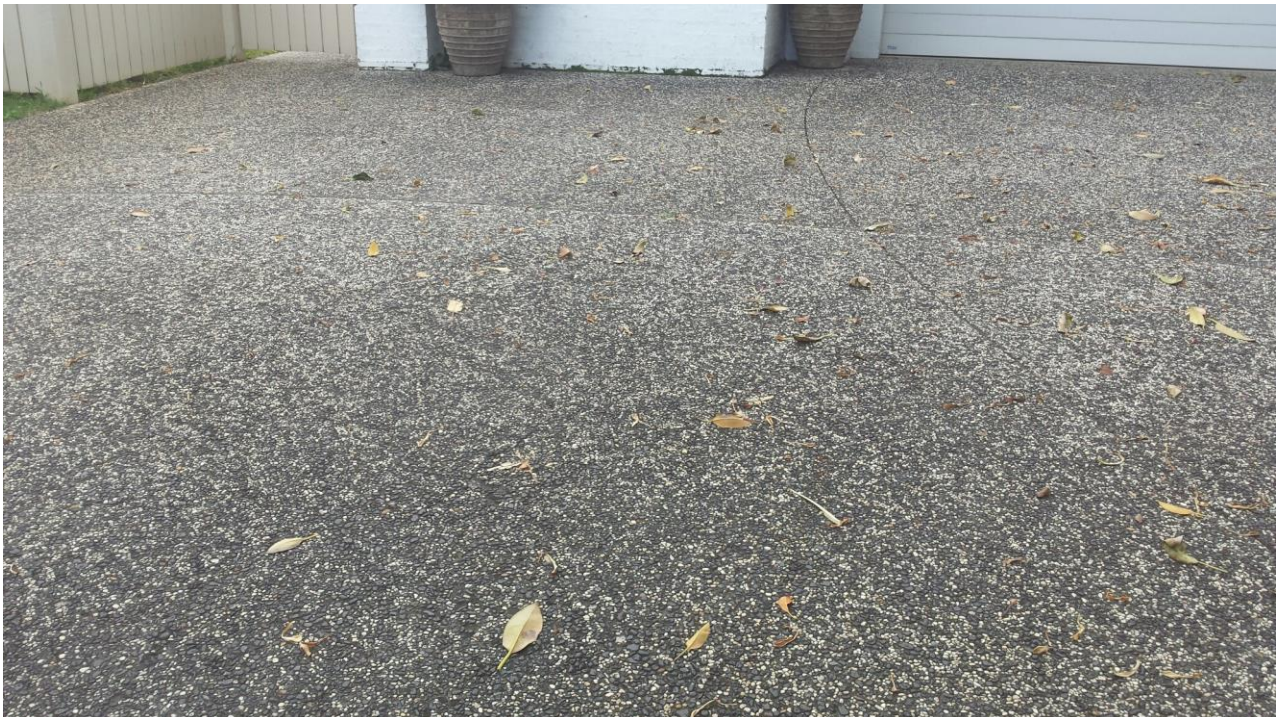
One of the cracks at this location also propagates across a contraction joint in the driveway slab into an adjoining panel of concrete to the south (refer to Photo No. 4).

Photo No. 4 – Reflected cracking across a joint in the driveway slab.

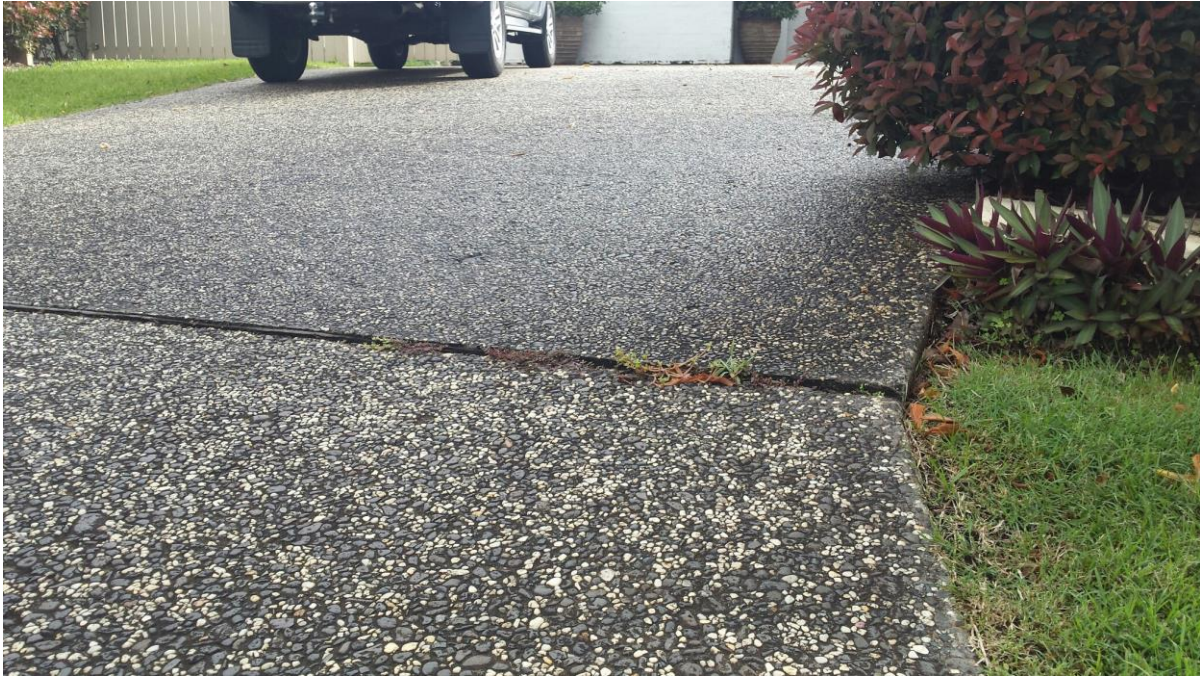
A crack is also present in the next panel (that extends out to the property boundary). However this crack may be a shrinkage crack induced by the acute shape of this panel of concrete. At the front boundary of the property, the contraction joint in this panel has a significant step of up to 15mm high (refer to Photo No. 5). It is uncertain whether this can be attributed to tree root action or settlement of the adjoining slab. It is noted that a sewer line traverses beneath the adjoining slab and consolidation of backfill within the associated pipe trench offers a possible alternative explanation for this discontinuity in the driveway level.

Photo No. 5 – A step in a contraction joint in the driveway slab at the property boundary.

1. It will be difficult to match the existing pebblecrete finish and having a slightly different concrete finish occurring at the property and extending to the road could be considered to be an acceptable outcome
2. The 15 step in the driveway pavement at the property boundary could thus be corrected

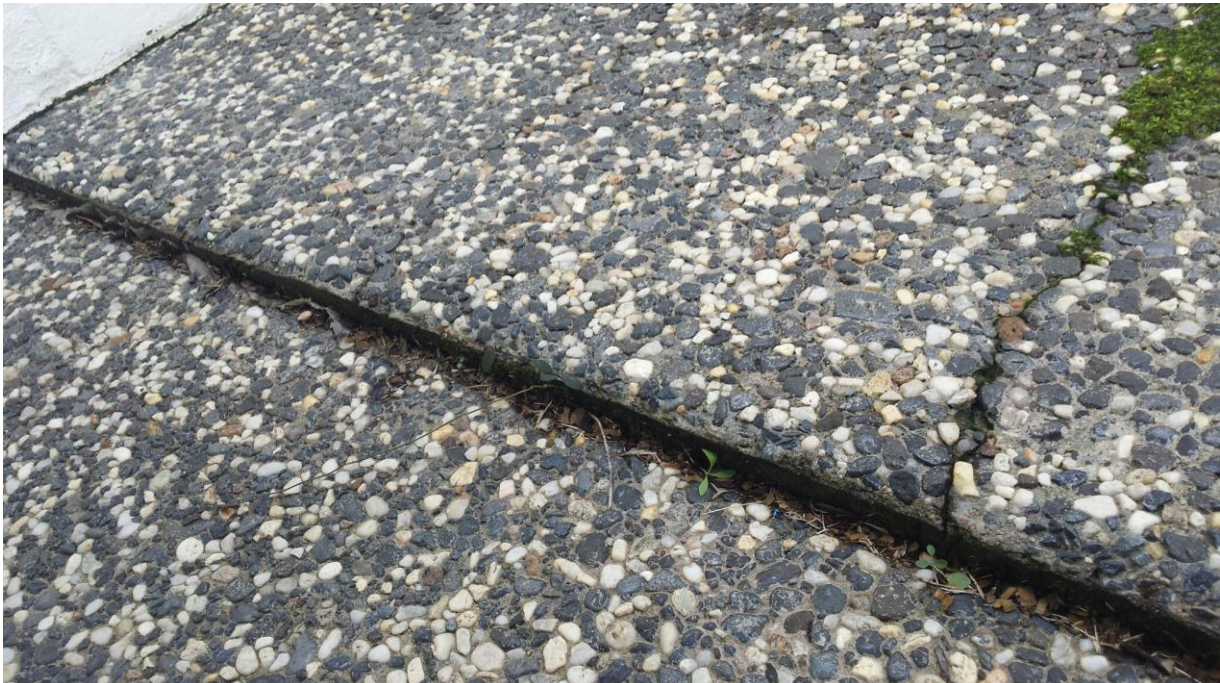
This brick privacy screen has been built on top of the driveway slab that extends across the front of the western side of the dwelling. This slab has also lifted as evident from the step in the joint where the slab abuts the house (refer to Photo No. 6).

Photo No. 6 – A step and crack in the slab behind the privacy screen on the western side of the garage.

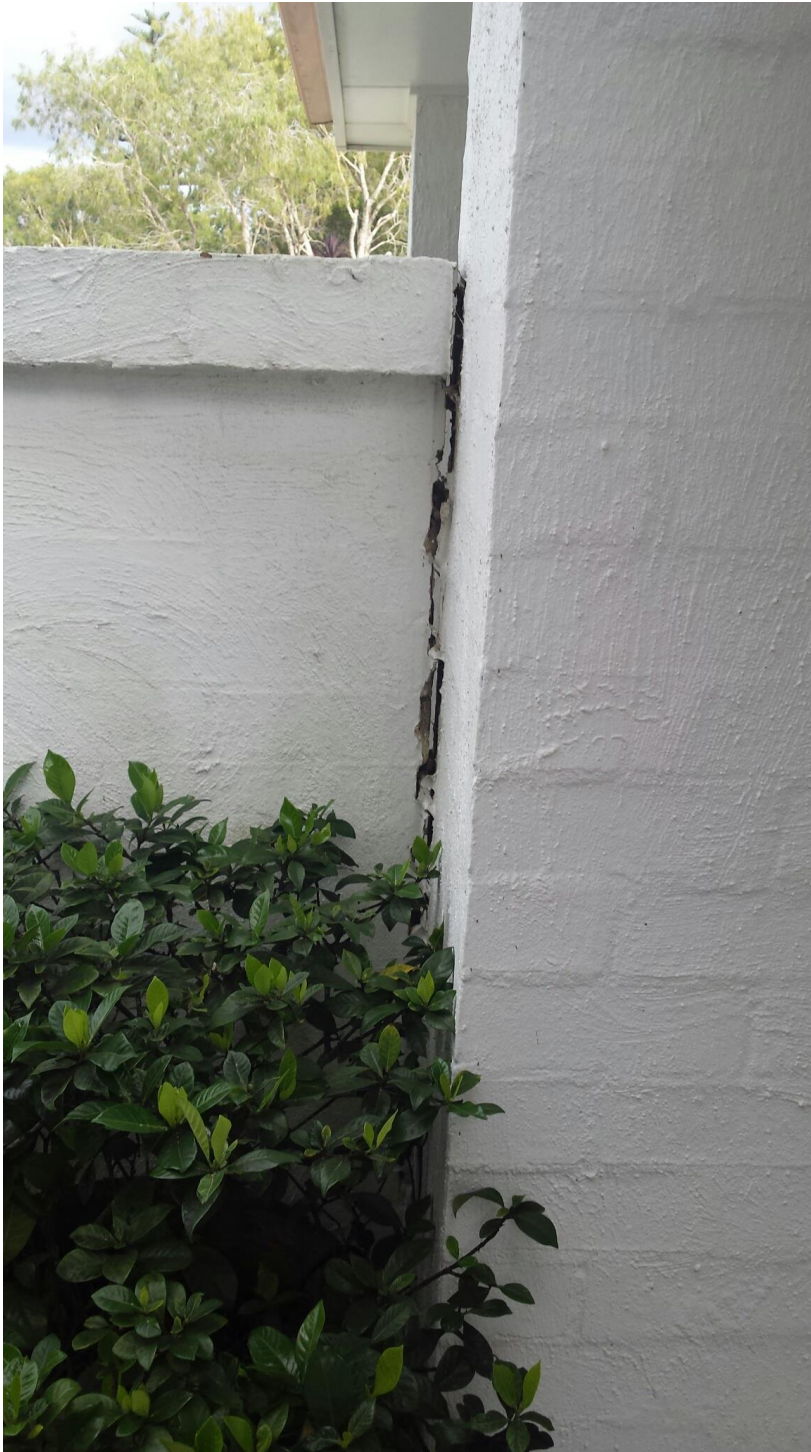
As noted in the Lucena report, the top of this wall has also rotated outwards away from the house (Refer to Photo No. 7). This is consistent with the upwards movement of the driveway slab, which is likely to have been pushed upwards by the tree root that extends across the front of the house.

At this location, the concrete slab has now lifted by up to 25mm and comparison of the photographs taken in 2015 and 2017 indicate that the amounts of movement and cracking in the slab appear to have increased over the past 20 months.

Photo No. 7 – Rotation of the brick privacy wall on the western side of the garage as evident from the gap that has opened up in the vertical joint.

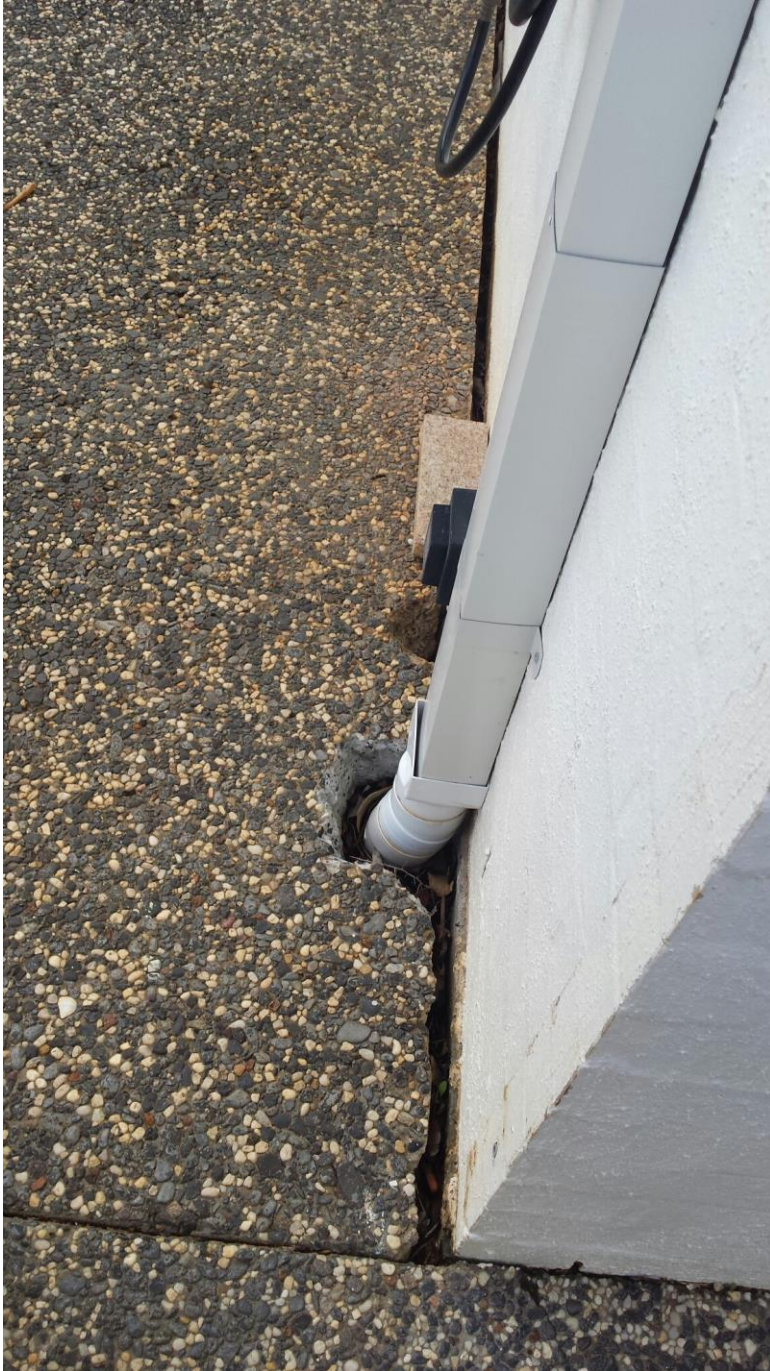
As noted in the Lucena report, the 1.3 metre wide path on the western side of the house has separated from the house by about 30 to 40mm (refer to Photo No. 8) and in parts there is evidence that the path has lifted. There are also cracks in this path (refer to Photo No. 9) which have most likely been caused by the lifting of the slab.

As noted in the Lucena report, this movement has been caused by the tree root extending along the western side of the house. This tree root is probably the same tree root that extends across the front of the house.

Photo No. 8 – Separation of the 1.3metre wide path from the wall on the western side of the house

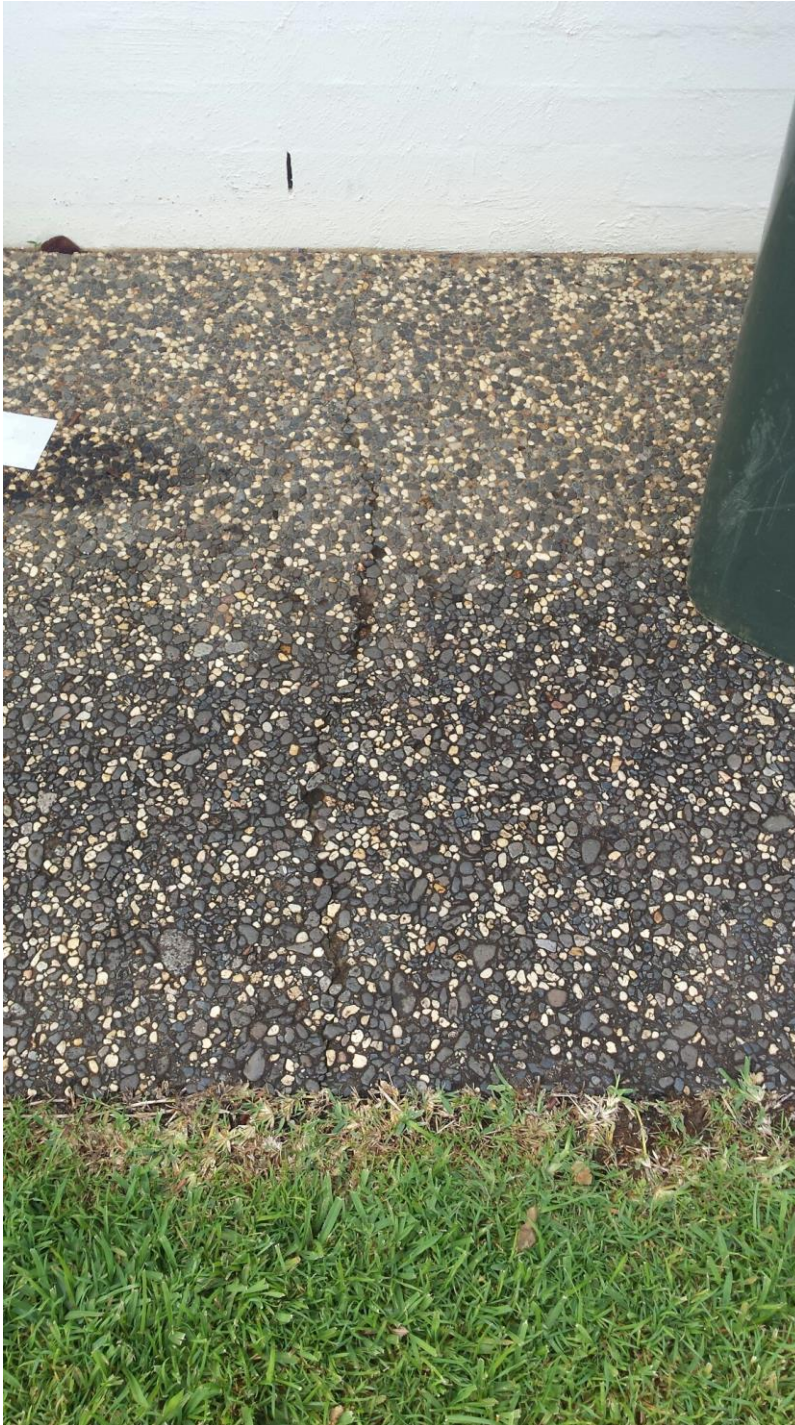
Photo No. 9 –A crack in the 1.3 metre wide concrete path on the western side of the house

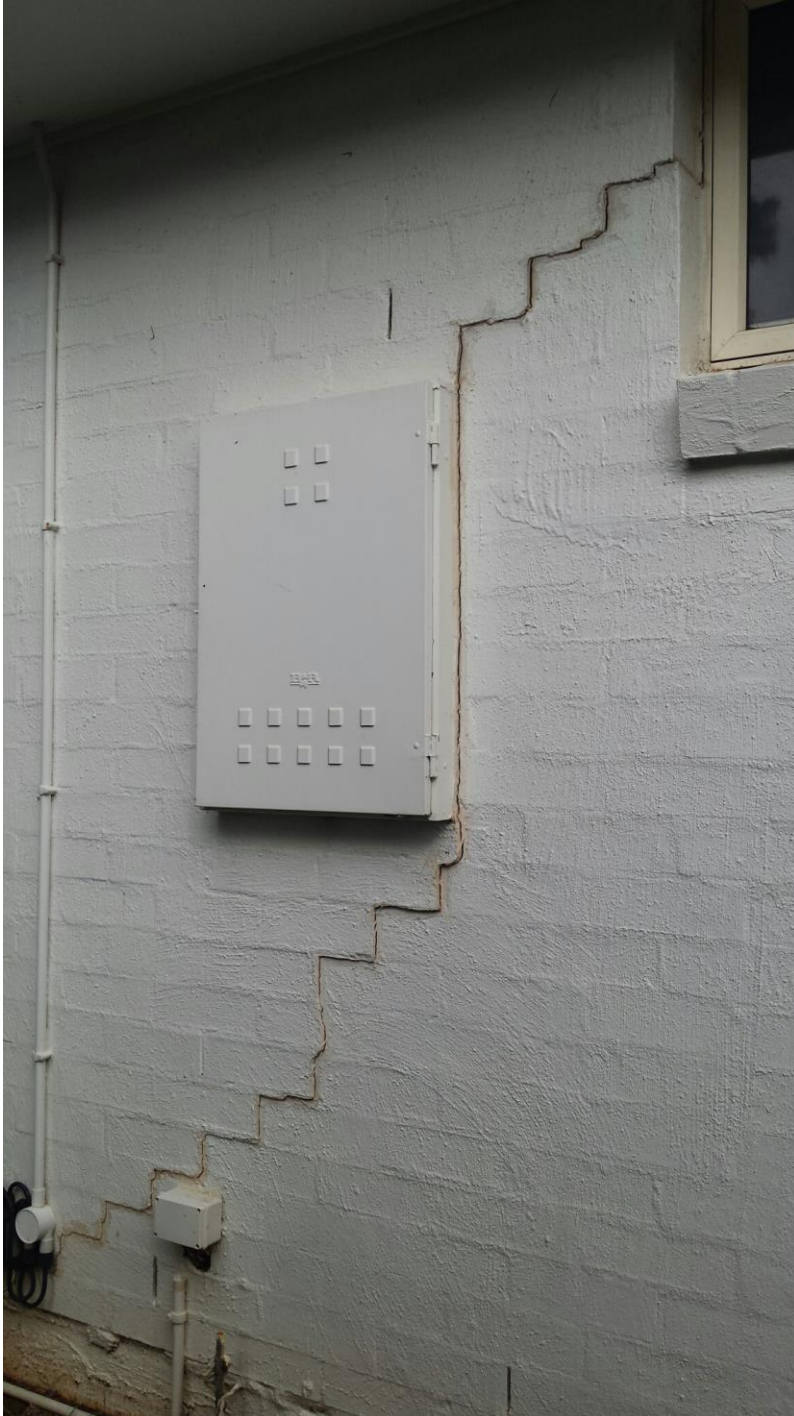
As noted in the Lucena report, a diagonal crack is located on the (eastern) side wall at the south-eastern corner of the house and this crack follows the bed joints in the brickwork (refer to Photo No. 10).

that the tree root traverses east-west across the front of the house. It is important to note that the pattern of the cracking indicates that at this location, the top of the brickwork in the southern wall has rotated outwards from the building (towards the south, in a similar fashion to both the adjoining brick privacy screen wall and the entry pillar). In addition to rotating towards the south, this cracked section of brickwork has also rotated outwards towards the east.

On the basis of the above, and in the absence of any evidence that the piers specified in the design drawings have not been provided in full, it is concluded that this crack is more likely to be attributed to tree roots.

Comparison of the photographs taken in 2015 and 2017 indicate that the amounts of movement and cracking in the brickwork at this location appear to have increased over the past 20 months. This is consistent with the cracking observed elsewhere on the property.

Photo No. 10 – Cracking in the brick wall at the south-eastern corner of the house.
