Peter Lucena
& Associates
Pty. Ltd.

19th August 2015

**Re: Report on Subsidence/Tree Root Damage at 7 Castle Dr
Lennox Head**

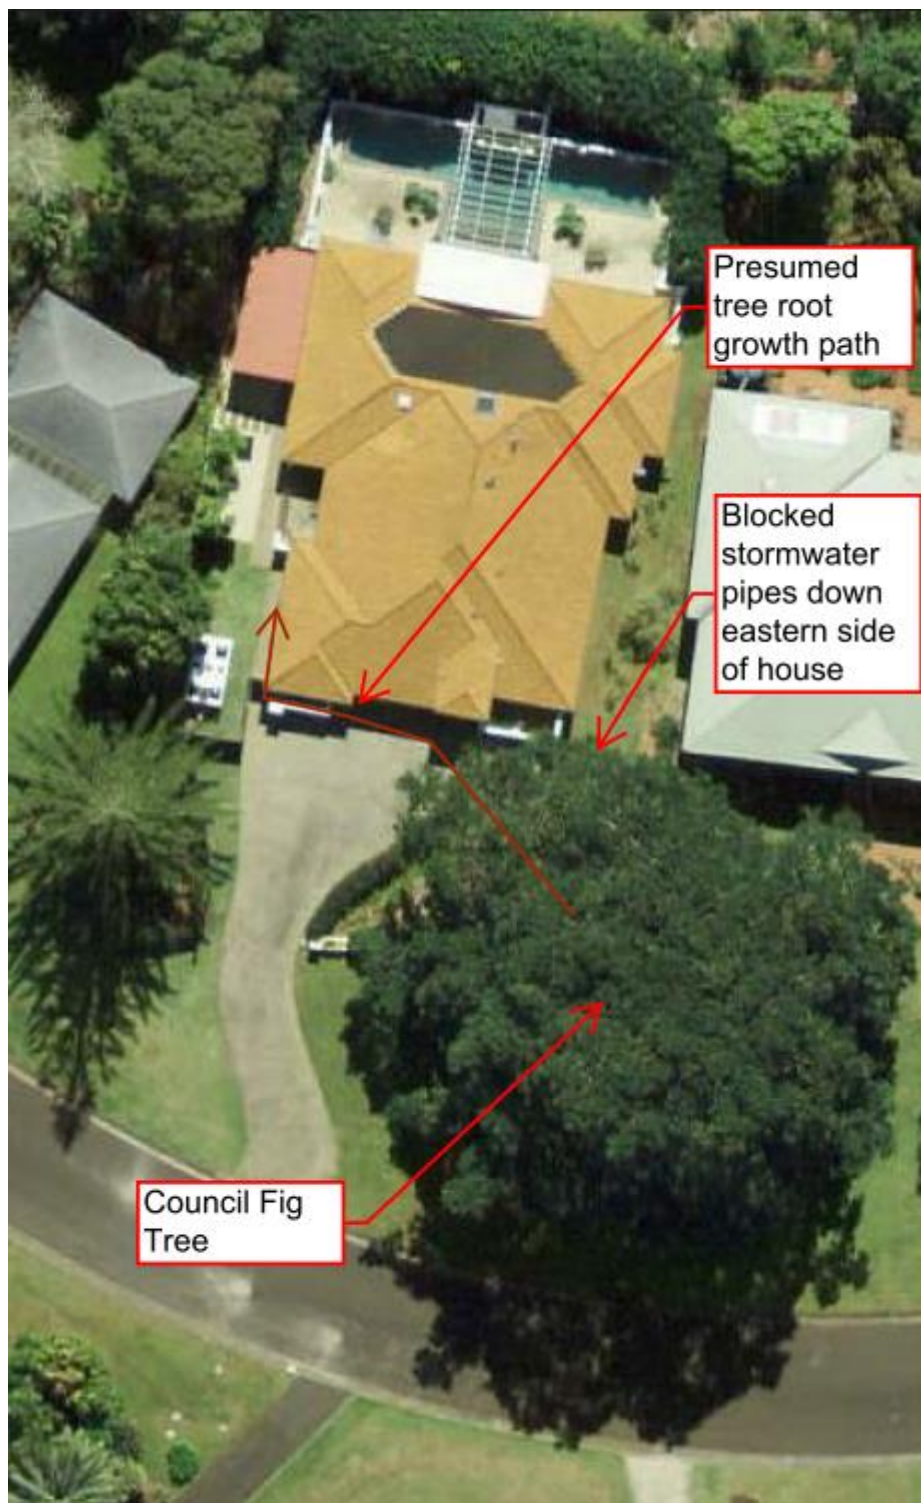
Figure 1: Aerial Image

As discussed, in our opinion some of the damage can be attributed to the fig tree. There appears to be a clear path that a single tree root is following and causing the damage (see Appendix Figure 1 for aerial image). Only a comprehensive destructive investigation would prove this, however from the current evidence, we believe this to be the case. The pre-existing damage to the house (masonry pillar rotation and eastern wall crack) does not appear to be due to the tree roots.

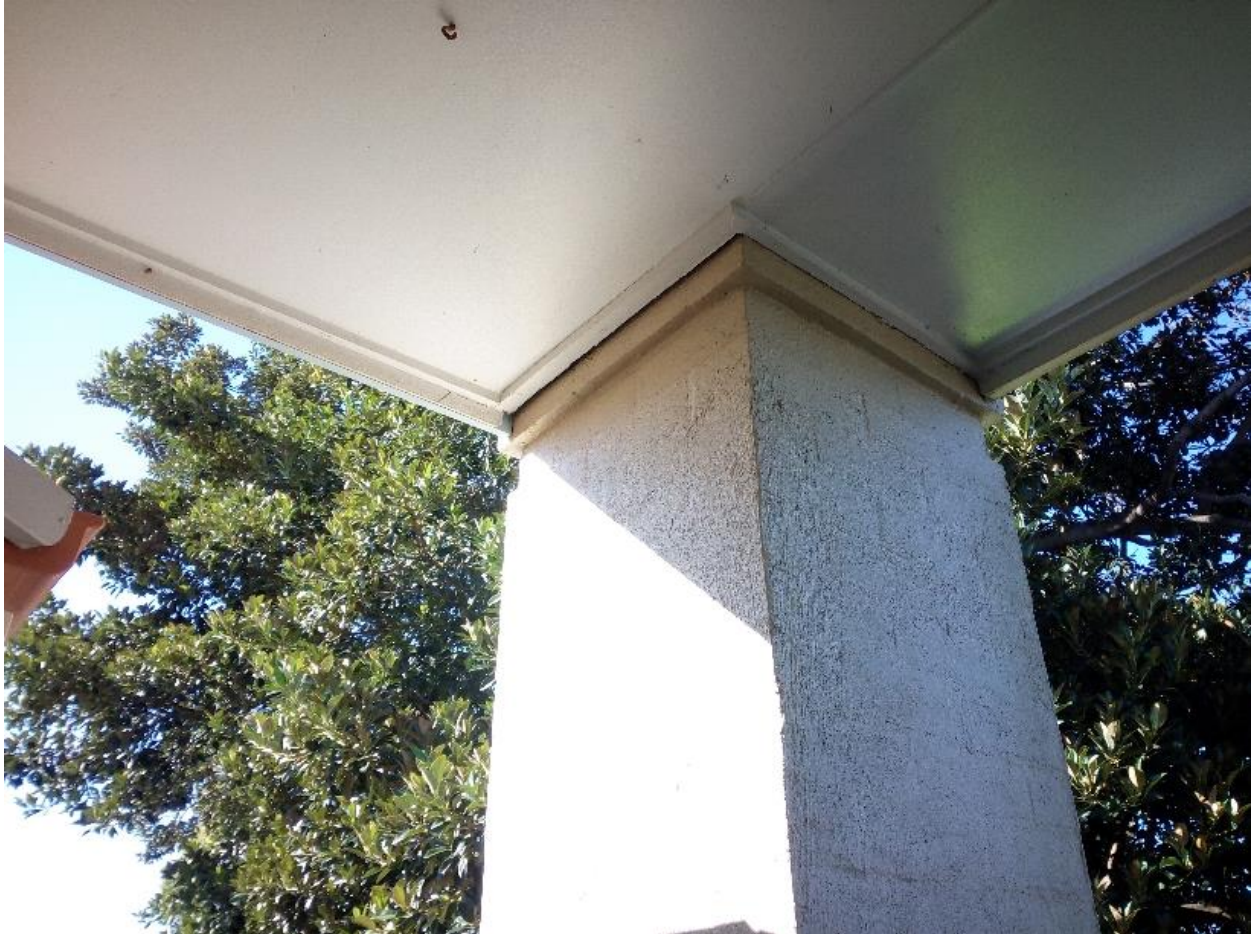
1. Leaning pillar at entry:

There is a masonry pillar to the right of the entry that is subsiding away from the house. There is evidence that the ceiling lining has been repaired in the past, indicating this movement has been occurring for some time.

The front of this house is built on fill, and it is known in this office that AV Jennings (the company who built the house, now defunct) had a reputation for not adequately piercing footings through fill. While not solid evidence, we would imagine this is a likely scenario. In our opinion the pillar movement is more likely to subsidence of the fill rather than root damage, particularly when observing the direction of rotation. The type of movement is certainly what we would describe as typical of foundation subsidence. It may have been worsened by nearby tree root growth, however this is not possible to determine. In either case, the movement has pre-dated the purchase of the property.

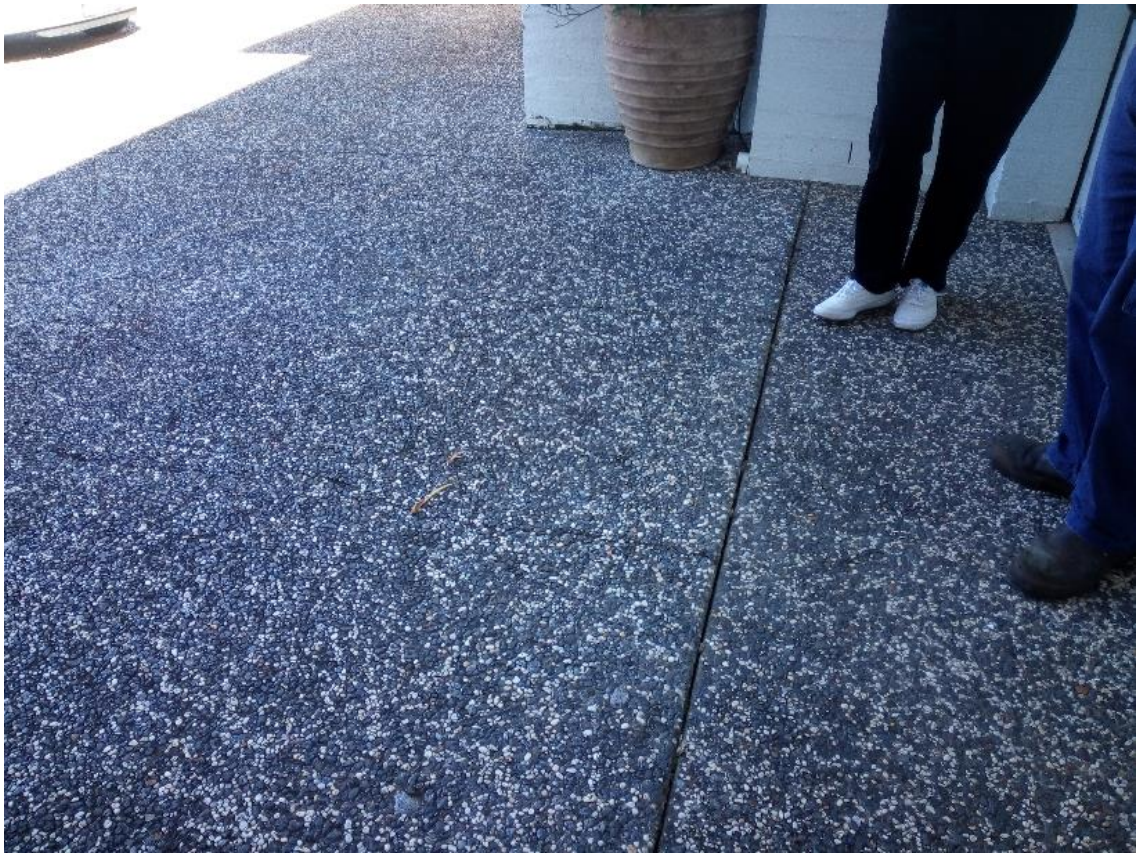
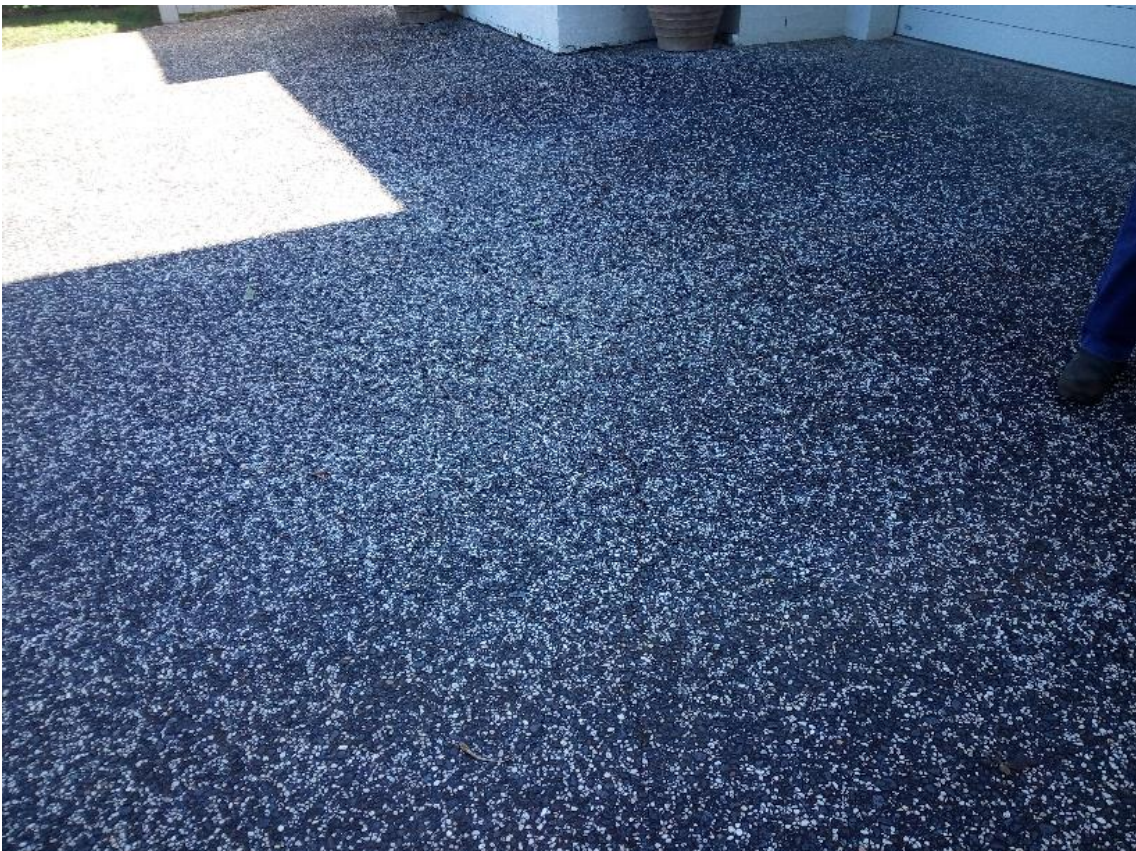
2. Driveway Slab – risen at entry to garage / cracking in driveway surface:

The driveway slab has lifted at a joint line parallel to the garage door. There is cracking in the pebblecrete surface of the driveway slab nearby.

The lifting of the slab almost certainly appears to be due to growth of a tree root underneath. It is very unusual to see this sort of movement from other causes in this local area. The location of the presumed tree root under the slab is in agreeance with the findings in items 4 and 5 below. A root appears to extend across the top of the driveway slab, under a masonry privacy wall, and around the corner up the western side of the house.

The driveway cracking is difficult to determine to attribute blame to – it looks very much like normal concrete slab shrinkage cracking. The surface of that slab panel appears generally flat and true with no obvious kinks.

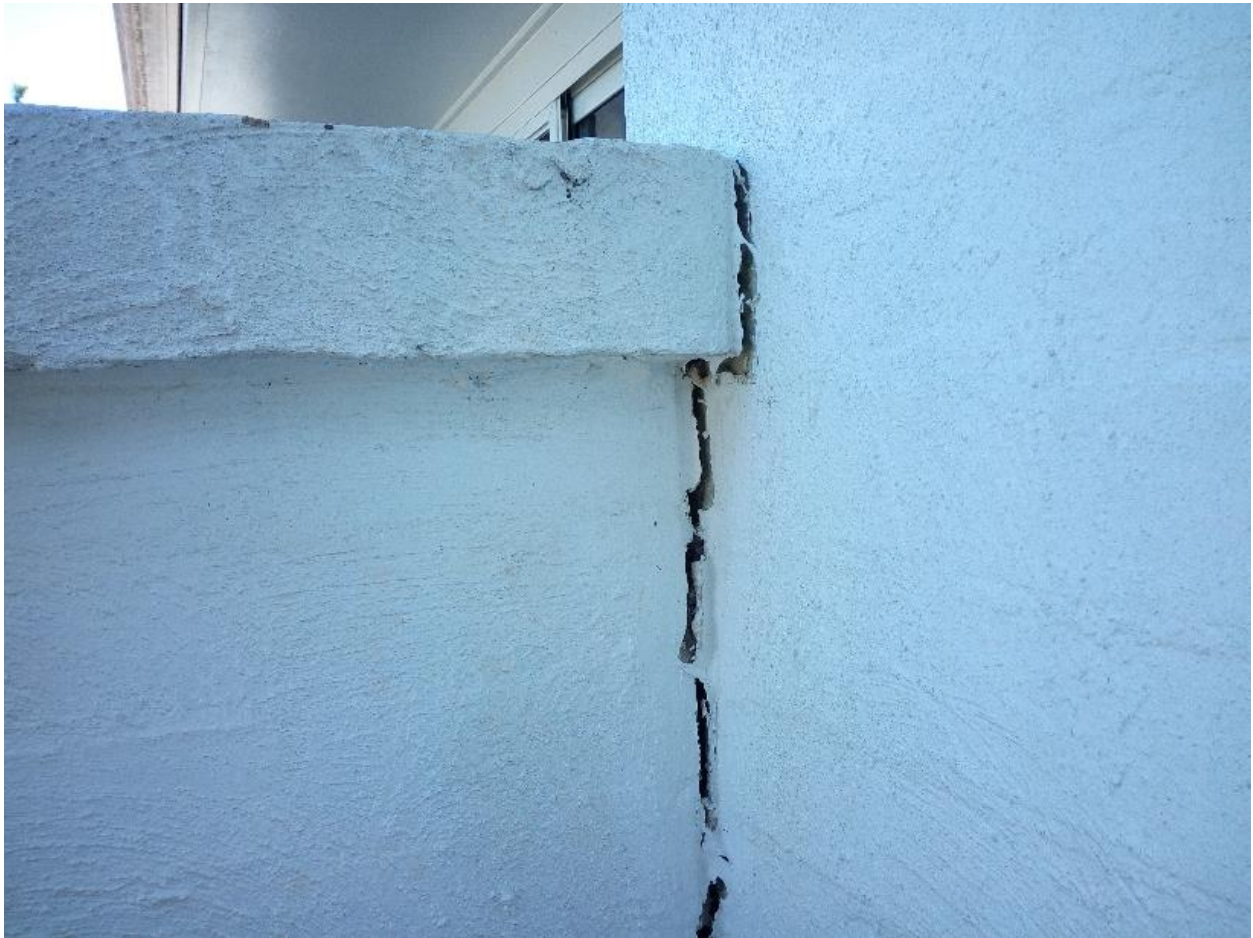
3. Rotating masonry wall adjacent to garage:

This privacy wall has a vertical joint where it joins the exterior wall of the house. The joint has opened up to around 15-20mm. Evidence from the owner indicates that this movement has worsened considerably in recent months. It appears that the wall is lifting at the joint location, at the location where a tree root is presumed to be growing underneath.

While this movement appears quite typical of subsidence due to settlement, given the presumed location of the tree root, the appearance that the wall is lifting at that location, and the worsening recent movement, it is very likely that this movement is caused by the tree root growing underneath the end of the wall against the house.

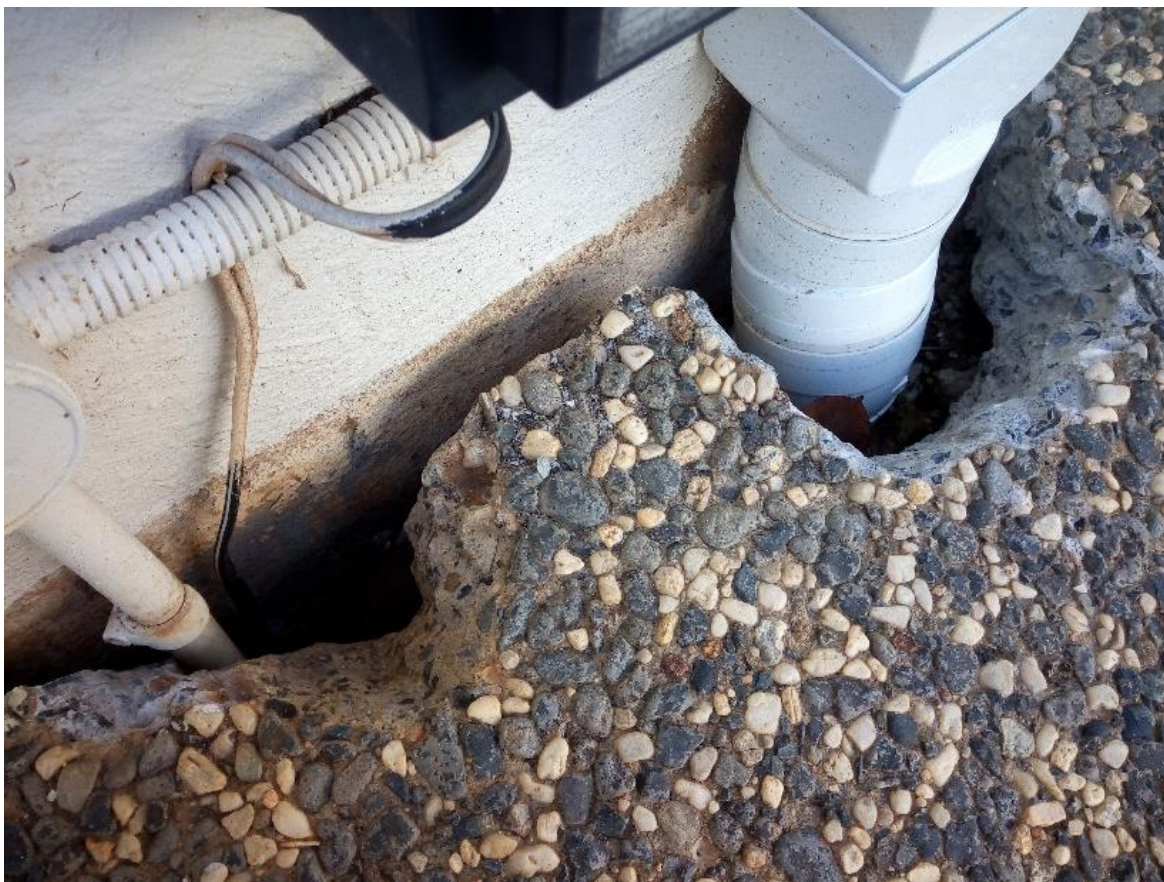
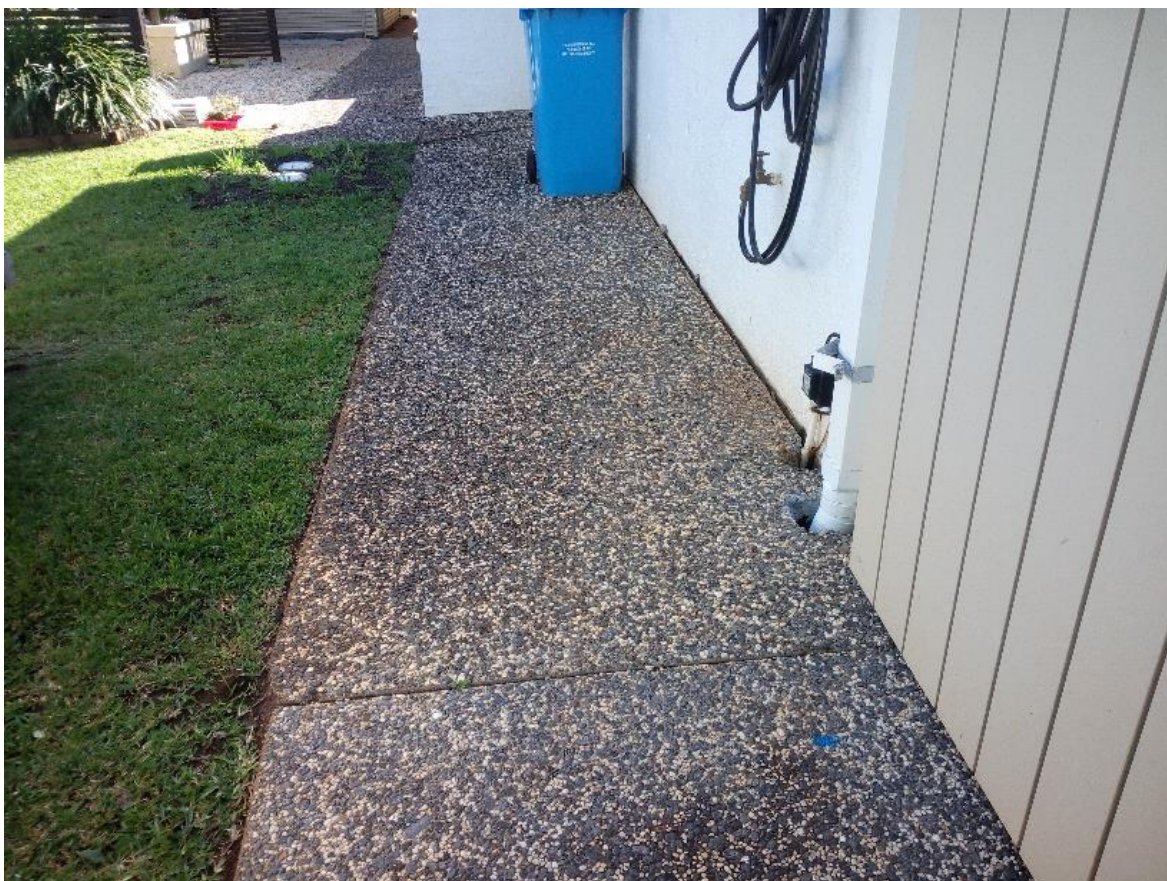
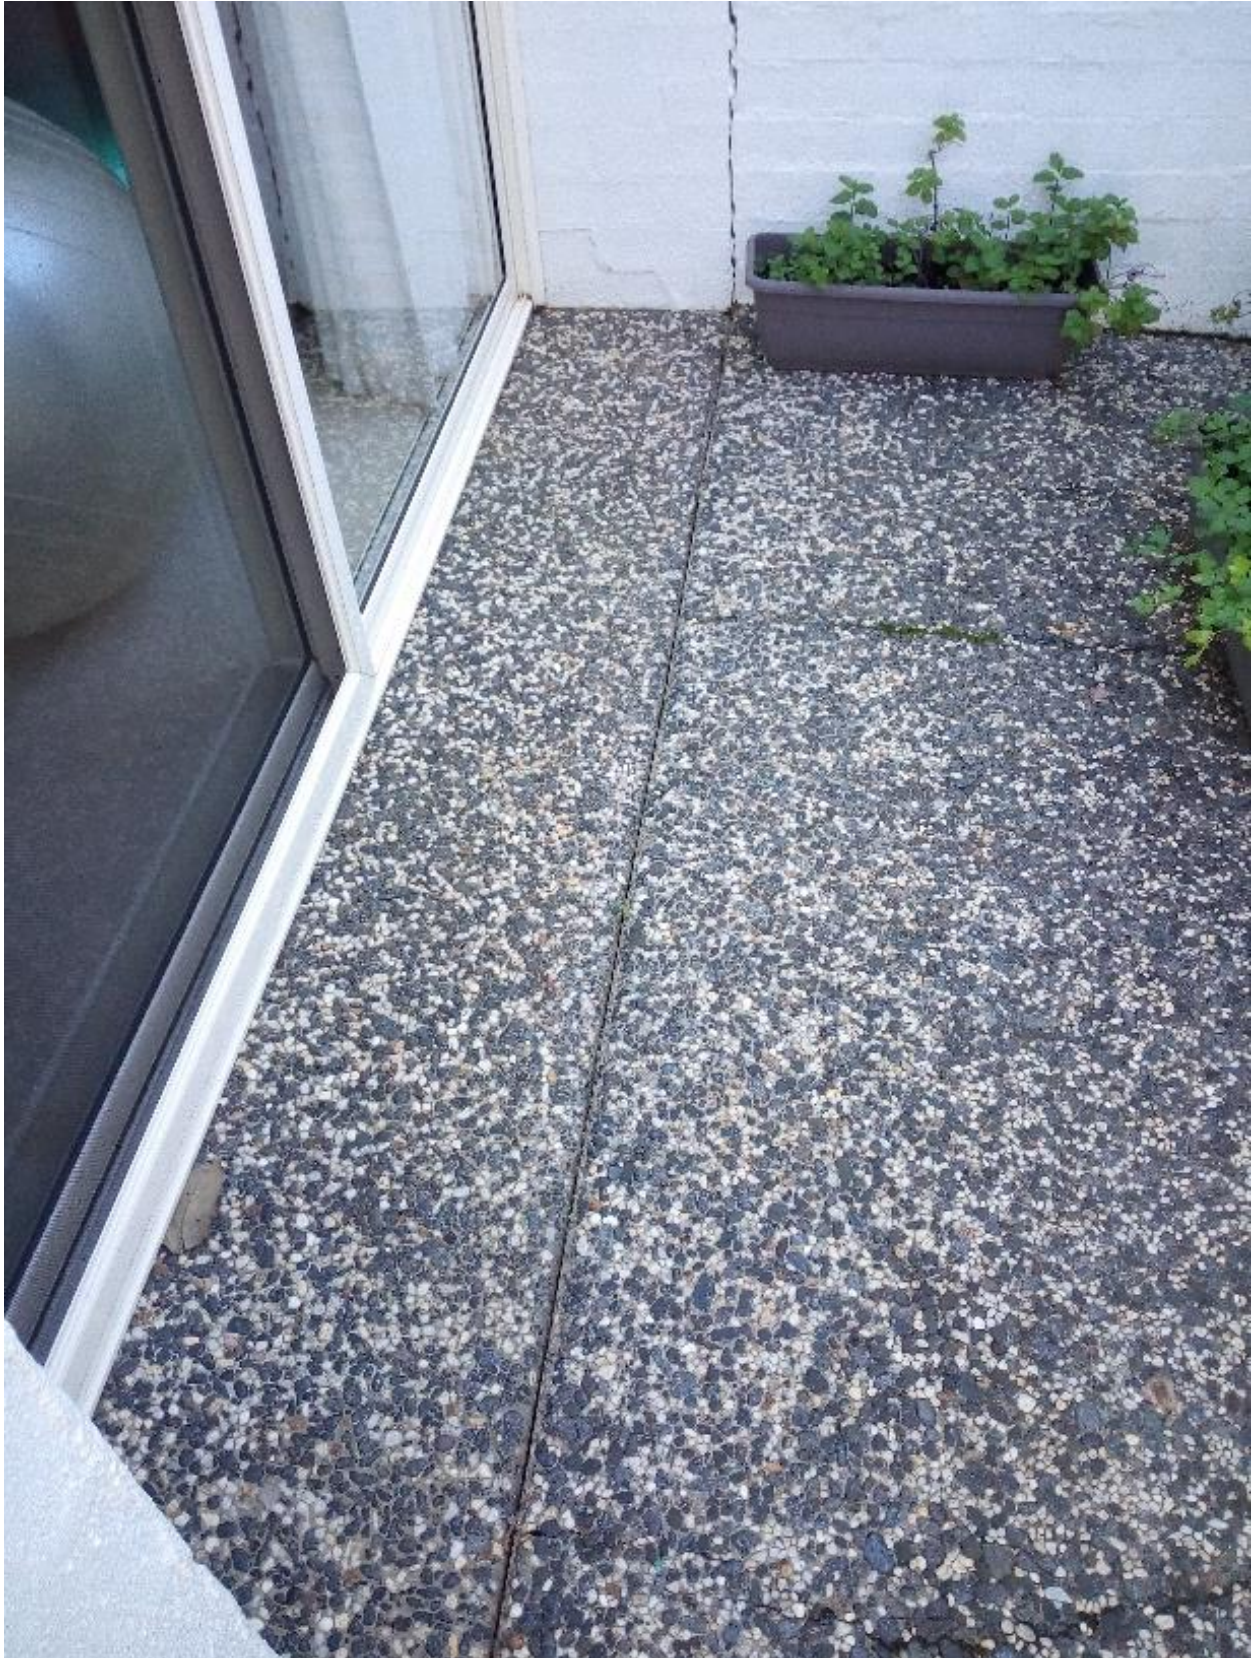
4. Path damage beside house, western side:

On the western side of the house is a concrete path that has separated from the house by around 30-40mm. A tree root can be seen growing in the crack, filling the space. Also a section of path between this location and the driveway has also lifted, similar to the driveway slab.

This all seems to be attributable to the same tree root, as the damage follows a line across the top of the driveway, around the corner and up the side of the house for a few metres where the tree root is visible. Other than the separation from the wall, the western path appears generally level. If the separation was caused by subsidence, we would normally see rotation of external paving slabs.

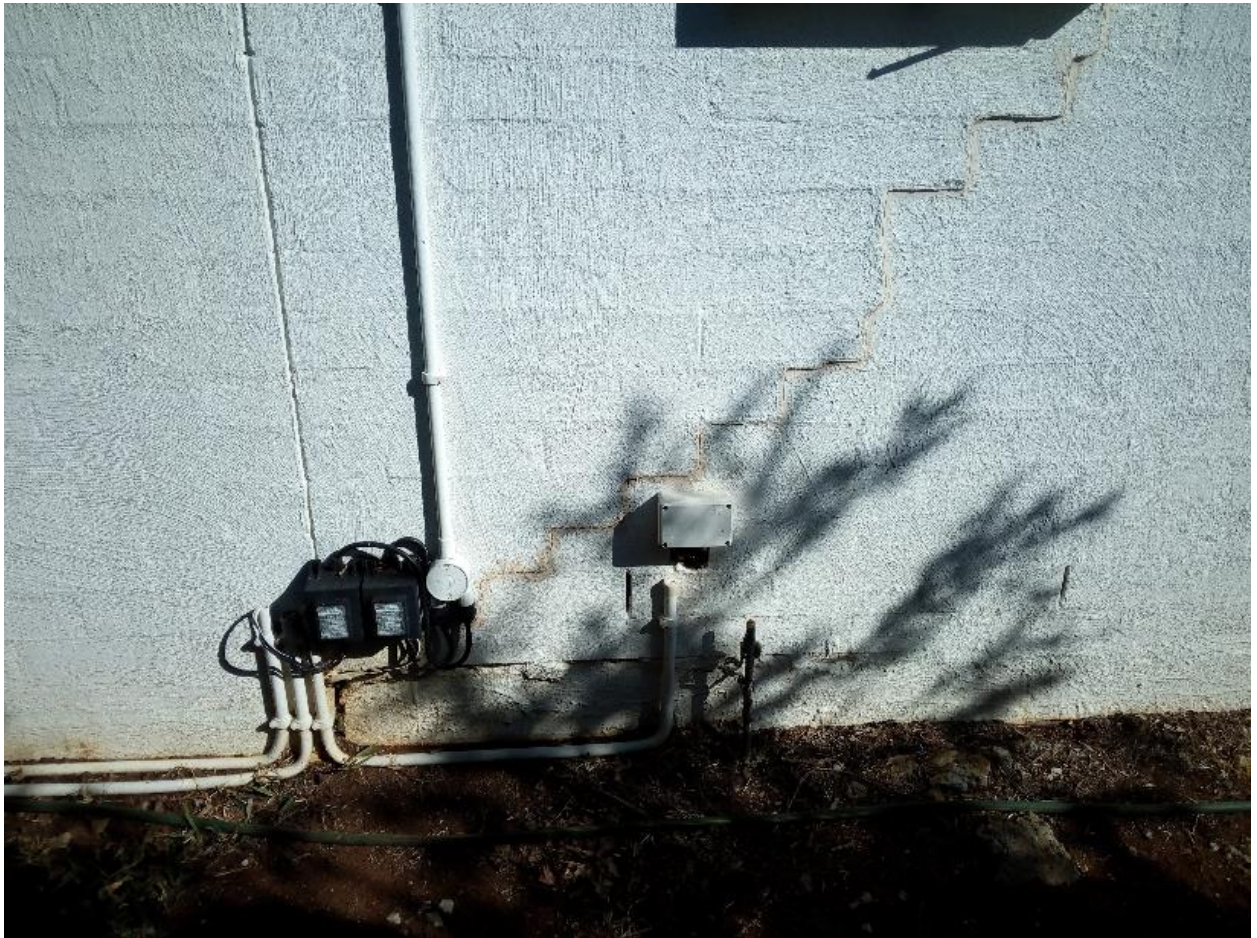
5. Diagonal crack in brick wall (east side):

There is a diagonal crack at the south-east corner of the house, on the eastern wall. The crack follows the bedjoints of the external brick wall and is around 3mm in width. It appears to have been repaired in the past, and has opened up slightly since then.

This crack was present prior to the purchase of the house 3 years ago. In our opinion, it appears to be a crack associated with subsidence of the fill that this corner of the house is sitting on, and is not associated with tree roots.
