4th May 2018

Our ref: 4325

Project:	Engineering Inspection & Report
Property Owner:	Robin Lowry
Property Address:	7 Castle Drive Lennox Head NSW
Ballina S.C. Work Order No:	62353

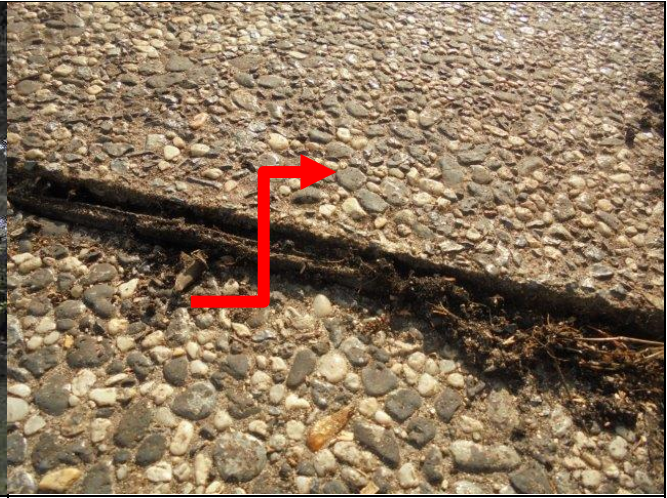
- **Driveway:** Slab vertical displacement (lifting) along control joints (in the driveway) and isolation joints (next to paths), some slab cracks also

- Our investigation indicates that the damages have most likely been caused by mechanical lifting from the roots of the fig tree.
- Some damage of the office courtyard wall is likely to be due to settlement of loose landfill and an absence of an adequate footing and piers.

02: Driveway slab panel displacement

Restoration/s of the driveway paths to "as new" condition will require replacement in accordance with the *Cement Concrete & Aggregates Australia Data Sheet Residential Concrete Driveways and Paths 2006*.

Alternatively, the elevated slab panel edges can be ground down and lower edges can be packed with dry-mix bitumen, but this method will look unsightly.

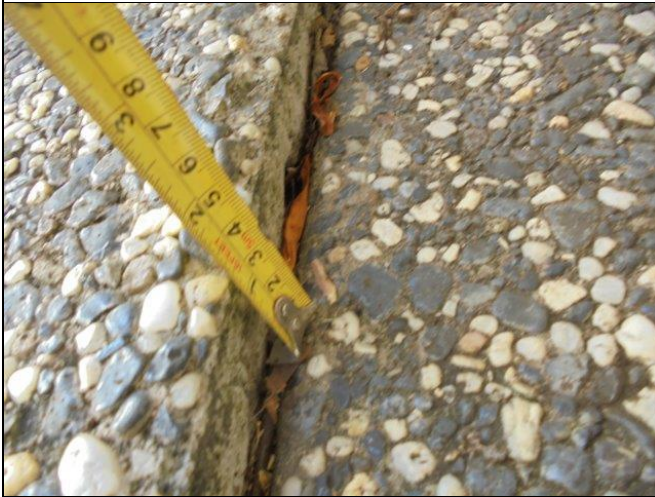
03: Driveway slab panel displacement

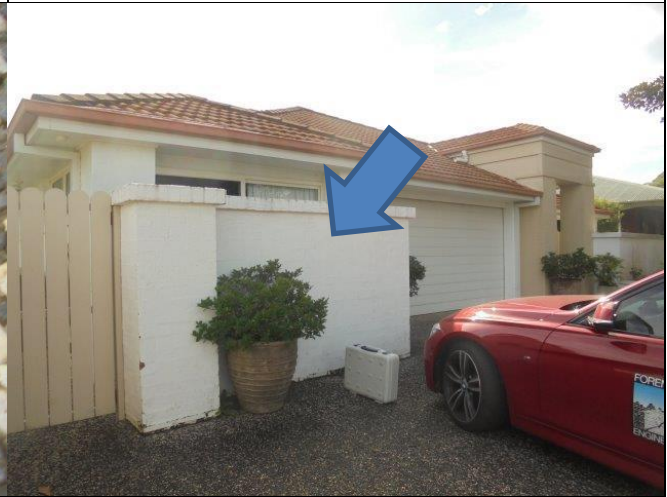
- **Office:** South side courtyard wall rotated outwards and large gap opened at house wall abutment, concrete path slab (apparently supporting the same wall) has lifted at the northern edge wall, crack at south east corner, concrete path at western side has tilted to the west

As far as we are aware, this wall is not supported on a footing and is located on landfill.

04: Office courtyard wall

To ensure stability, the wall will require to be rebuilt with a supporting footing founded in solid natural ground and in accordance with AS280-2011, *Residential Slabs & Footings*.

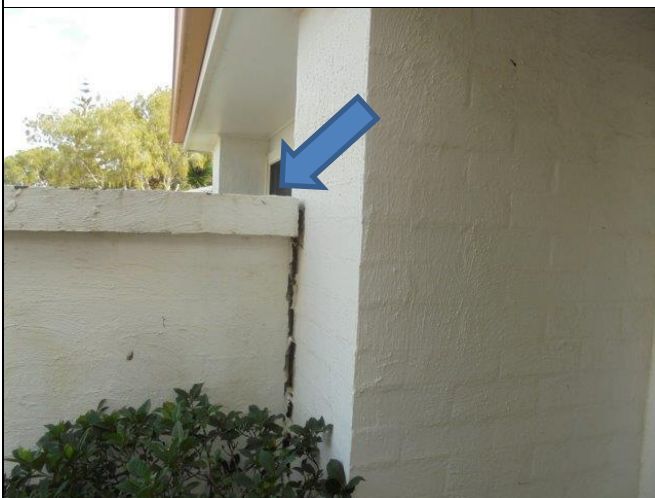
05: Wall rotated out at the top and gap formed

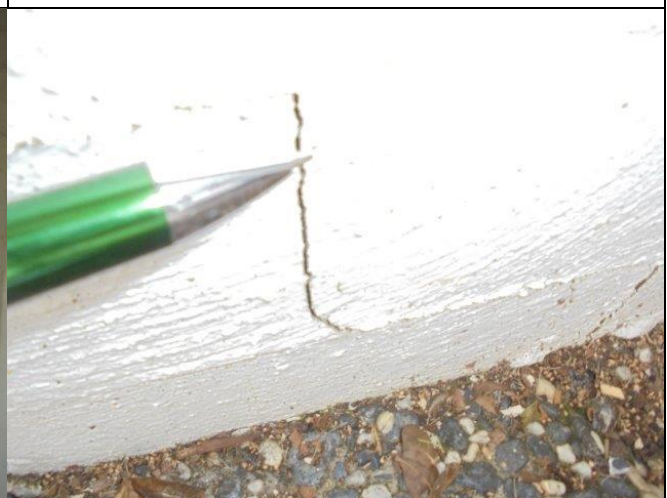
06: Office wall crack

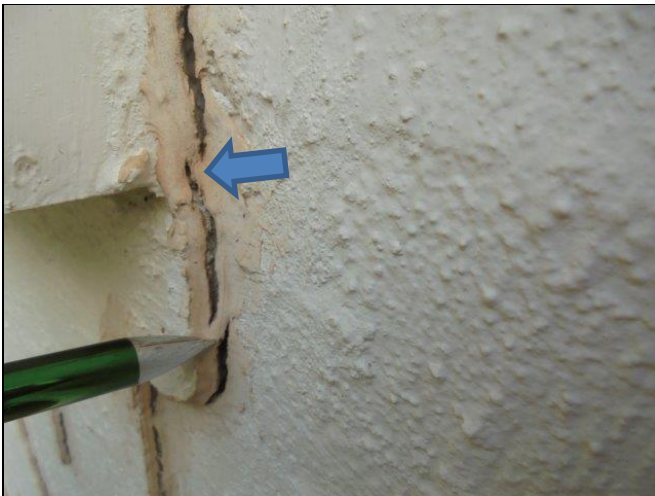
- **Bed 2:** Cracks (partially filled) and lateral (sideways) displacement in south end of east wall, hairline crack in south wall at east end, courtyard east wall has rotated outwards and gap has opened at house abutment

07: Bedroom 2 east wall crack. Note lateral displacement

The damaged bricks can be removed and replaced then re-rendered in accordance with the relevant requirements of the Building Code of Australia.

Other wall cracks can be repaired by grinding and cleaning and bonding with epoxy or cementitious grout and rendering.

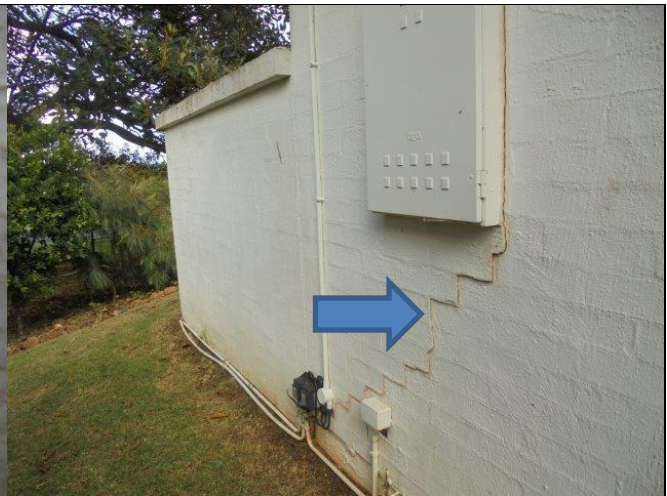
08: Bedroom 2 east wall crack

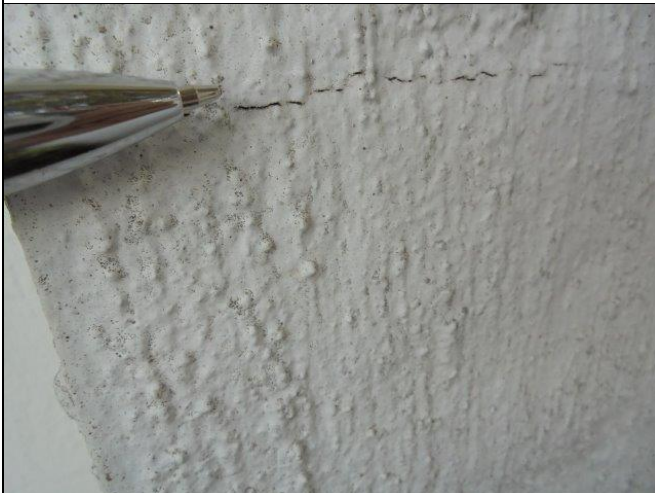
09: Bed 2 crack in south wall

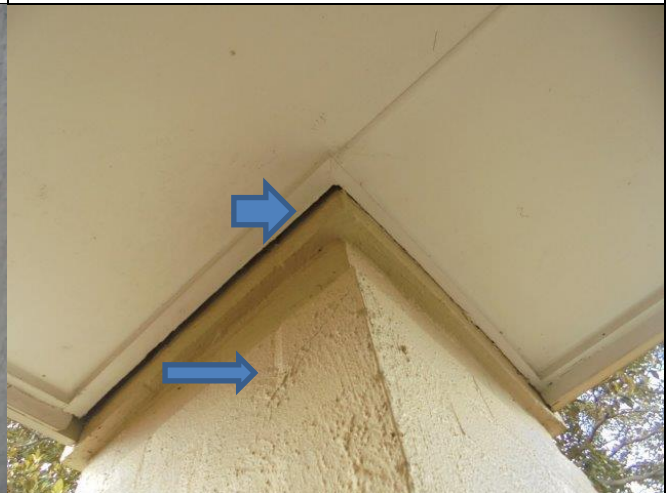
- **Portico:** Top of column at east side has rotated slightly outwards to the south and soffit lining gap has appeared. Column also has hairline horizontal tension cracking

10: Portico column slight rotation and soffit gap

The column doesn't require structural repairs. The gap in the soffit lining can be filled with architrave and then painted.

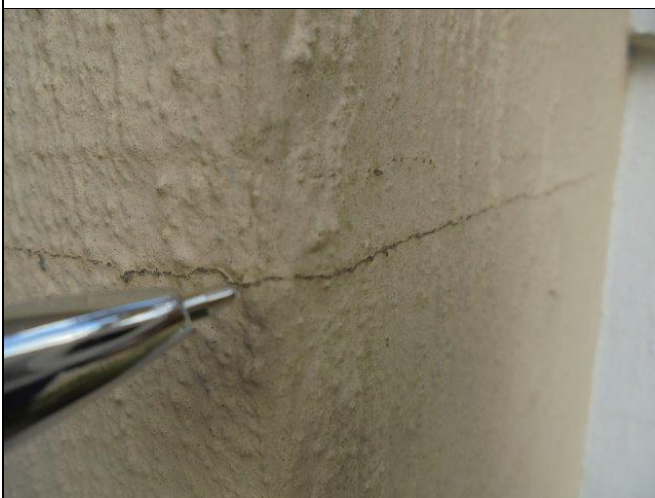
11: Portico column crack

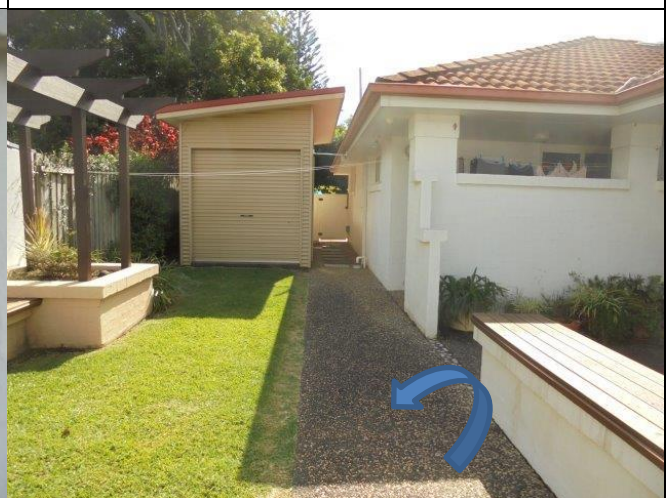
12: Path at west side rotated outwards

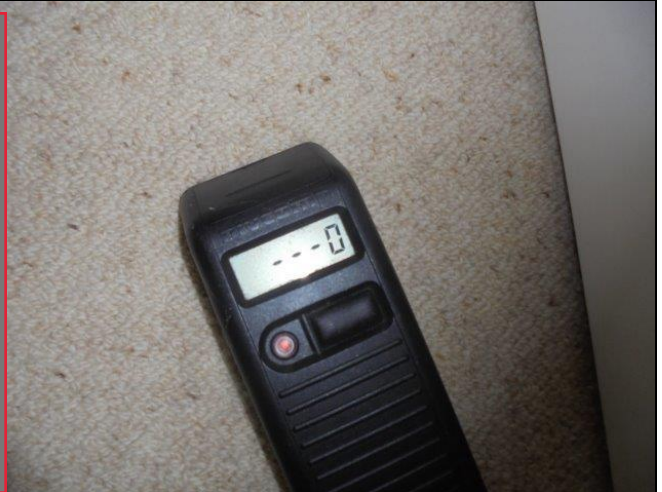
We took levels on the floor and apart from some slight variations which would be “as constructed”, there are no variations of any significance, they are not excessive and level variations are within the allowed tolerance of 1:150 as determined by AS 2870 appendix C and table 4.1.

It is apparent from the floor level readings on the house that there has not been any subsidence (of any significance) from soil settlements or heave (lifting) of any significance, from soil swell.

16: Floor levels show no evidence of heave or settlements of any significance

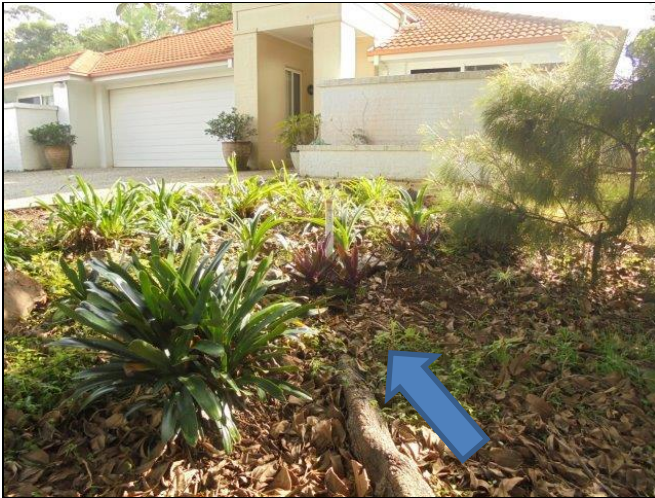
- **Tree roots:** Fig tree surface roots identified in abundance at the south east corner. Surface roots also visible at the east side of the house near Bedroom 3 / bathroom. The insured advised that tree roots had been removed from drains at the east and west sides of the house.

The tree roots can be expected to continue to spread and cause additional damages to the driveway and the house.

19: Tree roots running towards the house

It is recommended therefore that, subject to an arborist's recommendations and project management, either the tree is removed or the roots are trimmed and a structural root barrier (not a conventional moisture barrier) is constructed to isolate the tree roots from the house and driveway.

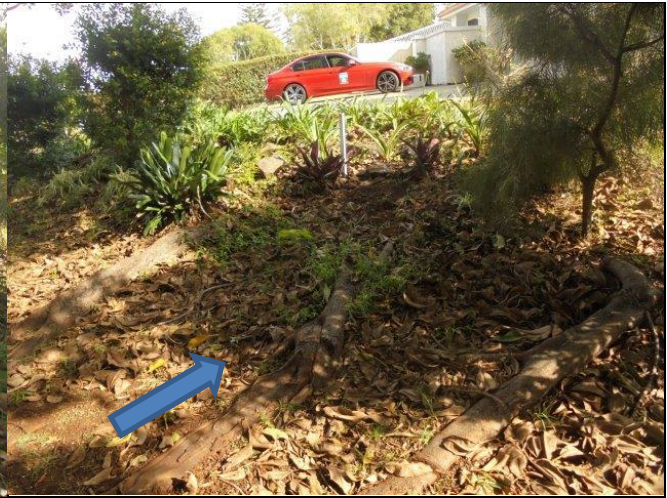
20: Tree roots running towards the driveway

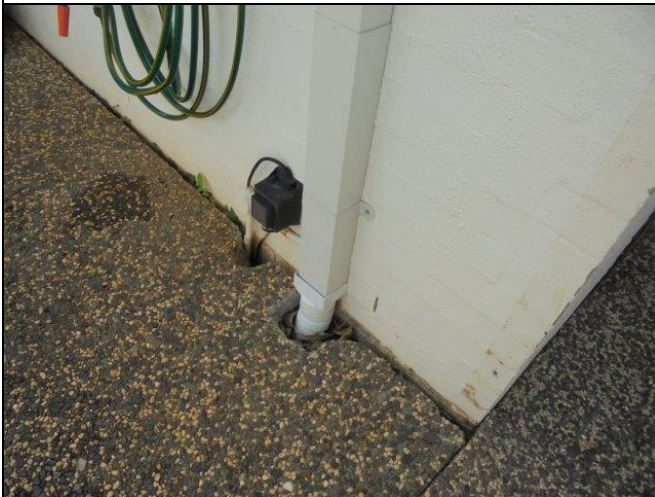
21: The owner found tree roots between the house where the path is lifting at the western side of the office

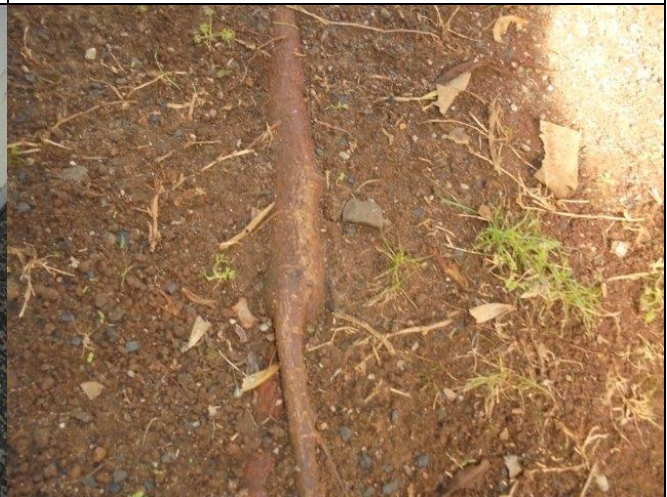
22: Fig tree roots at the east side of the bathroom

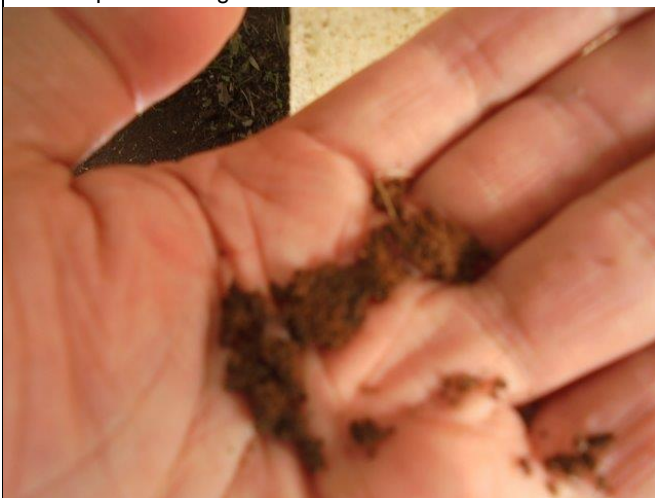
23: Surface soils are low plasticity silty clays (CL) with trace of sand
