Arborist's Report

Site: 7-9 Castle Drive
Lennox Head NSW 2478

Client: Ballina Shire Council

Date: 9 March 2018

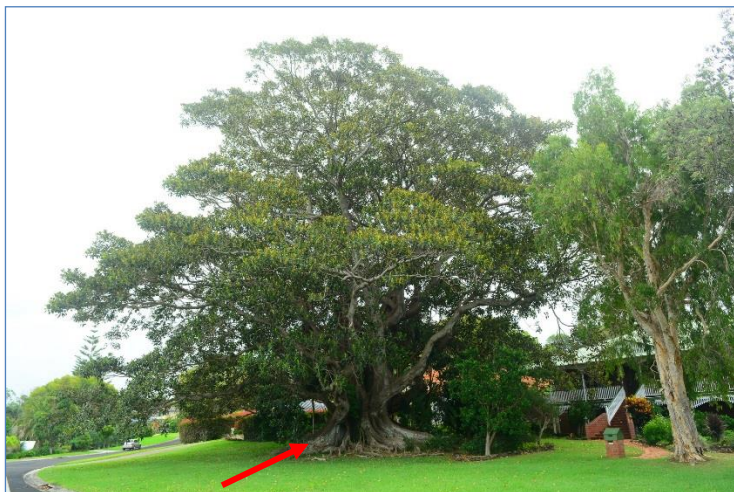
The epicormic regrowth resulting from the pruning and damage is generally of acceptable form and structure with strong attachments and production of adaptive growth being evident. Some saprophytic surface decay of larger wounds is evident, as is typical of the species, however, no significant structural weakness was noted. Some small diameter epicormic shoots, i.e. less than 100mm diameter, are evident; this growth will become redundant and will be shed as deadwood (see Figures 2 and 3).

Figure 2. Subject tree viewed to north-west.

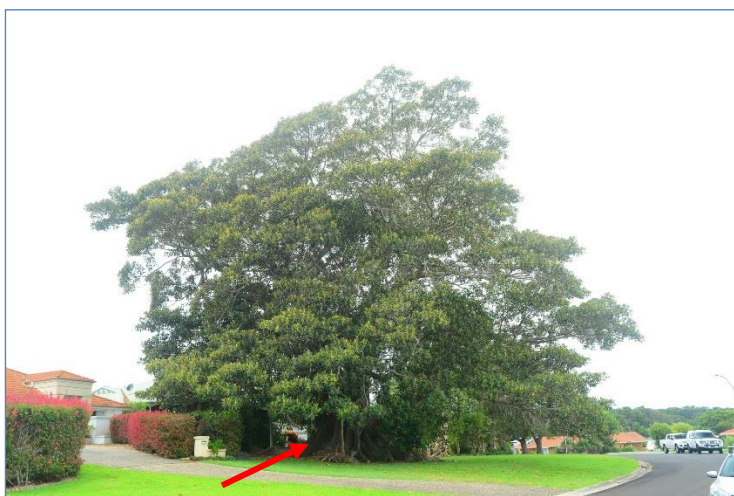
Figure 3. Subject tree viewed to east.

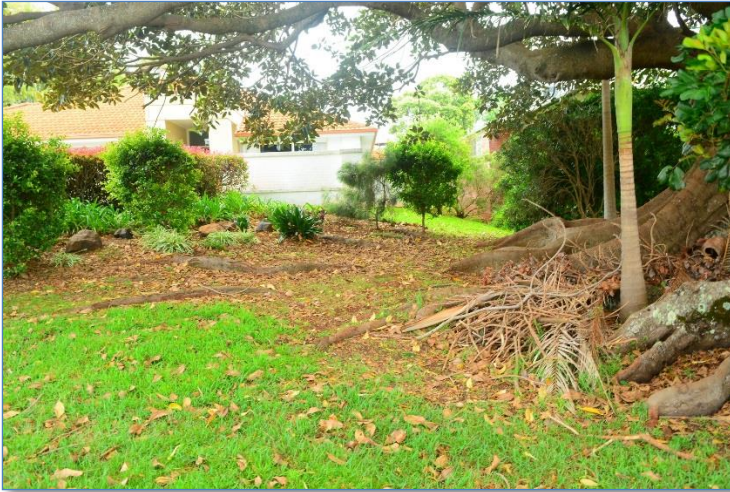
The tree appears to be growing at or near to natural grades with the presence of fill over the root zone being noted to the north-west of the root zone (see Figure 4). The site exhibits a gentle slope to the south of less than 5°.

Figure 4. Subject tree viewed to south-west.

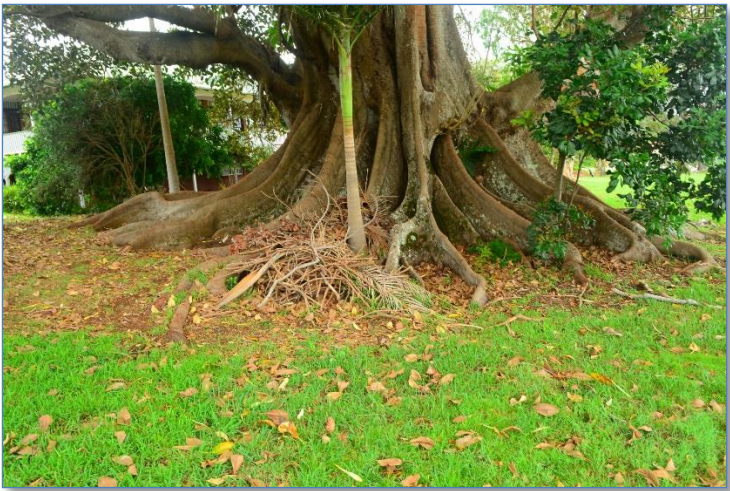
The root crown is of good form with extensive, pronounced buttressing present and is without evidence of weakness or defect (see Figures 5 to 8).

Figure 5. Subject tree – root crown detail west face.

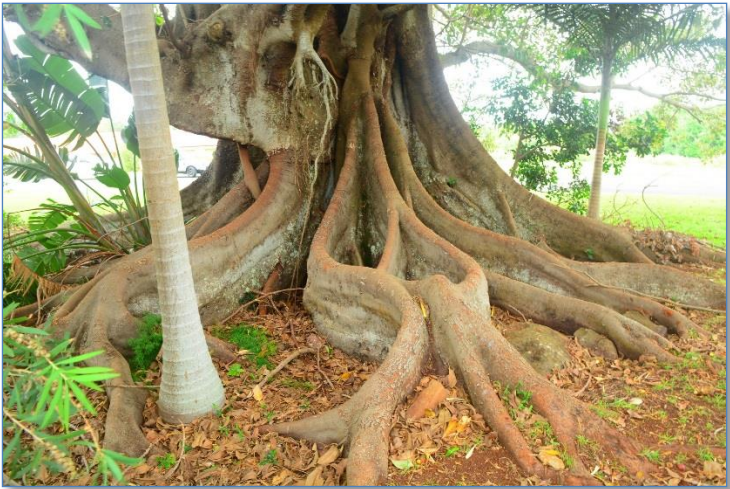
Figure 6. Subject tree – root crown detail north face.

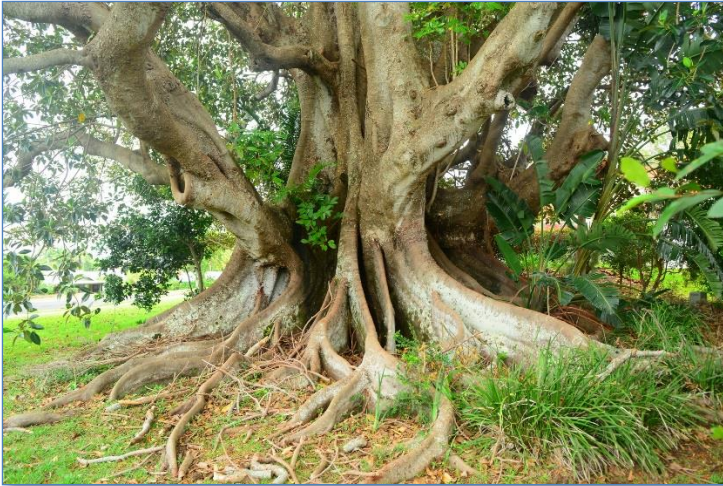
Figure 7. Subject tree – root crown detail east face.

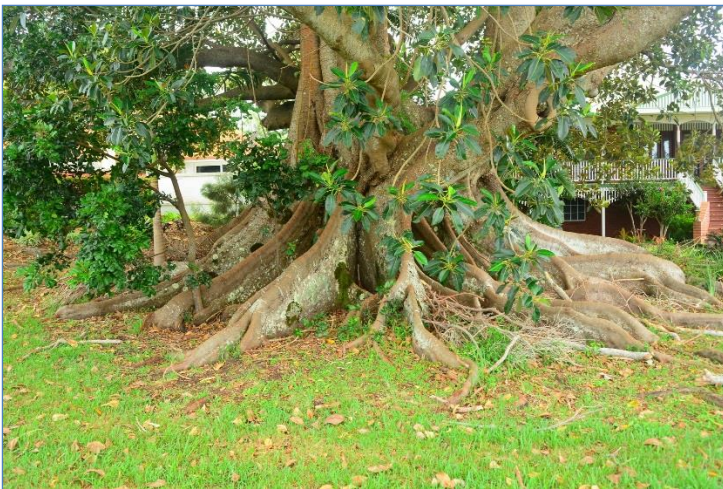
Figure 8. Subject tree – root crown detail south face.

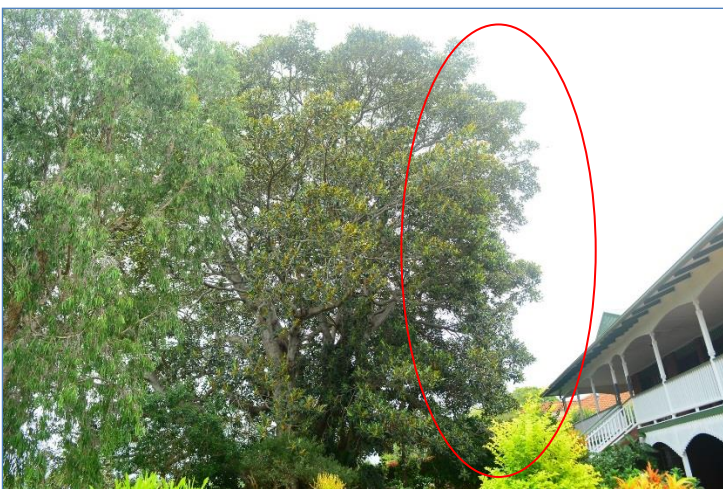
Some pruning to raise the canopy has been performed on the south face. The canopy has been reduced in width on the north face to reduce encroachment and provide building clearance to the dwelling at 9 Castle Drive. The pruning will have no detrimental effect on the tree (see Figure 9).

Figure 9. Subject tree – pruning to provide building clearance on the north face of the canopy.

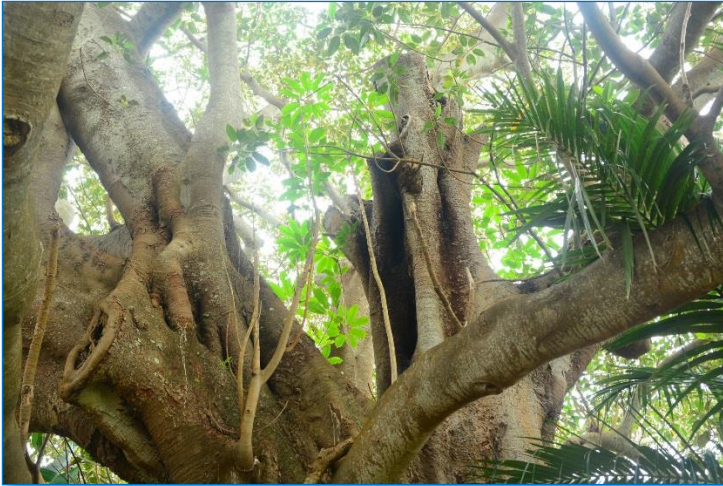
The upper canopy is of typical form and acceptable structure with strong branch taper and branch attachment evident. The upper stem and several first order branches exhibit evidence of past heavy pruning or lopping with several large wounds being evident (see Figures 10 and 11). The pruning may have been a result of storm damage repair and hazard mitigation. Live crown ratio is approximately 90% (see Figures 2 and 3).

Figure 10. Wounds created by previous lopping and or storm damage repair viewed from north-west.

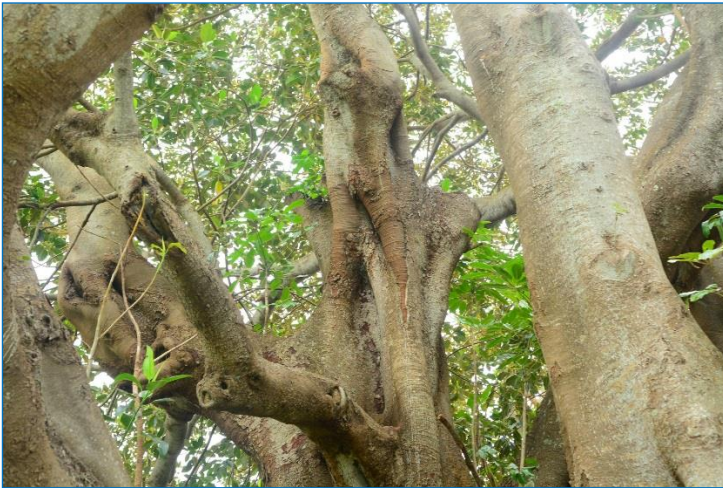
Figure 11. Wounds created by previous lopping and/or storm damage repair viewed from south-east.

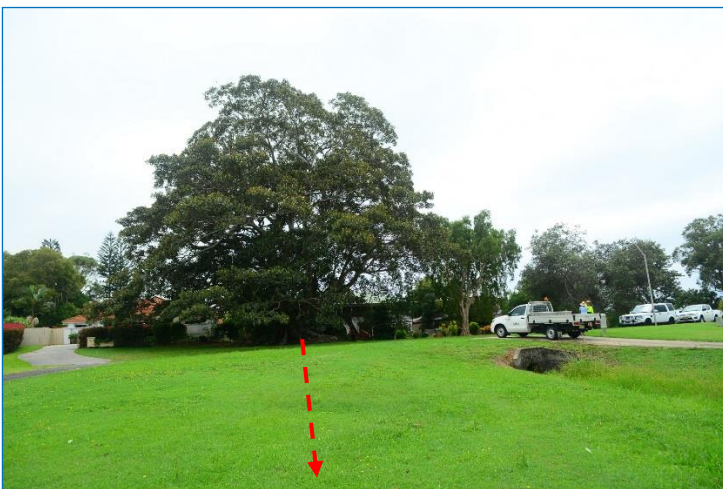
Figure 12. Subject tree viewed to north from open space area suitable for the planting of the relocated tree.

A large open area, suitable for the planting of the relocated tree, is present to the south of the tree on the opposite side of the street (see Figures 12 to 14). Other than planting site excavation and the installation of drainage around the root ball, no significant works are required to plant the tree in the open space. An exact planting position for the tree was not discussed or determined, however, the open space area is of sufficient size for the tree to be replanted without hindrance to adjacent properties and for suitable root control systems to be installed.

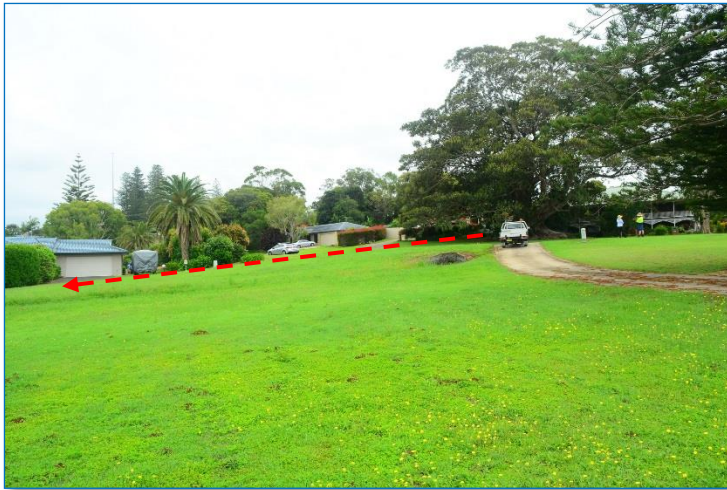
Figure 13. Open space area viewed to west. Note the decline in gradient of approximately 2- 3m depending distance moved.

To install the pipe raft under the tree, a drive line is required; an area approximately 18 metres wide and 30 metres long is needed to allow the pipes to be installed by the excavator. In this instance and so as to minimize excavation and allow ease of tree movement, the drive line is best sited to the south of the tree across the road toward the proposed planting area (see Figure 13).

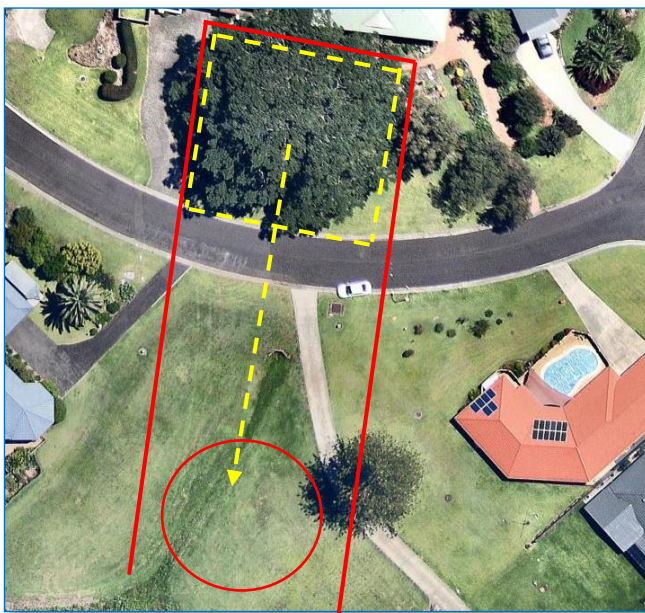
Figure 14. Aerial image of site indicating approximate position, orientation and direction of movement of a 14m x 14m rootball (dashed) and limits of excavation (red). A suitable planting area is also indicated.
