Lot 3 DP525783 Compton Drive, Ballina

Geotechnical Assessment for residential use.

Mr Ricky Lau
Slope Hazard Assessment
23 Compton Drive, Ballina

RE: Slope Hazard Assessment: 23 Compton Drive, Ballina

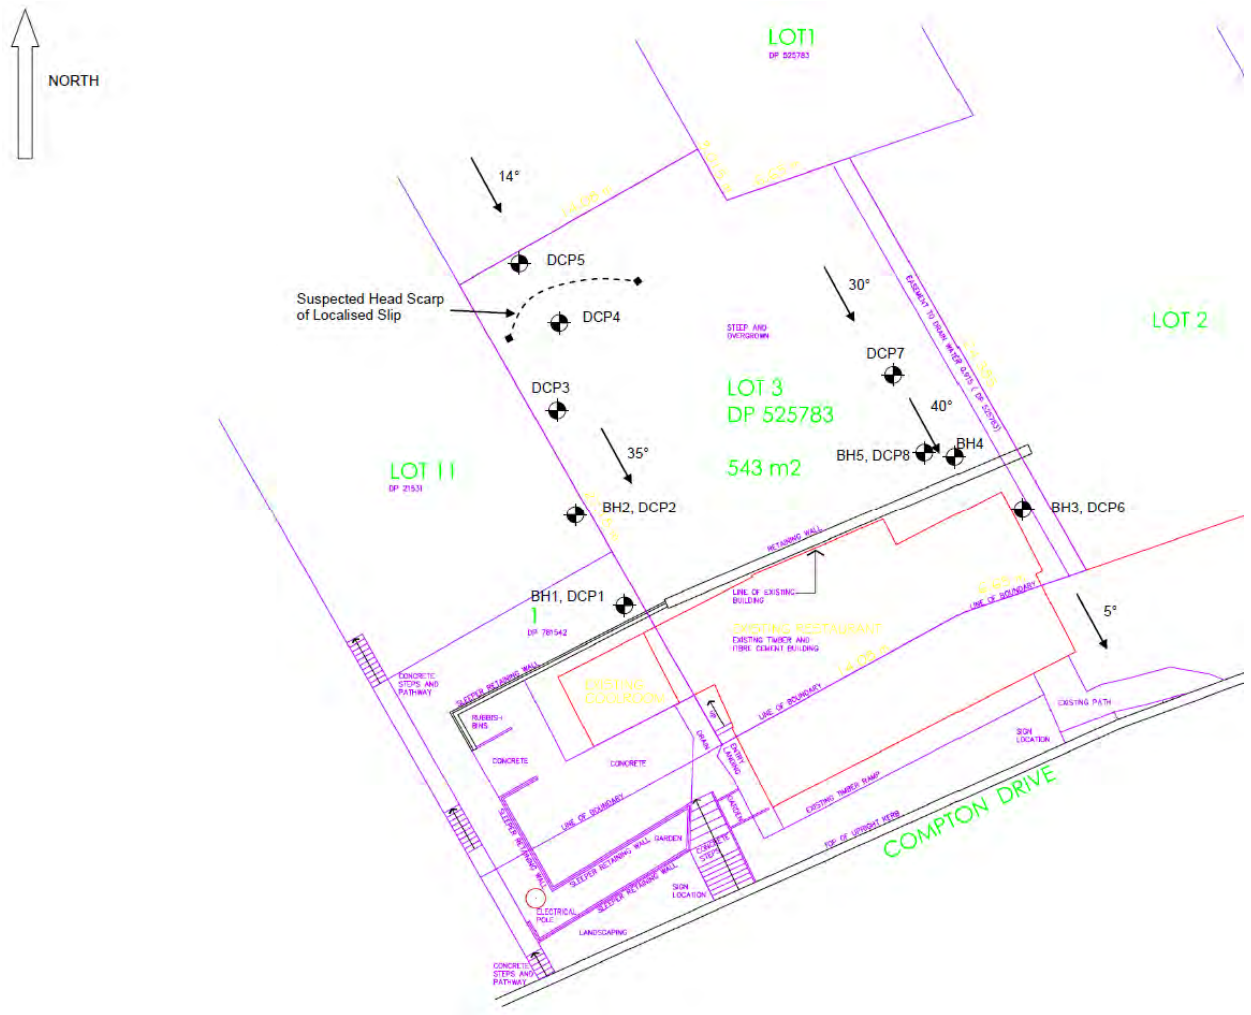
Figure 4-1 Site plan from 2013 report

The geotechnical report included subsurface investigations (5 boreholes drilled by hand auger with 8 dynamic cone penetrometer (DCP) tests) and developed a geotechnical cross section. The location of the investigations is shown in Figure 4-1. The geotechnical model interpreted from the conditions observed in the 2013 report is shown in Figure 4-2.

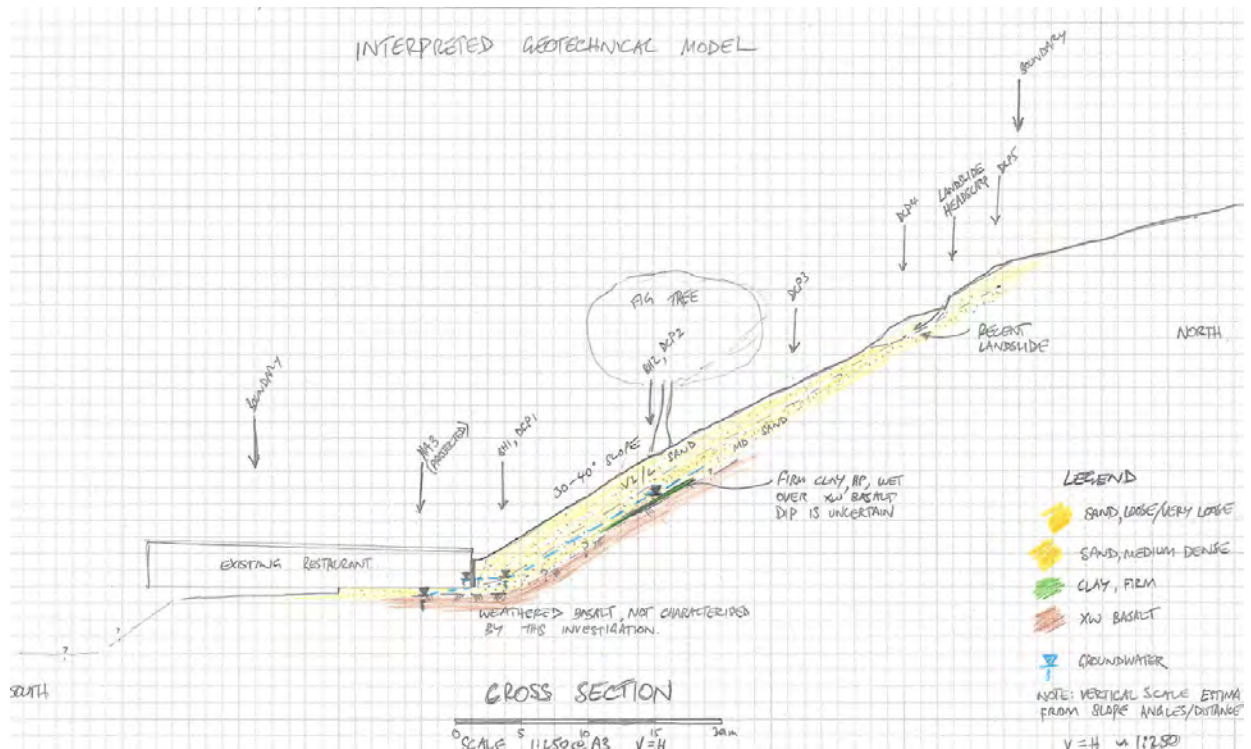
Figure 4-2 Geotechnical model from 2013 report

In summary, the geotechnical model comprises a weathered basalt basement material, mantled by loose and very loose sand. The sand comprises an older dune system and at its angle of repose. The sand slope dips down to the south east at 30° to 40° towards the current development and shows signs of slope instability in the form of a small landslide headscarp and soil creep. The sand slope is retained at the base by a retaining wall of two or more different types.

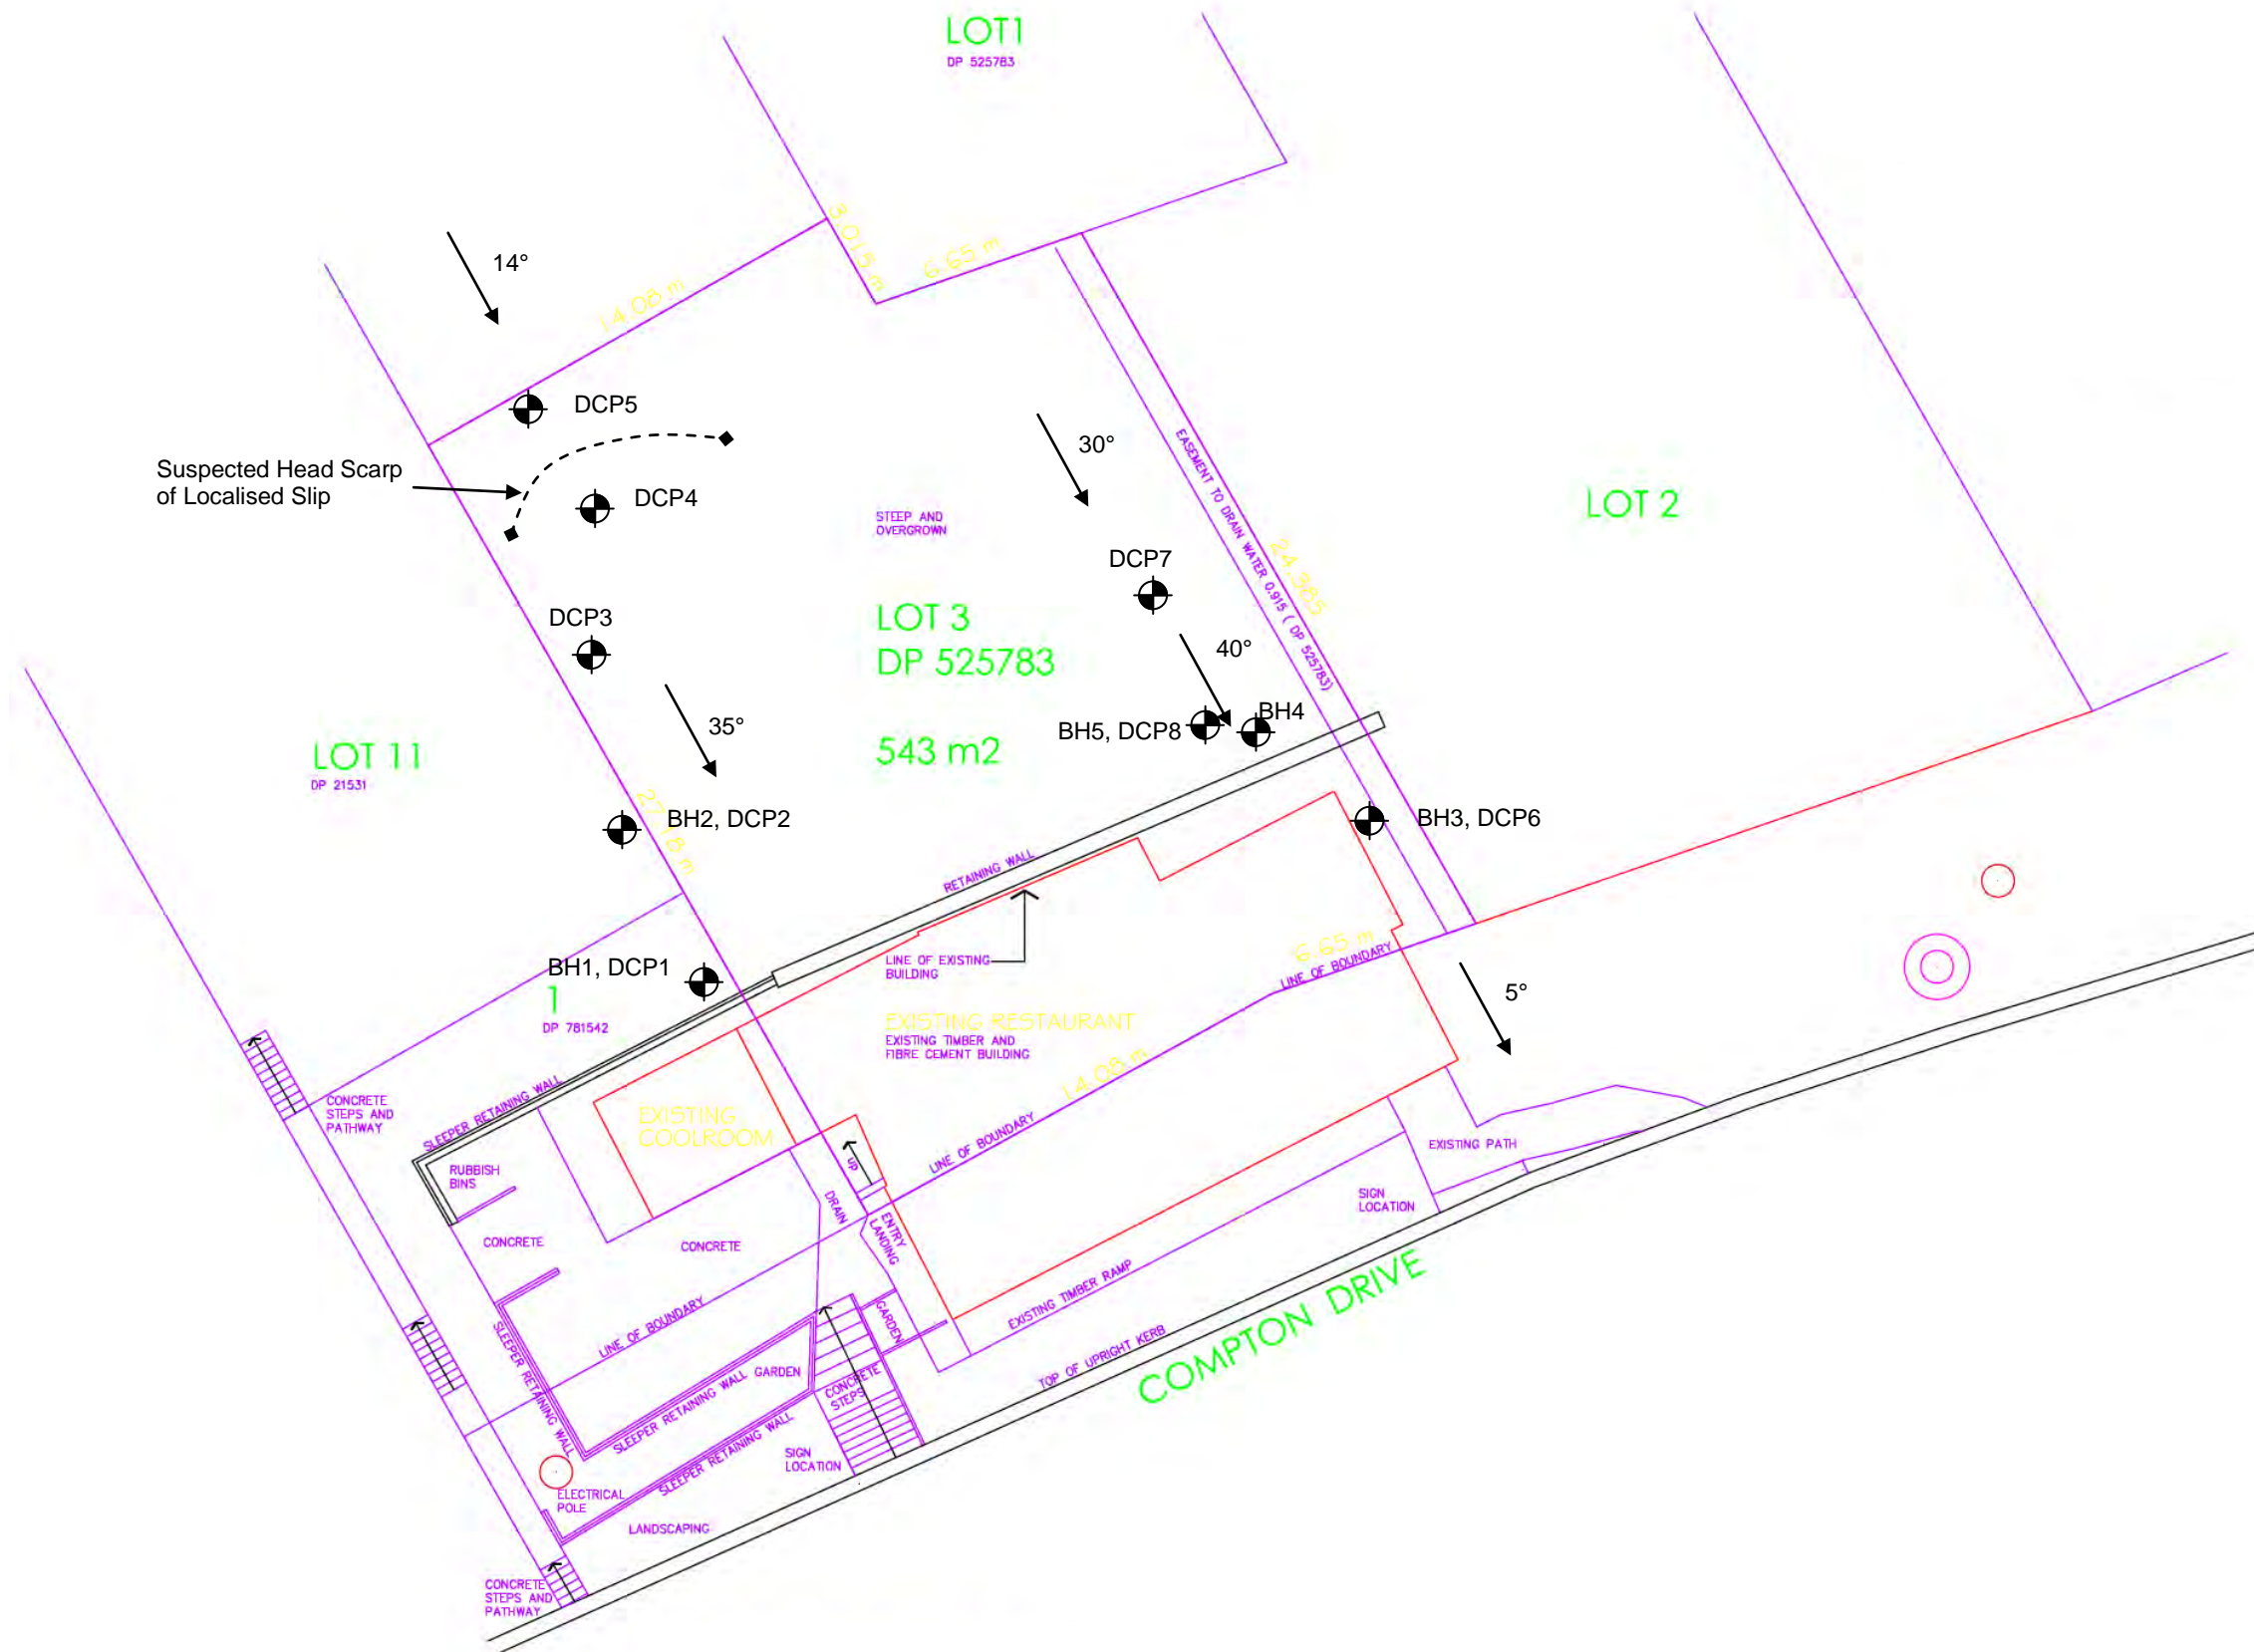
Within the steep slope above the retaining wall, near the crest of the slope, a small arcuate landslide headscarp was observed. The headscarp of the landslide is around 10m in lateral extent and has formed a step of around 0.7m in vertical extent. Above and around this headscarp the garden waste and fill (including some bottles) was observed. This fill is of uncertain depth.

The general arrangement of the site, and the slope observed are indicated on Figure 1.

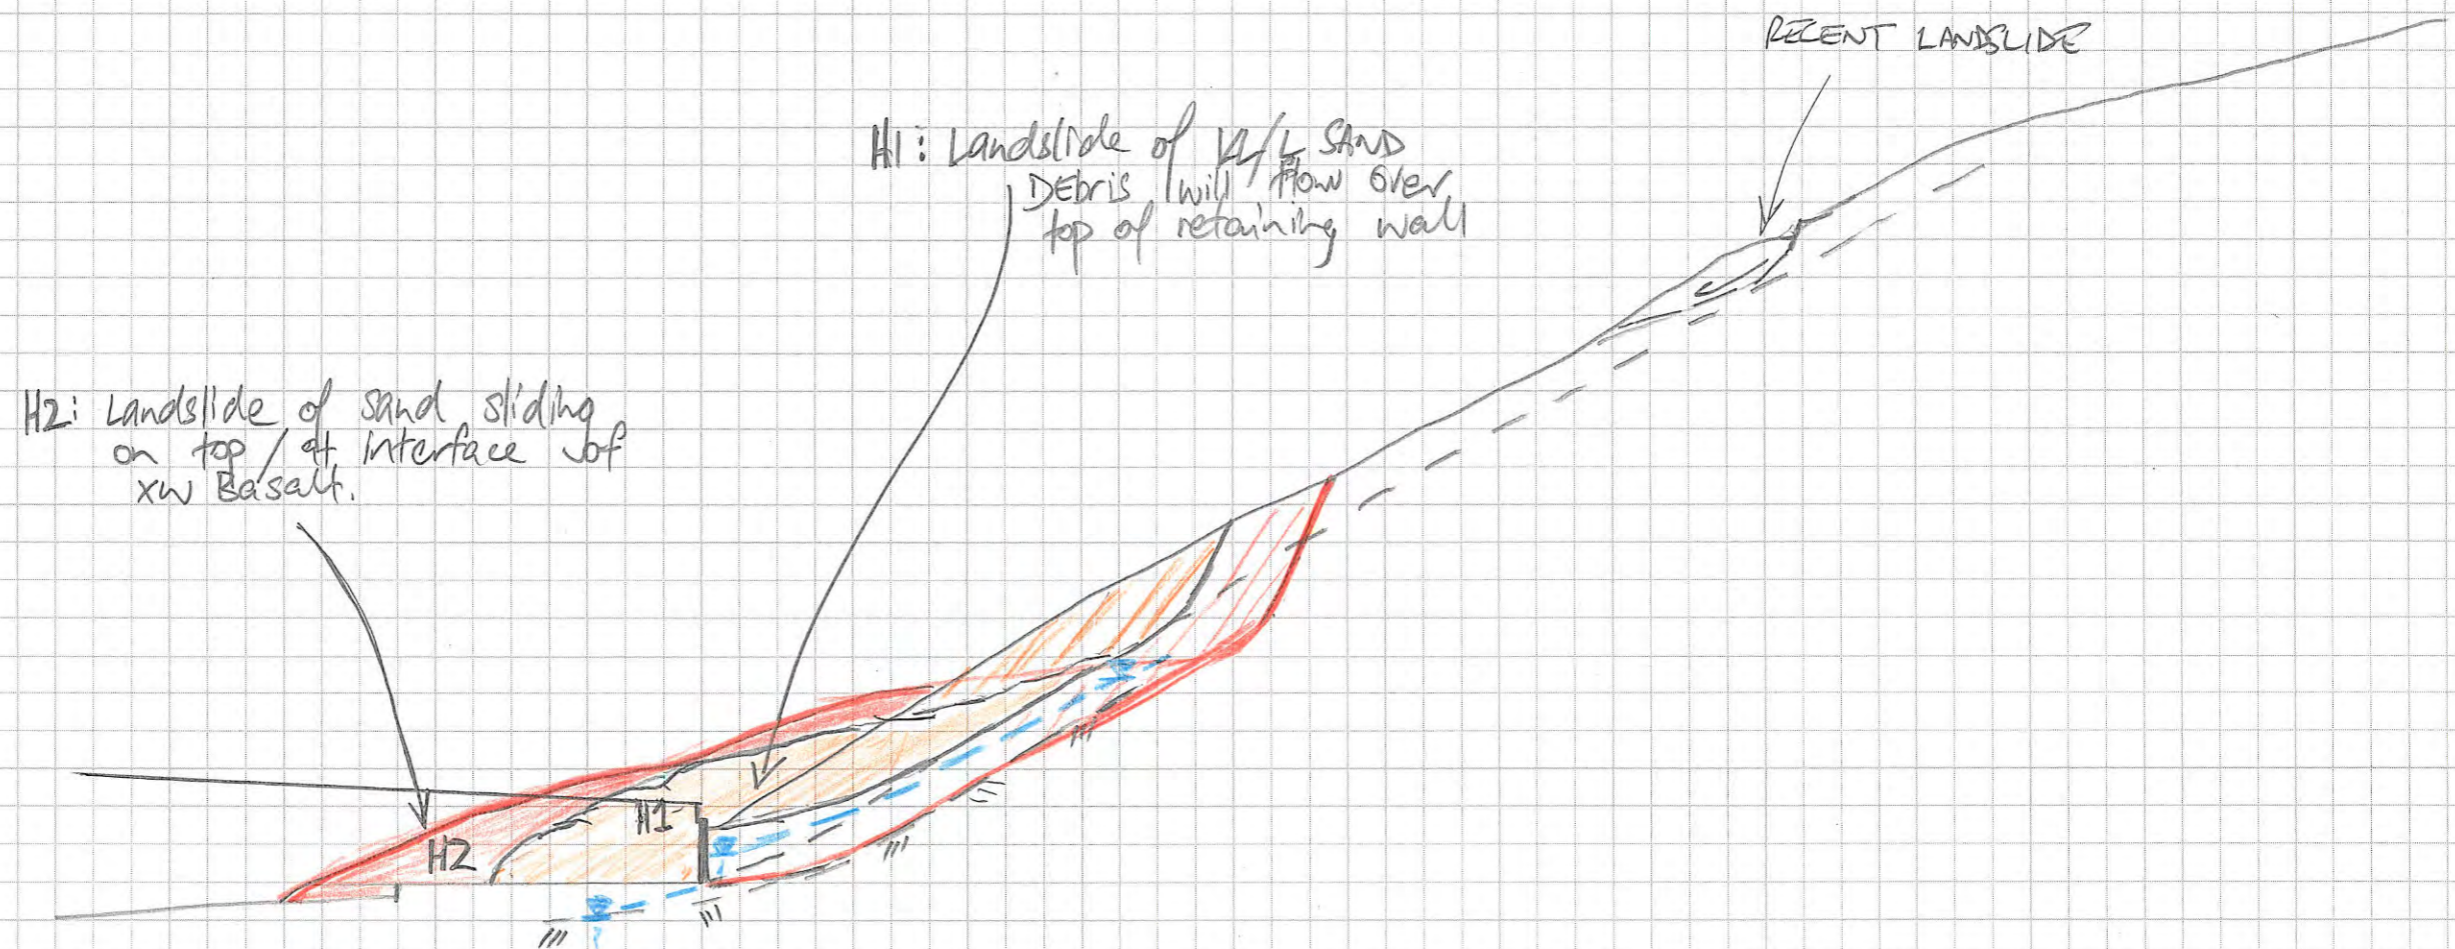
CREDIBLE HAZARDS

Hazard	Likelihood	Possible Consequences	Potential Mitigation Options
<p>H1) Shallow landslide of the loose to very loose sand (above the existing retaining wall).</p> <p>The landslide may be in the order of say 10m wide, 2 to 3m deep and say 10 to 15m long. When it slides down the slope we would expect it could overtop the existing wall, or topple it in part, and leave a debris pile that extends say 5m to 10m into the restaurant area.</p>	<p>The presence of an existing landslide of this type, coupled with deep loose sand and elevated groundwater indicates that this type of hazard is likely to occur.</p> <p>The trigger for the event could be minor rainfall or small changes to the slope vegetation and drainage.</p>	<p>If this hazard occurred, moderate volumes of soil could slide down the slope above the retaining wall, and spill over into the rear half of the restaurant. The debris could move faster than running pace with little or no warning.</p> <p>The consequences of the hazard are likely to be moderate to major with extensive damage to much of the existing structure possible, if no restraint of catch structure is built.</p>	<p>Retain the hazard in place or construct a catch structure above the development to provide protection</p> <p>H1+H2-a) Soil nailed retention systems,</p> <p>H1+H2-b) Piled retention systems installed within the slope above the existing retaining wall, stepped up the slope.</p> <p>H1+H2-c) A large retaining wall founded at the base of the slope with additional height to act as a catch structure or to provide a wall to backfill against to resist landslide forces. The wall could be an anchored piled wall or a gravity wall.</p>

<p>H2) Landslide of the soil above weathered rock (above the existing retaining wall)</p> <p>The landslide may be in the order of say 10m wide, 3 to 4 m deep and say 10 to 15m long. When it slides down the slope we would expect it could topple or slide through the existing wall, and leave a debris pile that extends say 5 to 15m into the restaurant area. If the debris was very wet greater travel distances could be expected.</p>	<p>The presence of a moist to wet clay layer at depth (HA2), which potentially dips downslope, indicates that a moderate sized landslide that would encompass a large amount of the slope, is considered possible.</p> <p>The trigger for the event could be moderate rainfall or changes in the slope loading or support. (Such as developing the slope without taking this into account).</p>	<p>The event could occur rapidly with debris moving downslope faster than running pace, or slowly with movements occurring over a number of years.</p> <p>The consequence of such a landslide is considered to be catastrophic for the current restaurant, with debris extending out from the base of the slope in the order of some 5m to 15m. In some circumstances, debris could reach the roadway.</p>	<p>H1+H2-d) Accept the hazard and develop such that the hazard does not affect the proposed structure. Such a strategy could rely on a specifically reinforced structure designed to withstand the forces should soil slide into the building, or design the structure such the landslide could travel below the proposed structure without unreasonably endangering life.</p>

Figure 3 presents a visual interpretation of Hazards 1 and 2.
