## **ASSESSMENT AND MANAGEMENT OPTIONS**

***Ficus macrophylla***

**Castle Drive, Lennox Head**

**Date:** February 2018

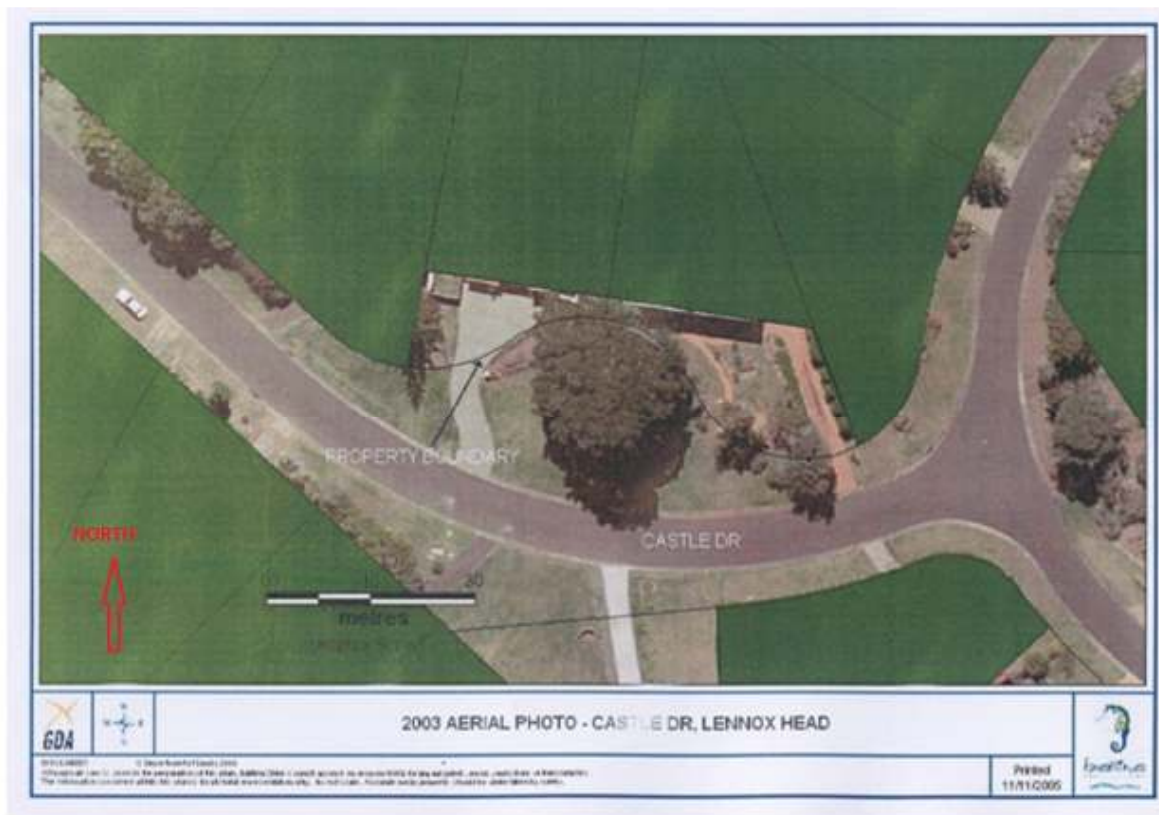
The unfenced and unmarked boundaries of the adjacent lots were set back behind and around the tree (see fig 2). It was n However, portions of the tree canopy appeared to overhang the property boundaries and it was evident that roots from the tree were growing within the adjacent properties for a good distance beyond the canopy. There were landscaped garden and turf areas under the canopy of the tree in both lots. The ground surrounding the tree was mostly well mulched with leaf litter close to the stem and mown grass under the canopy within the verge.

Figure 2: Image provided by Council indicating property boundaries in relation to the tree.

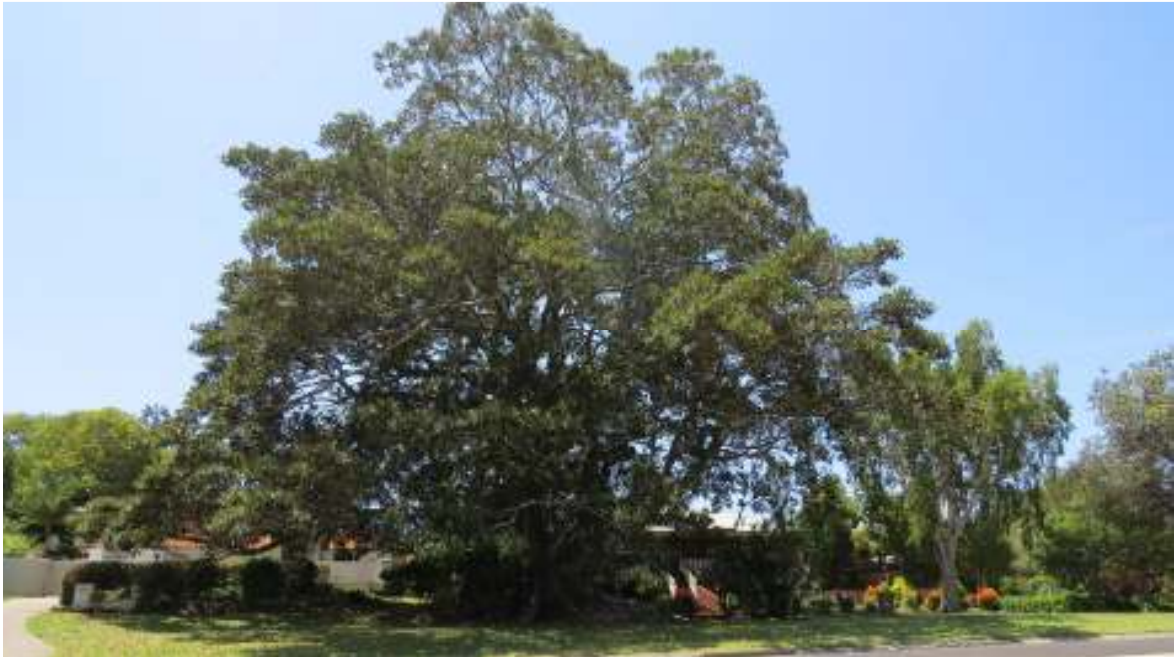
Figure 3: *Ficus macrophylla* (from south)

The tree had a large broad spreading domed canopy with no obvious phototropic bias, albeit with some past removal of large leaders and reduction of the spread over private property to the north. The canopy was partially exposed to ocean winds but there was no salt burn or wind shearing evident. The growth form of the tree was typical of similar open grown specimens of *Ficus macrophylla* found on similar sites, but overall untypically large for those remaining within urban subdivisions.
