Arboricultural Impact Assessment Report

13 Martin Street BALLINA NSW 2478

Prepared for: Ballina Shire Council

Prepared on: 12 September 2019

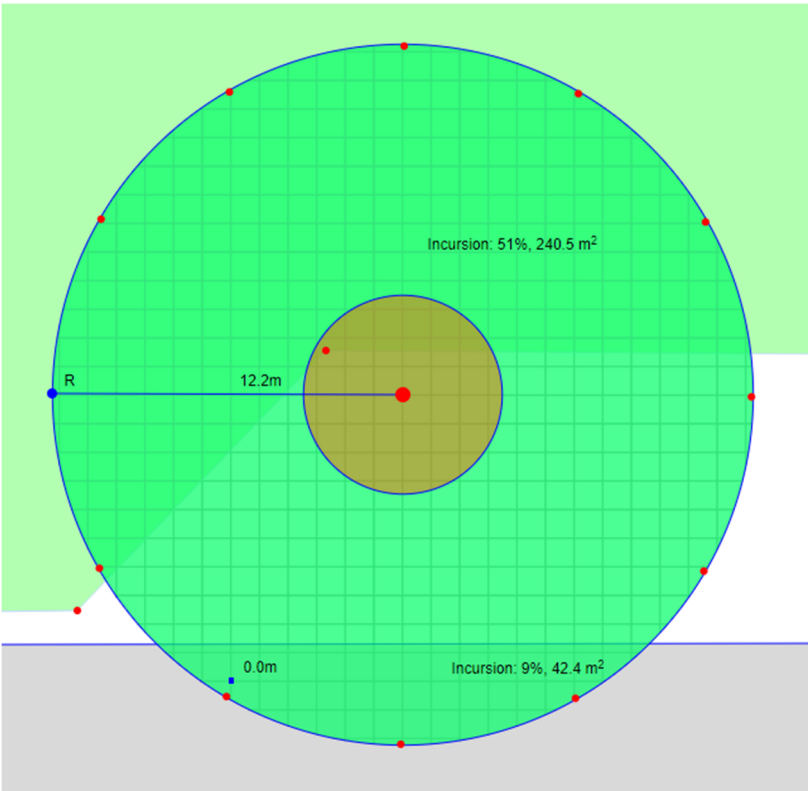
Appendix 3: TPZ incursion calculator showing development (road & footpath)

The Fig forms part of an avenue of commemorative plantings along Tamar Street. The Fig is also listed on the Ballina Shire Council Significant Tree Register. Development has encroached upon the tree from all sides over the years. (See appendix 2) 51% of the trees TPZ has been encroached by the road and a further 9% by the building. Leaving the tree with only 40% of its theoretical protection zone for root development, water and nutrient uptake. Yet the tree appears to be coping with this very well. The remaining grassed area underneath the tree and the lawn to the east are assumed to be the trees main source of water and nutrients.

Shaded areas indicate extent of existing development.

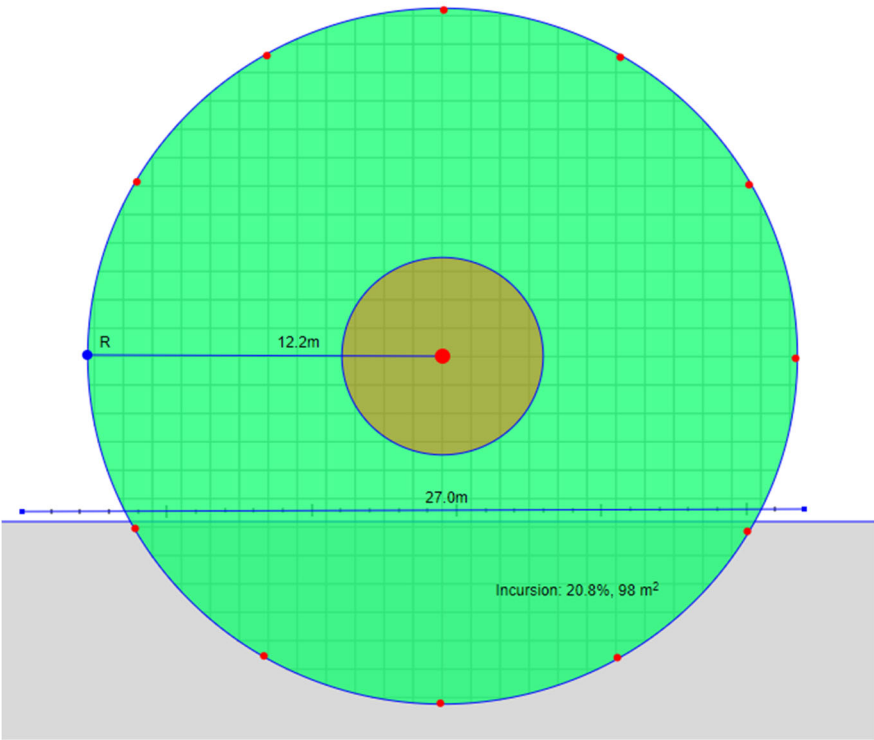
Excavations required to carry out the works would encroach upon the TPZ of the tree but remain outside the SRZ. The proposed site to excavate and severe the roots would be between 5.3m & 4.8m from the tree. This equates to 21% (98m²) of the TPZ and would be considered a major encroachment. If the proposed encroachment is greater than 10% this area should be compensated for elsewhere and continuous with the TPZ (Australian Standard 4970-2009 Protection of trees on development sites)

TPZ incursion calculator showing extent of proposed root barrier works.

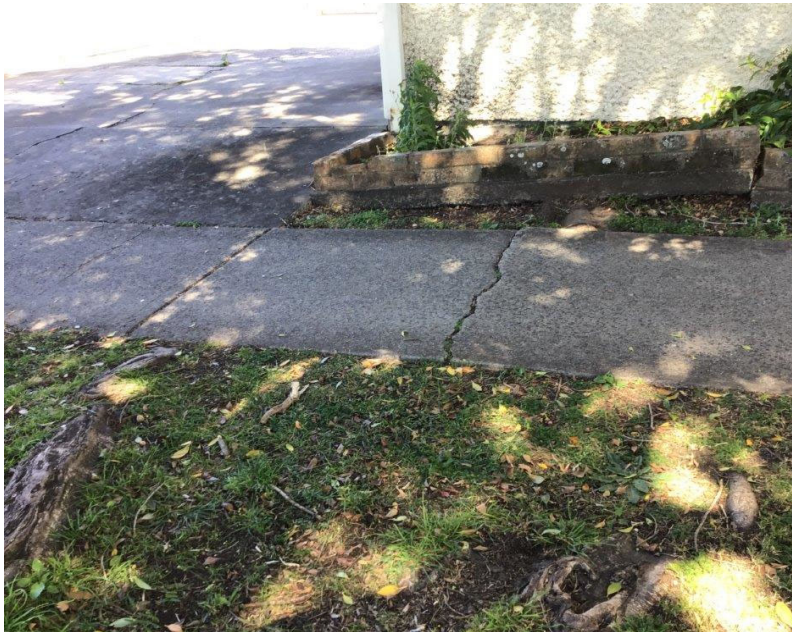
Several roots with an estimated diameter of 150-200mm were present at a distance of less than a metre from the base on the building.

Fig Root heading under footpath on northern side of building. *B. Branch 10/09/2019*

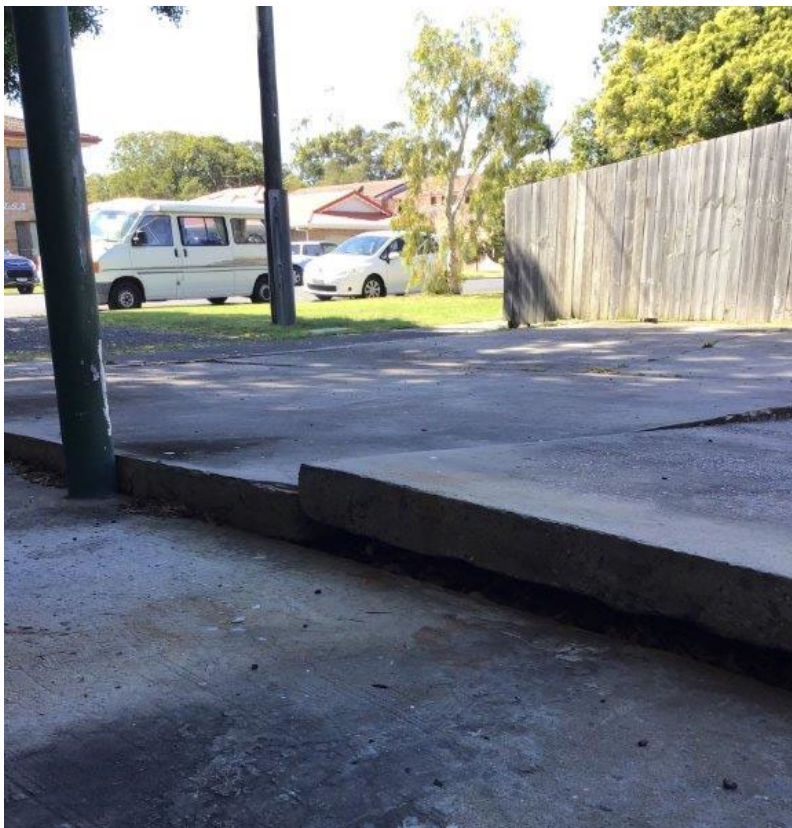
A root 150mm in diameter and belonging to this tree was sighted approx. 19m away lifting the slab in the carpark of the building. Other damage to the concrete drive way slabs appears consistent with this as the heaving is commonly measured to height of 150mm.

Carpark slabs lifted 150mm by visible root. *B. Branch 10/09/2019*

Fig tree roots are robust and 1000um grade non permeable root barrier should be installed to specifics as detailed in Appendix.3 With the addition of a concrete or timber capping to pinch 80-100mm of barrier above ground level to preventing it from being sucked into the earth and breached by surface roots.

Installing the barrier will require trenching to a depth of 1m along the northern edge of the existing footpath 5.3m from the trunk of the tree. The trench should be between 300-500mm in width. Dial before You Dig plans must be adhered to. The trench is proposed to continue west of the boundary of No.36 Tamar and 13 Martin Streets for a distance of 20m. A 2m clearance given to avoid the Telstra pit and lines located on the boundary. Works are proposed to continue in an easterly direction for a further 7m in front of No.36 Tamar St.

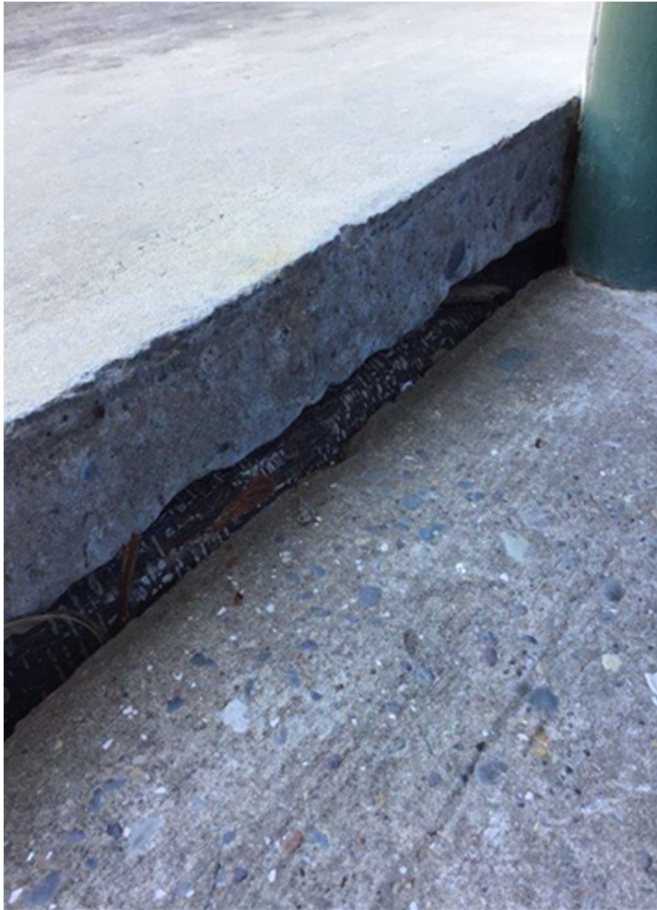
Fig root visible 19m from tree. B. Branch 10/09/2019

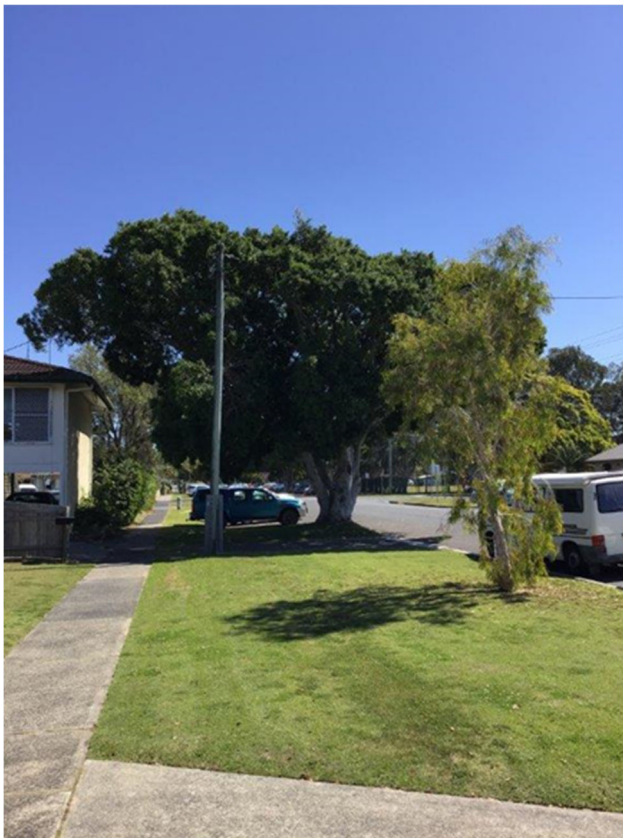
Grass area in front of No.26. Compensation for TPZ incursion. B. Branch 10/09/2019

The turfed areas to the east and west are to become part of the TPZ. The total sum of these areas amounts to 123m² (See appendix1) compensating for the 98m² incursion (App.2) to install the root barrier. These areas are provided for the benefit of the tree and its root system and any further development should be restricted to exclude hard surfacing and compaction in these areas as they are important sources of water and nutrients to the tree.
