>>> Lake Ainsworth water quality snapshot

February 2017

prepared by Ballina Shire Council

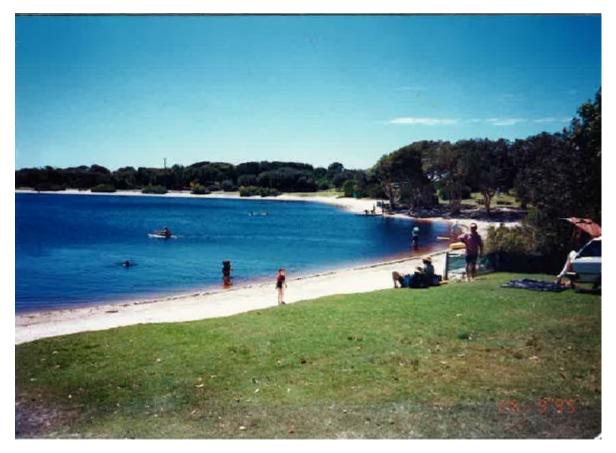
Figure 2. The south eastern corner of Lake Ainsworth on 26 September 1995.

Another issue gaining community attention is the foreshore erosion, particularly in the south eastern corner (Fig. 2 and Fig. 3) where it is suggested that high pedestrian activity, gaps in vegetation, and impervious surfaces contribute to the erosion and steep incline of the Lake's shores. Excessive erosion can increase sedimentation loads and turbidity, which in some cases has the potential to shorten the lifespan of a Lake system. High turbidity levels have the potential to become a nuisance to recreational users and can also increase water temperatures through enhanced solar absorption. The effect of erosion on the water quality of Lake Ainsworth is undetermined in this report.

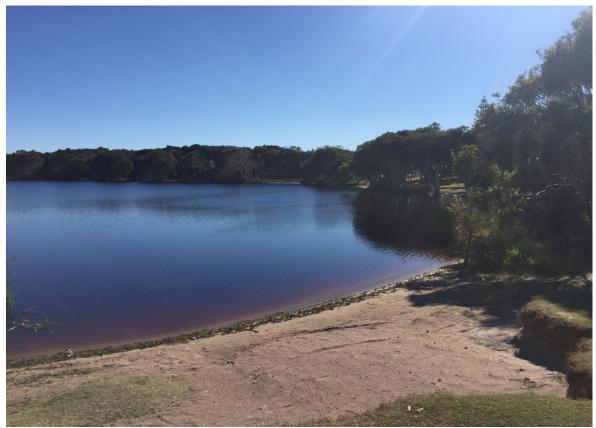
Figure 3. The south eastern corner of Lake Ainsworth on 18 October 2016.

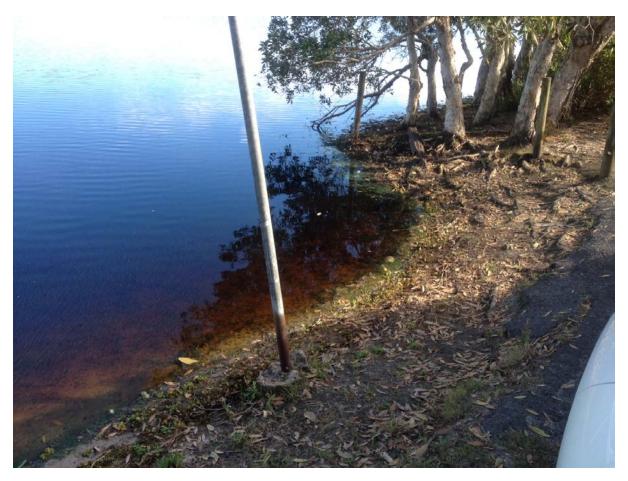
Figure 26. Erosion occurring along the eastern foreshore at Lake Ainsworth. Blue-green algae also present.

Another issue gaining community attention is that of foreshore erosion, particularly in the south eastern corner where it is suggested that high pedestrian activity, gaps in vegetation, and impervious surfaces contribute to the perceived erosion and steeper incline of the shore. This is largely anecdotal evidence, including personal communications of long term residents and various photographs (e.g. Fig. 2; Fig. 3 and Fig. 26). A comparison of the grassed areas in Figure 2 and Figure 3 suggests there may be a degree of erosion that has occurred which may be attributed to pedestrian traffic, stormwater runoff and/or wind/wave forces combined with fluctuating water levels. In surrounding areas (particularly near the south eastern corner) there has also been documented erosion with one source suggesting 15 metres of grass has been eroded over the past two years (pers. comm.). Various actions have been undertaken by Council to reduce foreshore erosion including the placement of logs, restoration of vegetation to stabilise banks, sand dumping in eroding areas, the use of exclusion zones programs. Excessive erosion has the potential to increase sedimentation loads and turbidity, which in some cases have the potential to shorten the lifespan of a lake system. High turbidity levels have the potential to become a nuisance to recreational users and can also increase water temperatures through enhanced solar absorption. Furthermore, areas which are prone to erosion have often shown to exhibit higher than normal nutrient loads in adjacent waters due to an increase in fertile material entering a waterbody. The effect of erosion on the water quality of Lake Ainsworth is at this point undetermined.
