# **Seven Mile Beach (Precinct 2) Beachfront Management Plan**

**Environmental Training and Employment Inc.  
EnvITE NSW**

**2005**

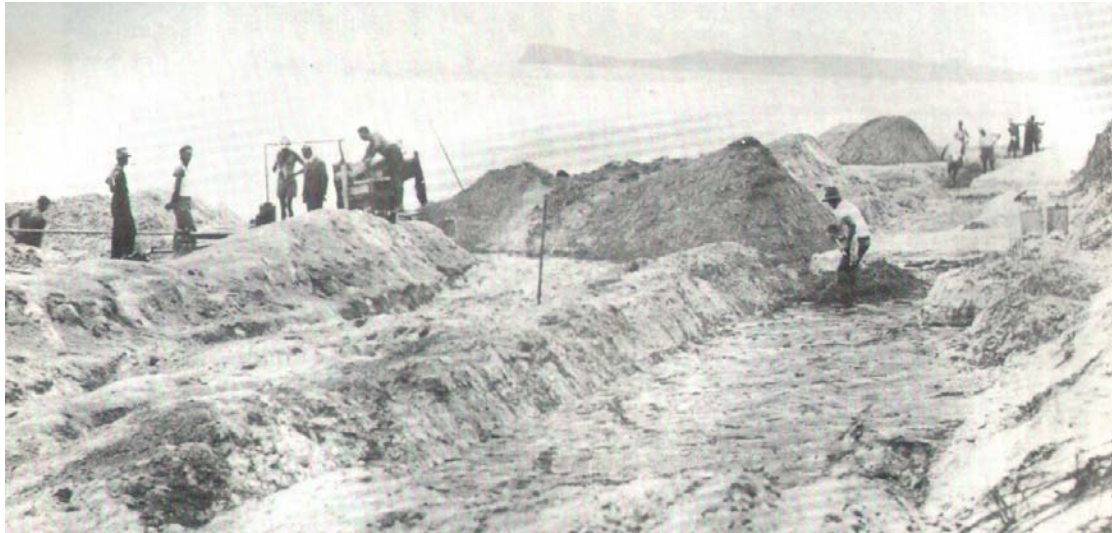
**Plate 2: Sand mining on Seven Mile Beach in 1935 (Source: Morley, 1981).**

Mineral sandmining was carried out at northern Seven Mile Beach from the 1930s to the 1970s (Plate 2), (Morley, 1981). However, the modified structure of the dunes in the study area is the result of erosion associated with cyclone events. In particular, the cyclone of June 1967 caused several significant breaches of the dunes. Damage from this event could have resulted in the loss of property if it were not for the combined efforts of residents and local Councils who constructed a 'Ti Tree fence' extending along the foreshore. This fence limited erosion from the cyclone and effectively began accreting sand. From time to time parts of this fence are uncovered in the sand, providing testimony to the longevity of the 'Ti Tree' (*Melaleuca quinquenervia*) poles used (Plate 3). The dune structure and vegetation communities are now less complex, with fewer micro-environments, than previously existed.

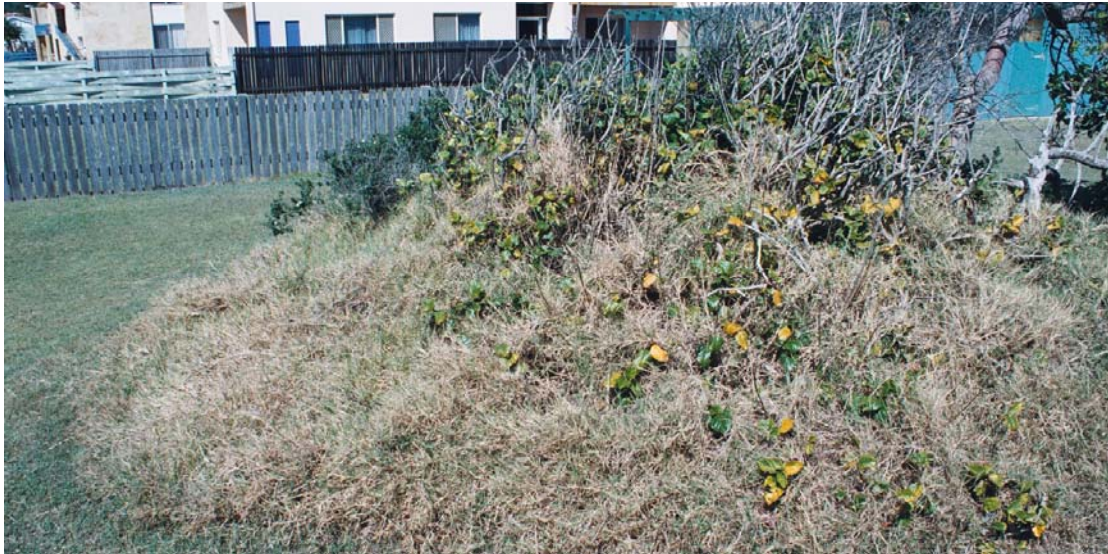
**Plate 4: Garden beds established to increase wind protection and amenity have become overrun by weeds.**

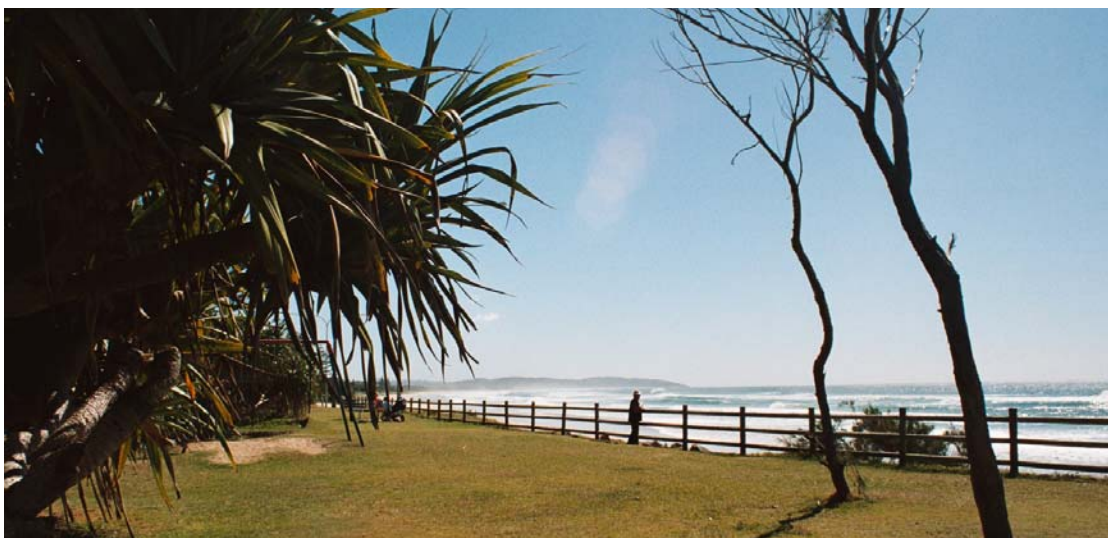
**Plate 5: Dead and dying old trees are recommended for replacement**

A number of dead and dying trees are present in the study area. The causes of death appear to be natural. Particularly affected are the Horsetail Sheoaks (*Allocasuarina equisetifolia*) which have reached the end of their lifespan.

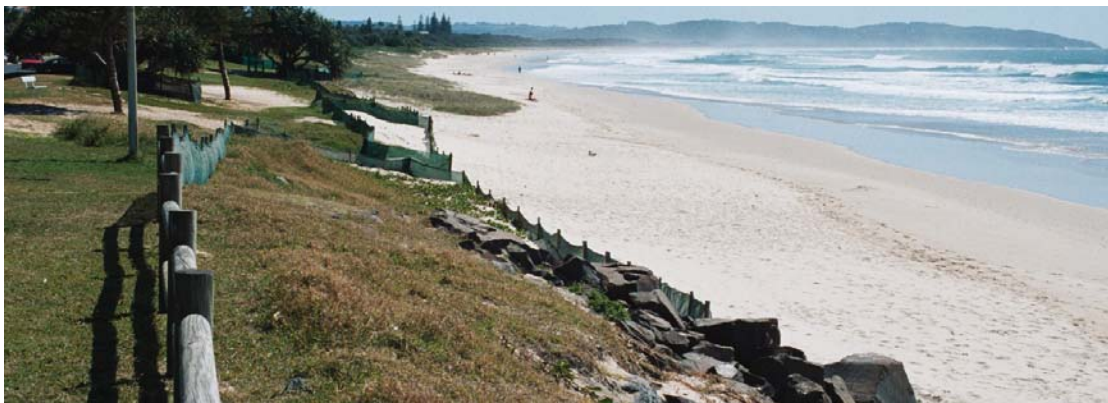
**Plate 6: View from Zone 1 towards Zone 2. Rocks have been placed on the foredune in an attempt to limit coastal erosion.**

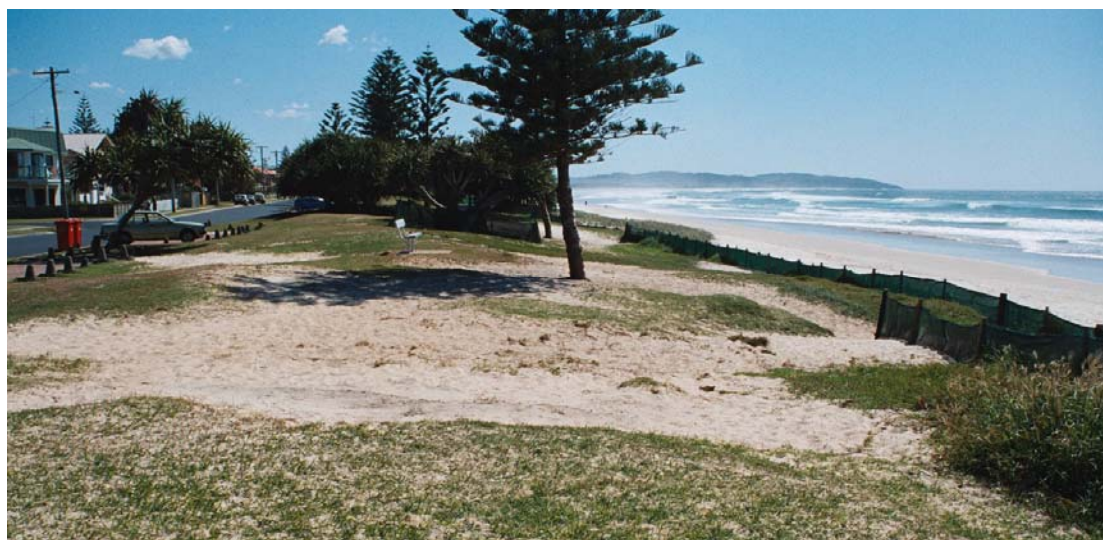
**Plate 7: Zone 2 has a high level of use and as a result turf is in poor condition. It is recommended to lay a reinforced turf product in this area. Plate 8: Zone 2 has a high level of use and as a result turf is in poor condition. It is recommended to lay a reinforced turf product in this area.**

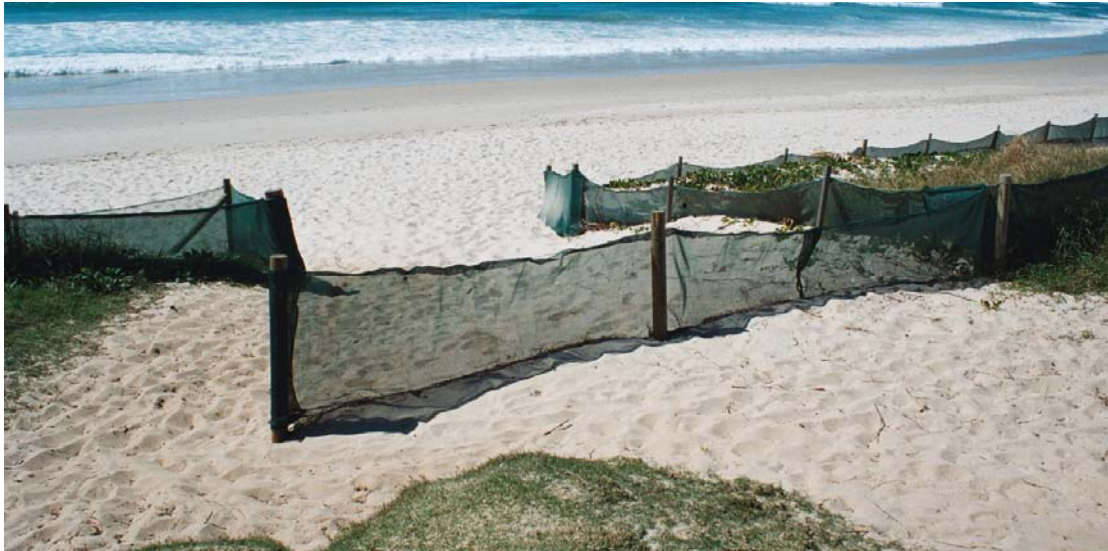
**Plate 9: Existing dune forming fences require reconstruction to assist accumulation of wind blown sand.**

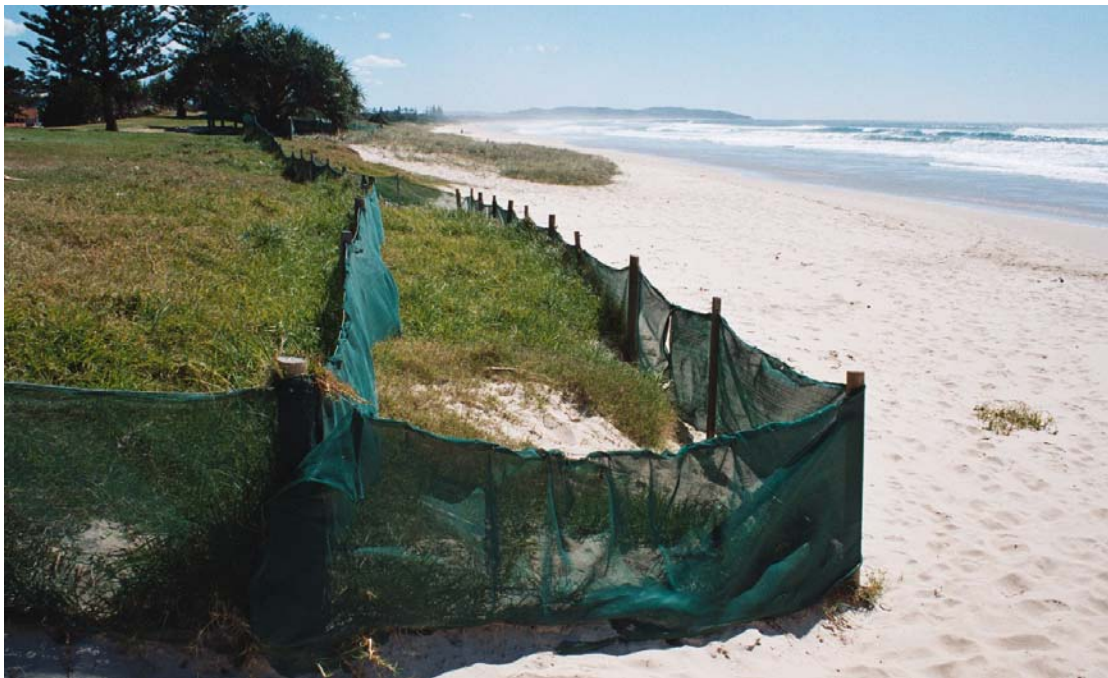
**Plate 10: New dune forming fences will extend a further 10 metres seaward to enable dunes to build up and to direct pedestrian traffic.**

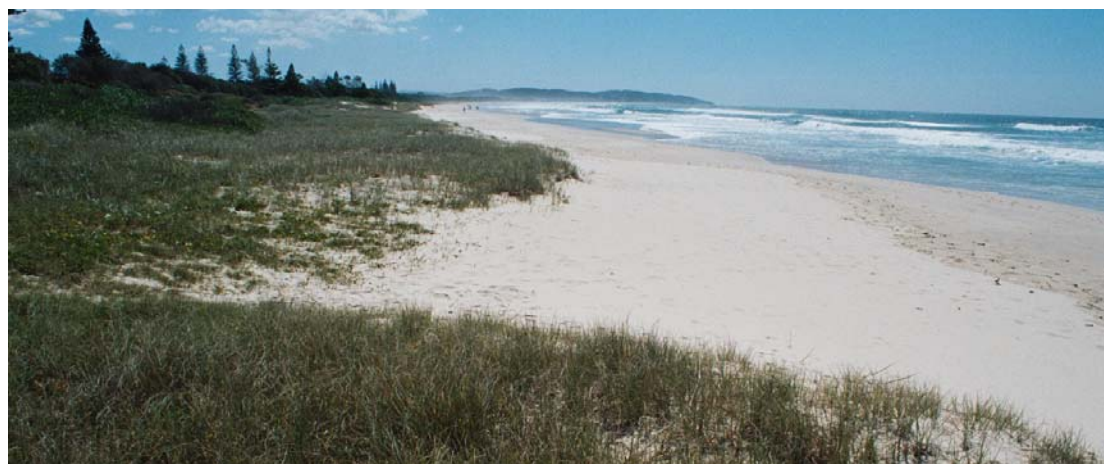
**Plate 12: Spinifex is unable to establish at the end of beach access tracks. Formalising access with fencing lining the track and extending the fence seaward to take users beyond the incipient dune area is recommended.**

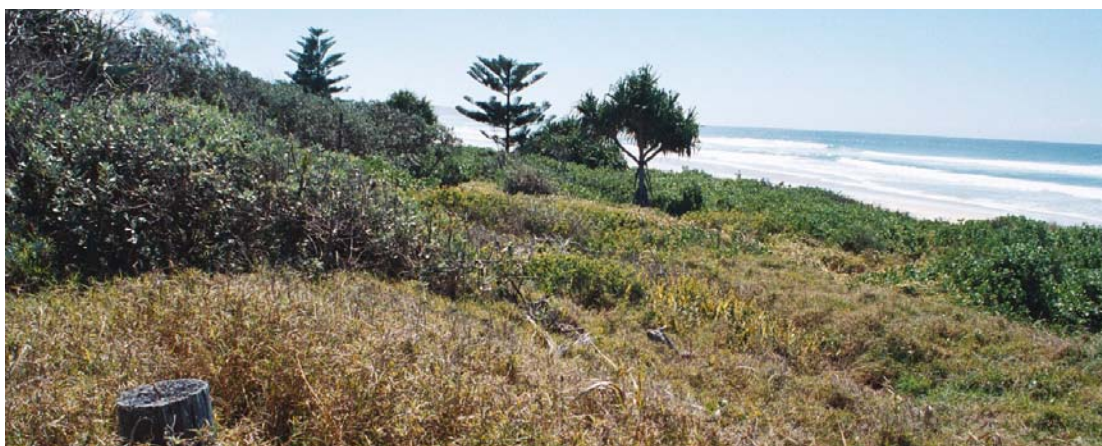
**Plate 13: Long grass deters walkers from this area.**

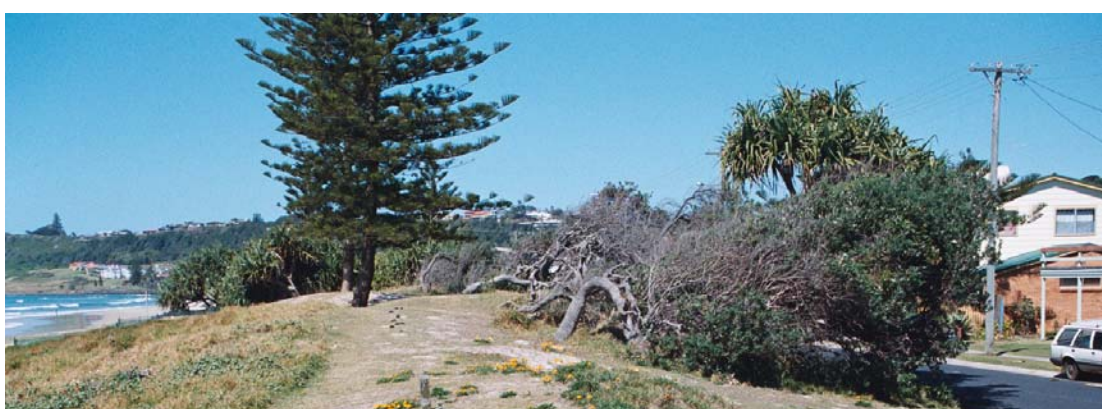
**Plate 14: Trees in the hind dune area are old and lack vigour with the exception of Norfolk Pines and Pandanus.**

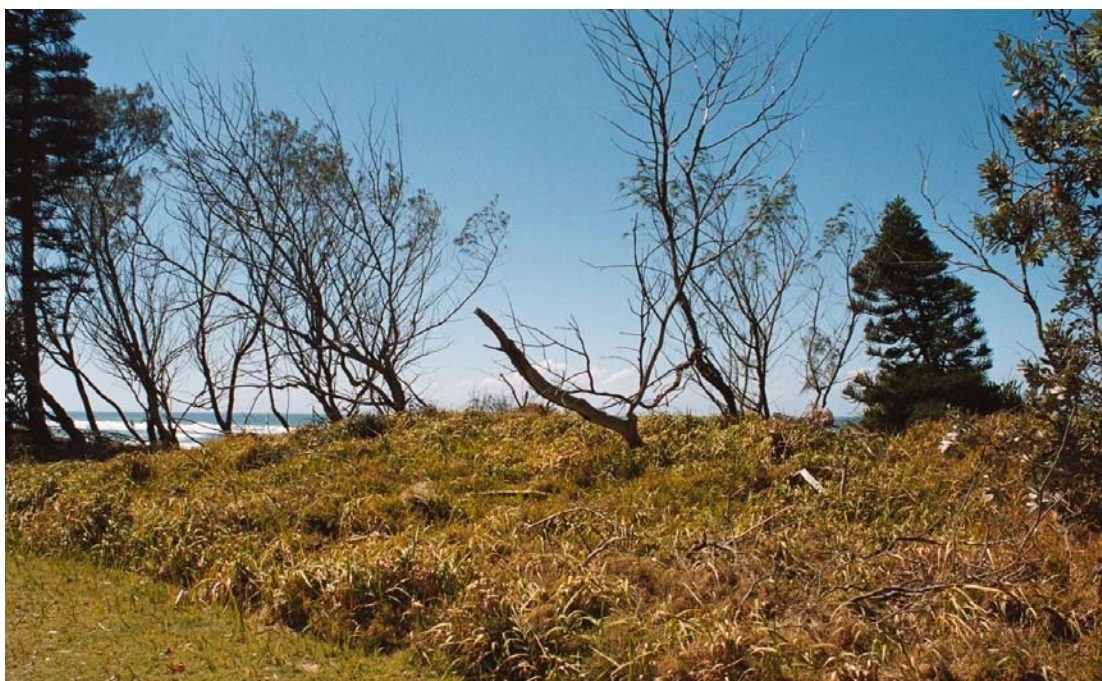
**Plate 15: Dead trees should be removed and replaced with semi-advanced local native plants. Avoid further use of Norfolk Pines.**

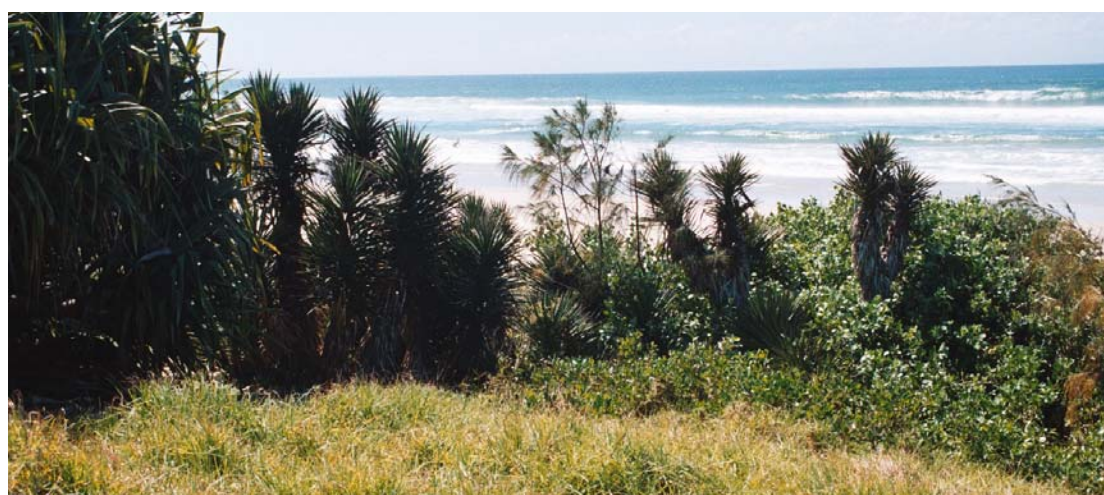
**Plate 16: Spanish Bayonets (*Yucca aloifolia*) are recommended for removal.**

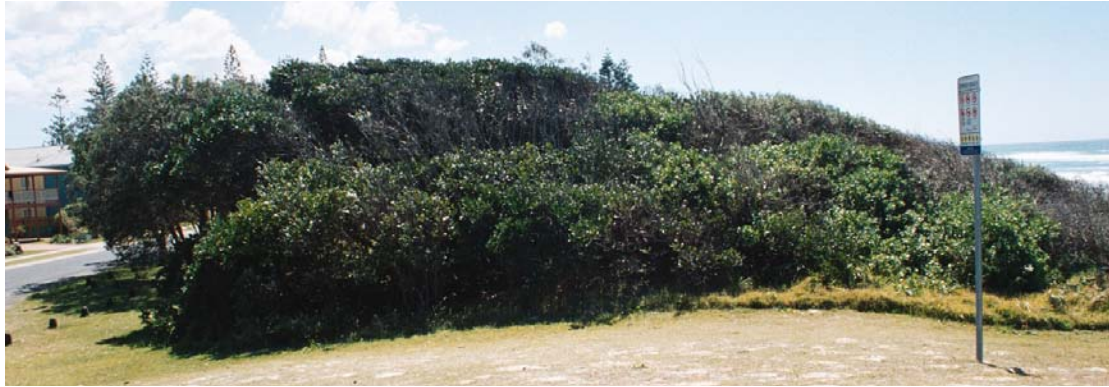
**Plate 17: Small windshorn remnant of littoral rainforest in Zone 5.**

<p><b>Zone 5.</b> <b>Williams St to Ross St</b> Small windshorn remnants of regrowth littoral rainforest (classified by Specht and Specht (1990) as Alliance V, Suballiance 17) can be seen in this zone (Plate 16). Littoral Rainforest is listed by the NSW Government as an Endangered Ecological Community (EEC) (Appendix 6)</p> <p>These remnants are dominated by <i>Cupaniopsis anacardioides</i>, <i>Alectryon coriaceus</i> and <i>Acronychia imperforata</i> and are surviving due to their intact canopy.</p> <p>Refer to Appendix 7 for Bush Regenerators Checklist which must be used when working in an EEC. Workers must be licenced by DEC to work in this community. (Appendix 6 &amp; 7 )</p> <p>Threats to remnants include competition from weeds such as Ground Asparagus and Turkey Rhubarb (Plate 17), inappropriate usage such as carparking in their shade and natural senescence.</p> <p>The native water vine (<i>Cissus antarctica</i>) is dominating the site and should be thinned.</p> <p>The topography in this zone provides opportunities for wind protected planting that will extend the edge of, and ideally link, these remnants (Plate 18).</p> <p>The beach access tracks, opposite the shop and leading from the carpark opposite Ross Street, receive high use and should be formalized to minimize further erosion (Plate 19).</p> <p>Water flow from the stormwater drain prevent the establishment of vegetation in front of the pipe. The gardens to the west of the Ross Street carpark require weed control, replanting, mulching and programmed maintenance.</p>	<p><b>Littoral Rainforest Protection</b> <b>Weed Control and Revegetation</b></p> <ul style="list-style-type: none"> <li>• These areas have survived thus far due to the protection afforded by the existing foredune. This protection must be maintained and ideally supplemented through the planting of endemic trees and shrubs, such as <i>Banksia integrifolia</i>, <i>Acacia sophorae</i> and littoral rainforest species.</li> <li>• Bitou Bush is performing a role in wind protection and should not be removed until new plantings are established.</li> <li>• Plant the strip between the remnants and the seaward Bitou Bush. This area is not extensively used by the public.</li> <li>• Weed species in the understorey (such as <i>Asparagus aethiopicus</i>) should be removed to allow germination of native seedlings (refer to Appendix 4 &amp; 5 for specific control methods).</li> <li>• Consideration should be given to linking these three areas together through planting to increase remnant resilience.</li> </ul> <p><b>Beach Access and Car Parking</b></p> <ul style="list-style-type: none"> <li>• Careful design could still allow pedestrian beach access ultimately beneath a canopy of trees.</li> <li>• If car parking is occurring beneath the canopy install road side bollards to prevent car access.</li> <li>• Existing beach access ways should each be repaired and supplemented with regulatory and educational signage, bins, and showers or taps.</li> </ul> <p><b>Other</b></p> <ul style="list-style-type: none"> <li>• It is recommended that stormwater drains be extended out further to allow the accumulation of sand and revegetation of the dune building fences should be built on each side.</li> <li>• Residents should be encouraged (via letter box drops, newsletters, posters, media articles etc.) to care for these remnants as a protective asset between themselves (and their property) and the ocean.</li> <li>• Carry out regular maintenance on car park gardens.</li> </ul>	<p>High</p> <p>High -in progress</p> <p>Medium</p> <p>High</p> <p>Medium</p> <p>Medium</p> <p>Medium</p> <p>Low</p> <p>Medium</p>	<p>LHL</p> <p>LHL</p> <p>LHL</p> <p>BSC</p> <p>BSC</p> <p>BSC</p> <p>BSC</p> <p>BSC or LHRA</p> <p>BSC or LHRA</p>

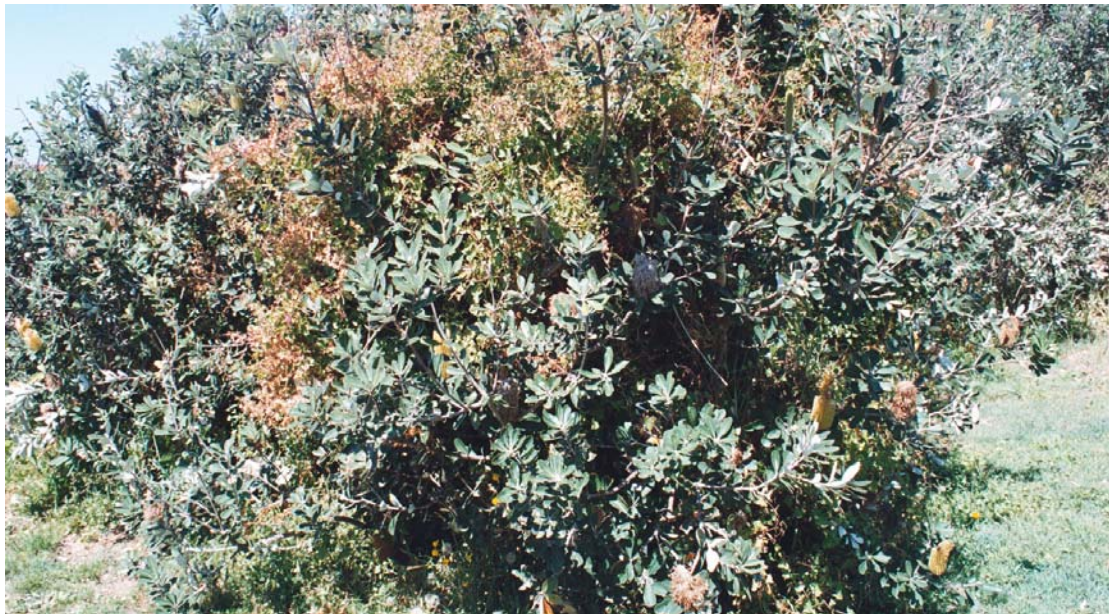
**Plate 18: Fruiting Turkey Rhubarb has climbed a Banksia in Zone 5. Control is required to prevent further infestation through wind blown seed.**

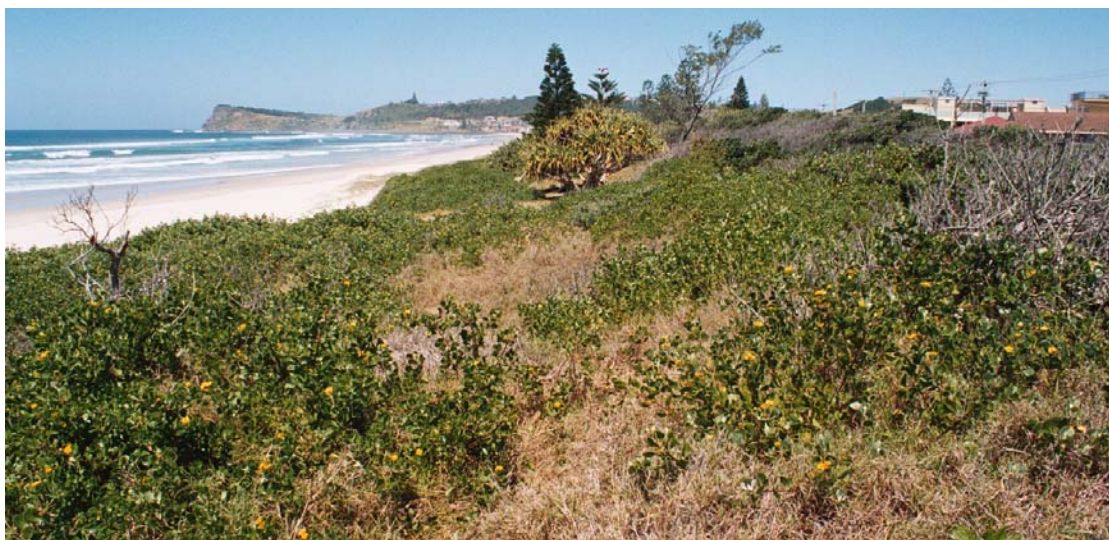
**Plate 19: This area in Zone 5 is suitable for planting. It is not used for recreation and plantings will provide protection for existing remnant vegetation.**

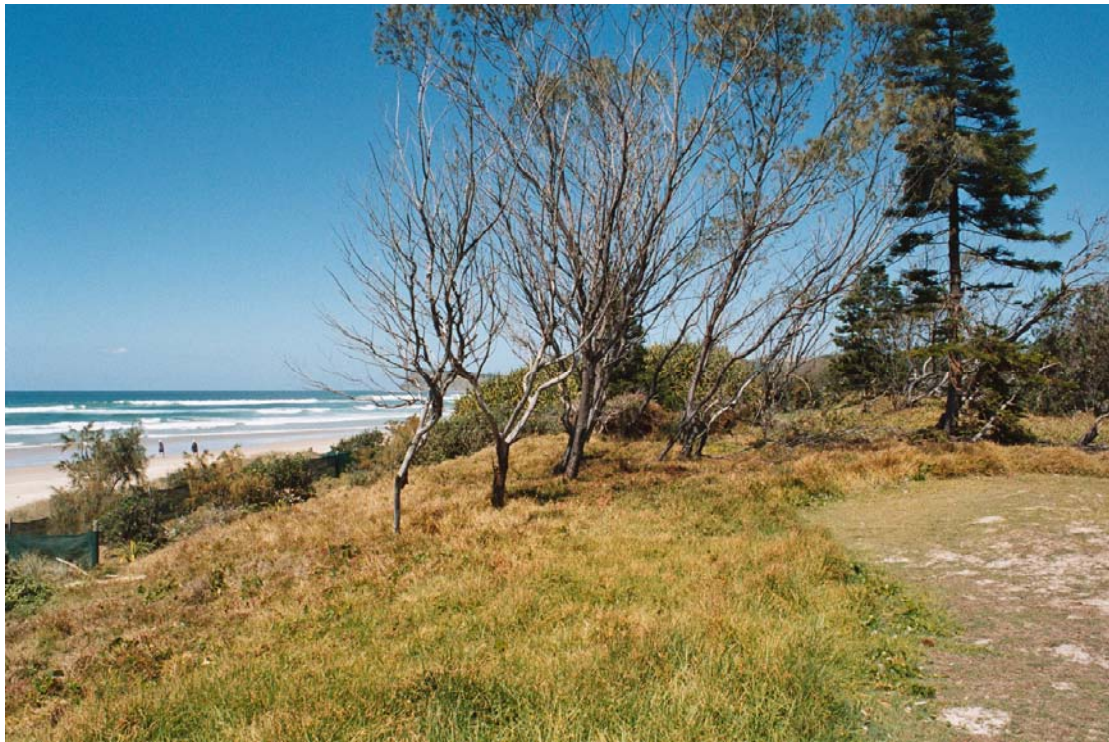
**Plate 20: This high use area is Zone 5 has no facilities. A table could possibly be constructed on the turf area.**

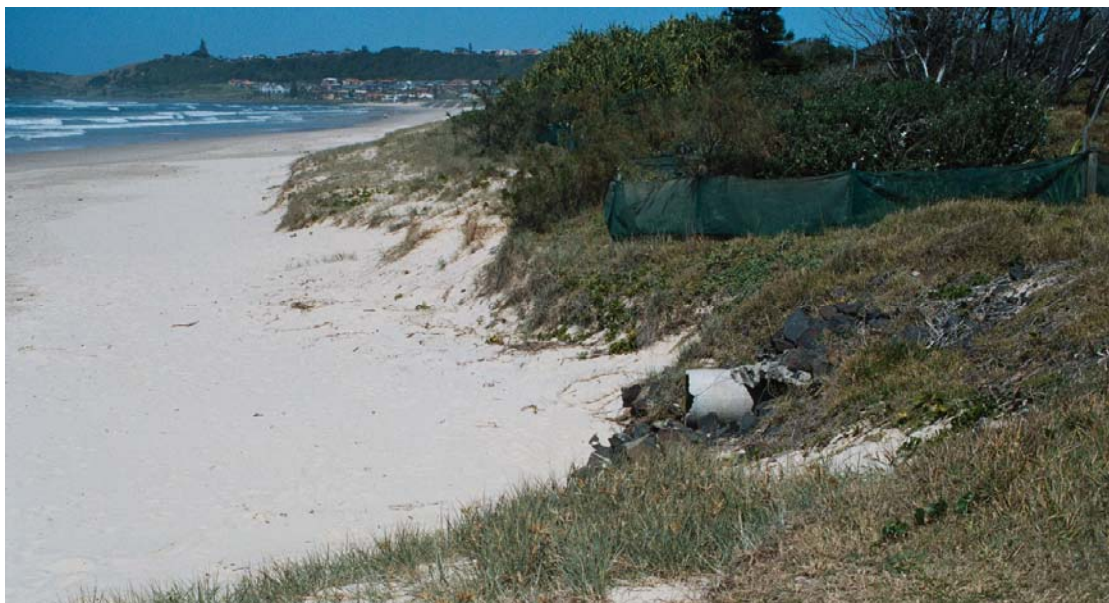
**Plate 21: Water flow from the stormwater drain prevents the establishment of vegetation in front of the pipe. It is recommended that stormwater drains be extended out further to allow the accumulation of sand and revegetation of the dune. Ideally, a rubbish catching device will be incorporated into the design.**

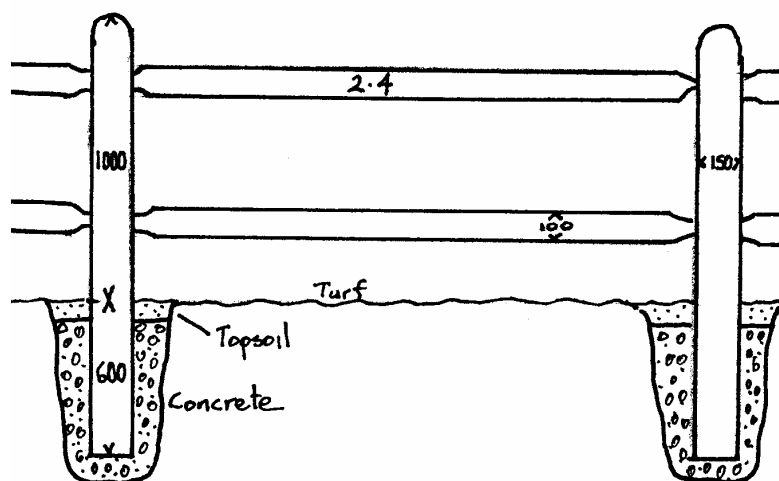
**Figure 6: Construction detail of post and rail fence.**

Dune vegetation is particularly susceptible to damage from pedestrian and vehicular traffic. Fences are therefore used in the dune areas to preserve both revegetated and naturally vegetated areas. Two major fence lines are generally used in dune rehabilitation projects, one along the seaward margin of the dune field, and other landward fence that protects hind dune areas.

Designated accessways provide controlled opportunities for beach users to cross the dune and these are also usually fenced. Fencing on either side of accessways is used to control traffic. If access is not confined to tracks, significant damage can occur to both mature and establishing vegetation. All accessways require regular maintenance so that they continue to function correctly and do not become a hazard to the public.

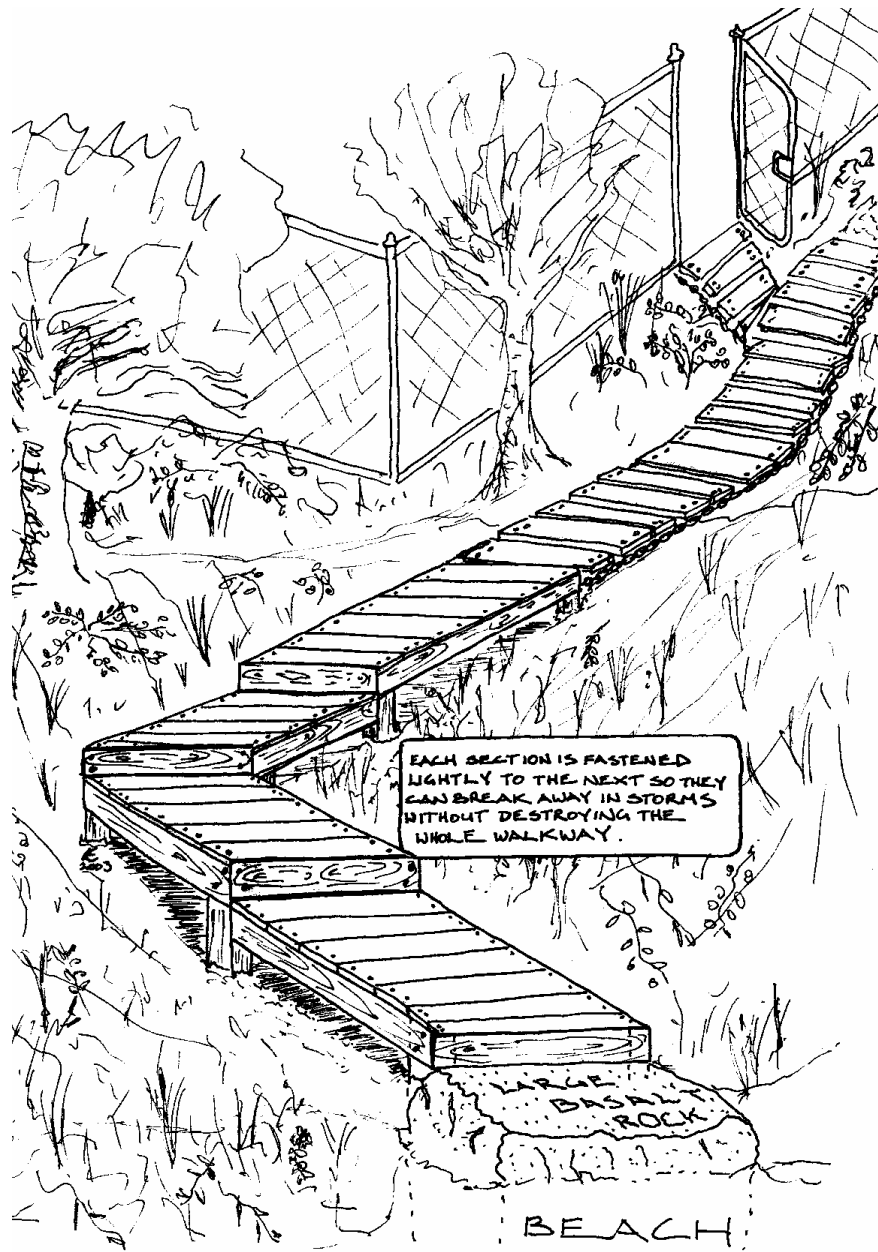
**Figure 7: Example of track design. A variety of design options are possible to suit a range of situations.**

There is no standard way to build a beach access track, each case must be considered for orientation, slope, rate of erosion and underlying material. An example is shown of a design for a particular situation at Byron Bay (Figure 7). This design incorporates a series of sections of walkway. Each section is lightly fastened to the next so that in the case of high seas the sections can break away without destroying the entire walkway. Design of a pedestrian board and chain walkway is illustrated in Figure 8.

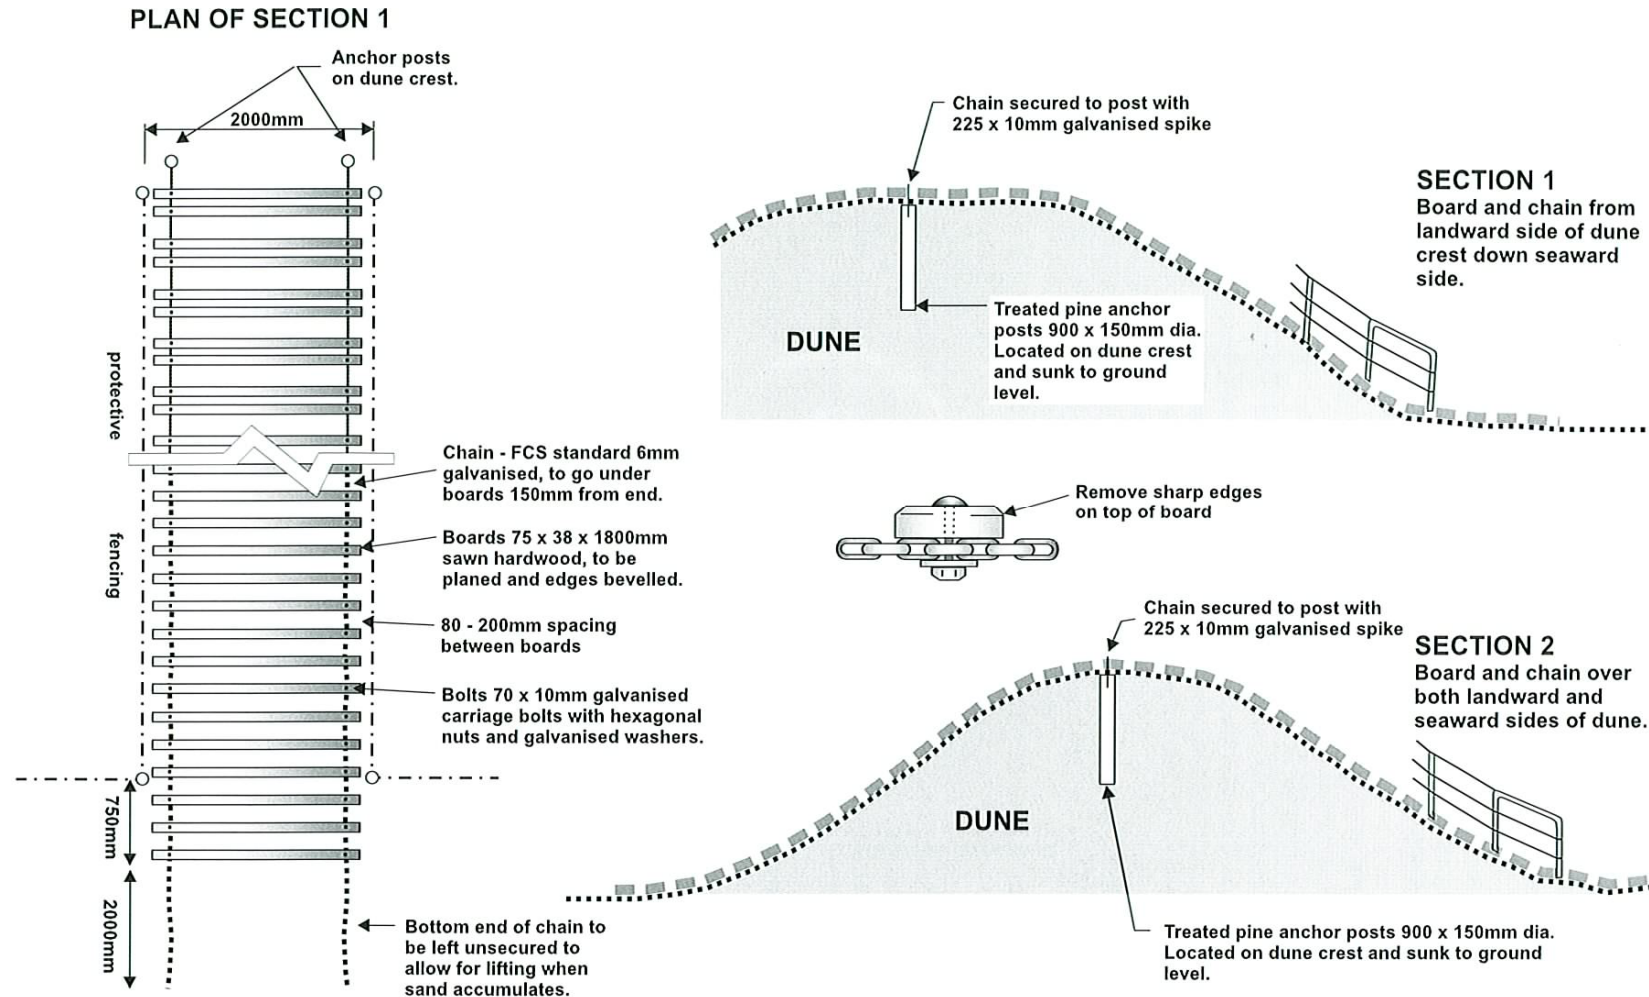
**Figure 8: Pedestrian board and chain walkway (NSW DLWC, 2001 *Coastal Dune Management – A Manual of Coastal Dune Management and Rehabilitation Techniques*).**

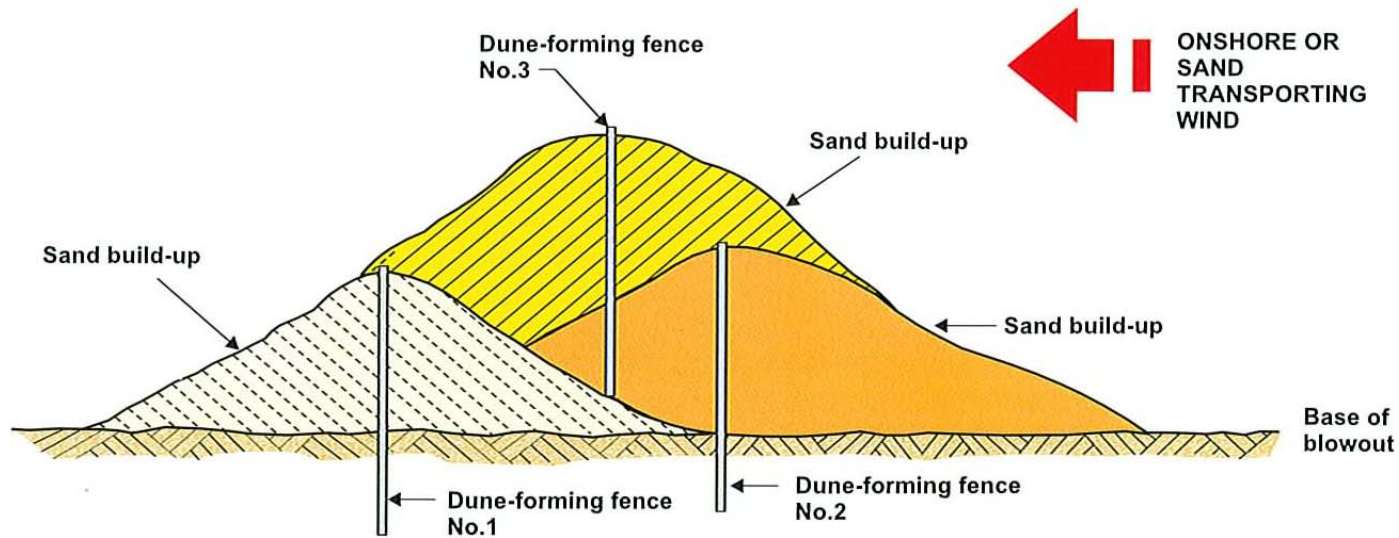
**Figure 10: Sequence for progressive installation of dune forming fences (NSW DLWC, 2001 *Coastal Dune Management – A Manual of Coastal Dune Management and Rehabilitation Techniques*).**
