# **STAGE 1: PRELIMINARY CONTAMINATION ASSESSMENT**

Proposed Residential Rezoning

**23 Compton Drive, East Ballina NSW 2478  
(Lot 1 DP781542 and Lot 3 DP525783)**

September 2019

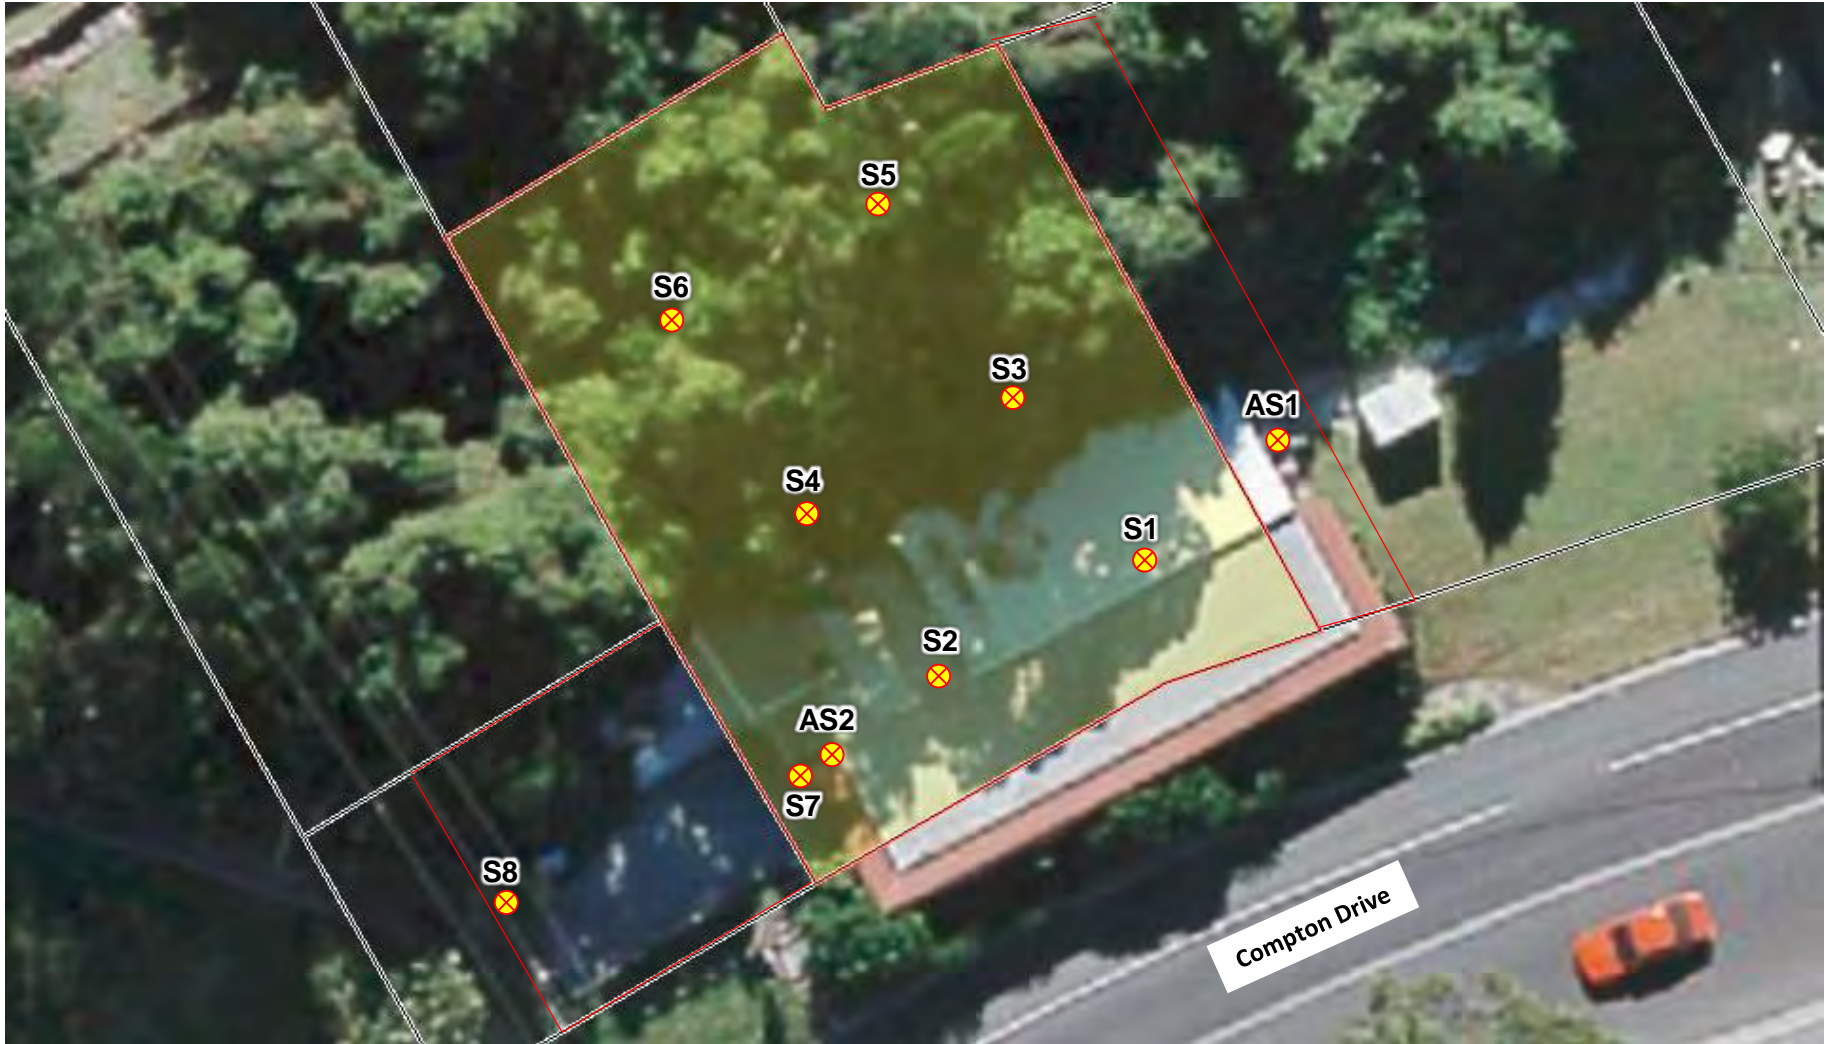
**Figure 2 - Sample Locations**  
23 Compton Drive, East Ballina, NSW 2478

Site area (approximate) – Boundary not shown in true location

incorporate areas of potential contamination (refer to Figure 2, **Attachment 1**). Samples were stored on ice in an esky and transported to the laboratory for analysis. The grid-based samples were composited into three sets of sub-samples (C1, C2 and C3) and analysed for the chemicals of potential concern (OCPs and heavy metals), while the two targeted samples were analysed for asbestos.

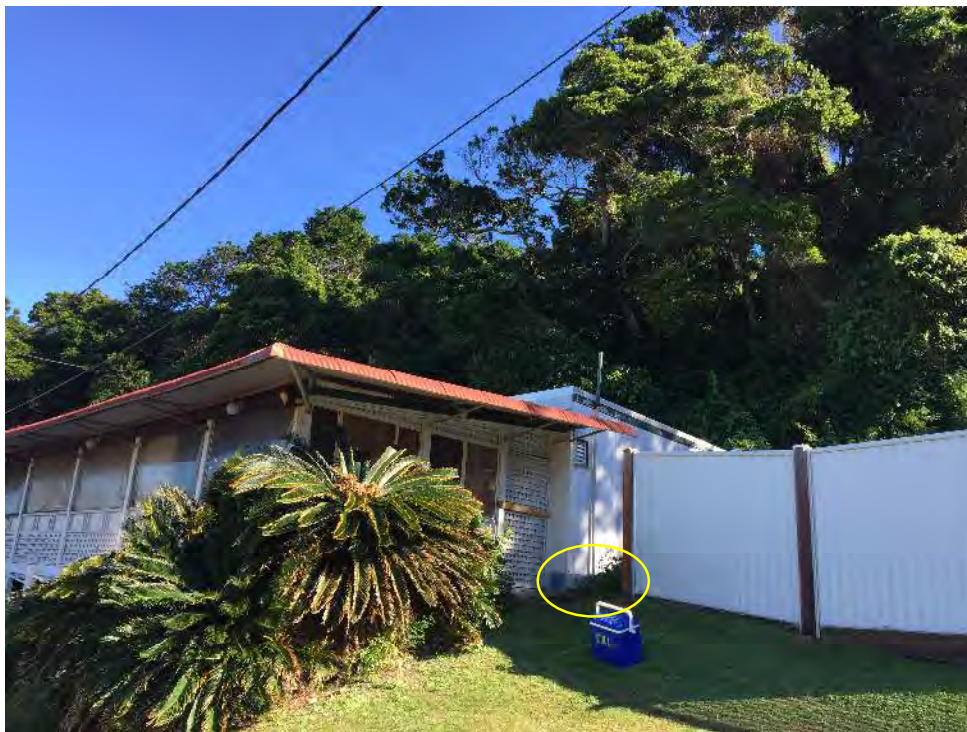
Image 1: View of the site looking from eastern corner of the property, where the vegetated rear garden is visible in the background. Location of sample 'AS1' visible in foreground.

The results from the targeted soil sample, 'AS1' obtained from the eastern perimeter, returned a positive result for bonded Chrysotile asbestos. It is believed that the 0.036g fragment originated from the adjacent building, which is known to contain ACM. As part of any future demolition works at the site, a post demolition soil scrape and asbestos clearance by a Licenced Asbestos Assessor (LAA) will be required. Taking this into account and the post demolition clearance, any asbestos fragments that are likely to exist in the shallow surface soils will be removed and therefore, are considered to pose negligible risk to future land users.

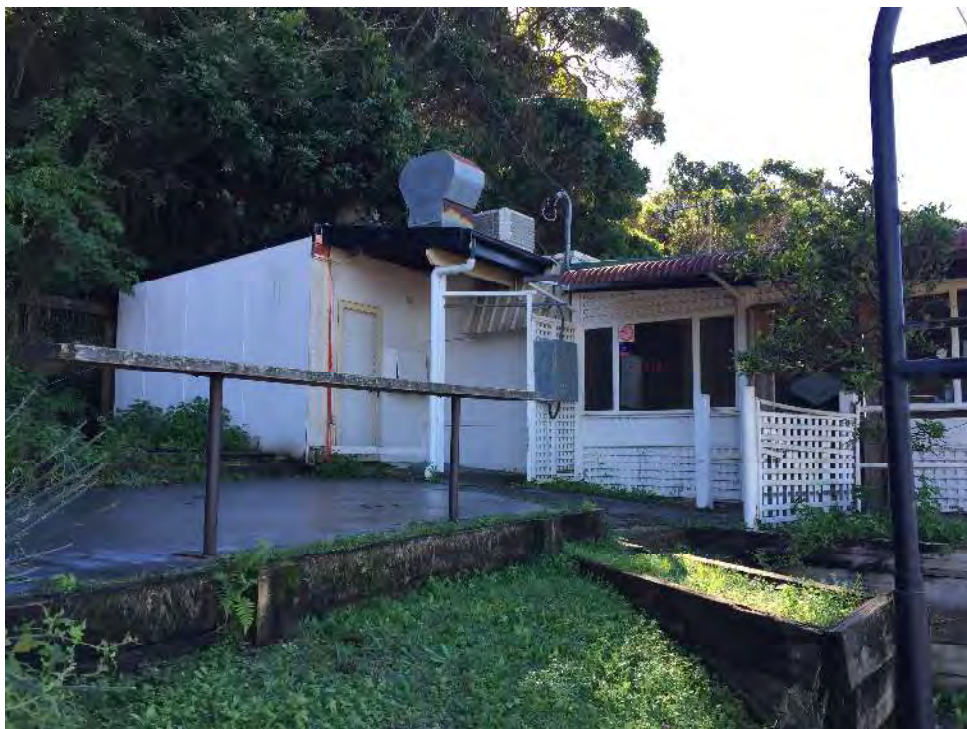
Image 2: A view from the south-western corner of the property towards entrance of the restaurant.

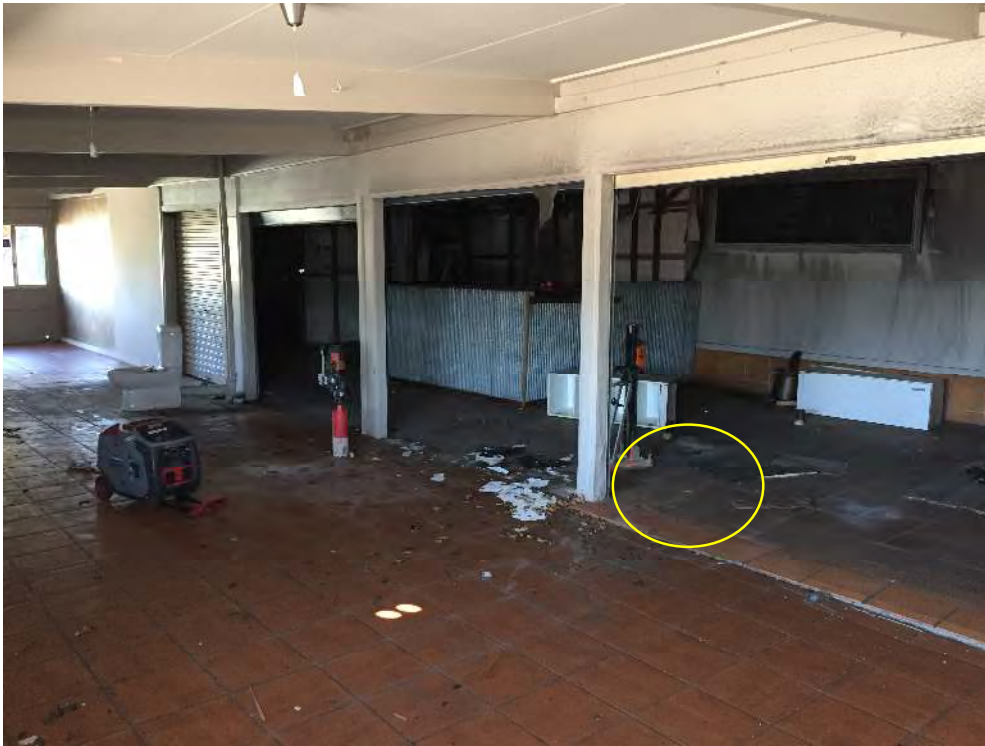
Image 3: Looking west across the front entrance of the building where the location of sample 'S1' is visible next to the concrete corer stand. Fire damage is also visible in the background.

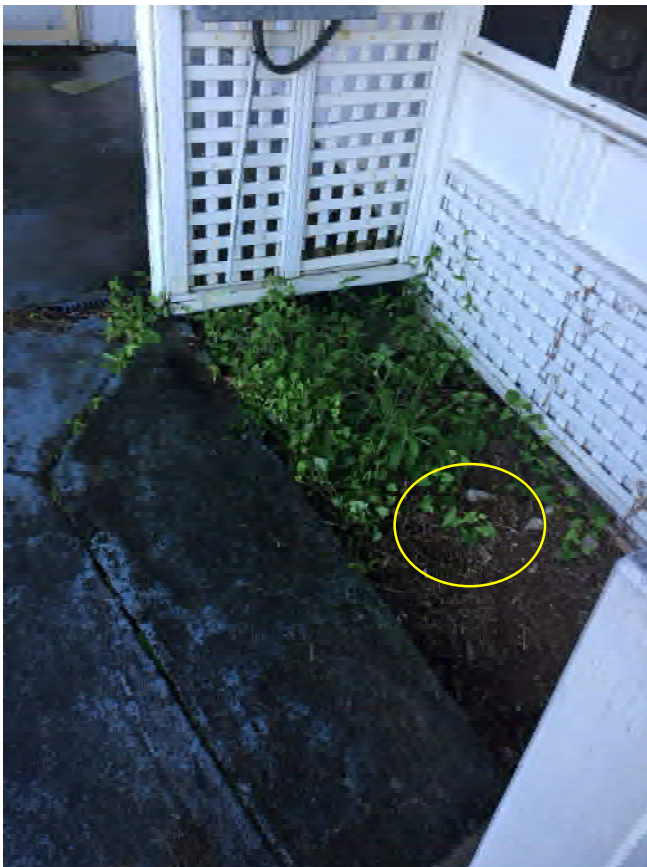
Image 4: A view of the western side of the building where sample 'AS2' was collected.

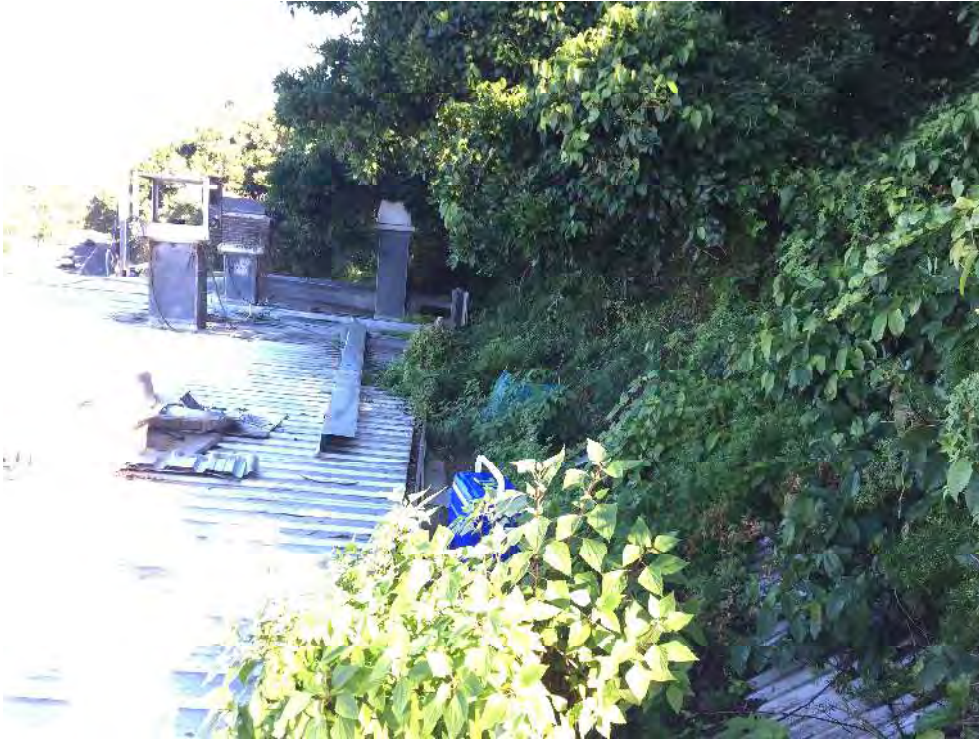
Image 5: A view towards the western boundary along the retaining wall that separates the building and rear yard.

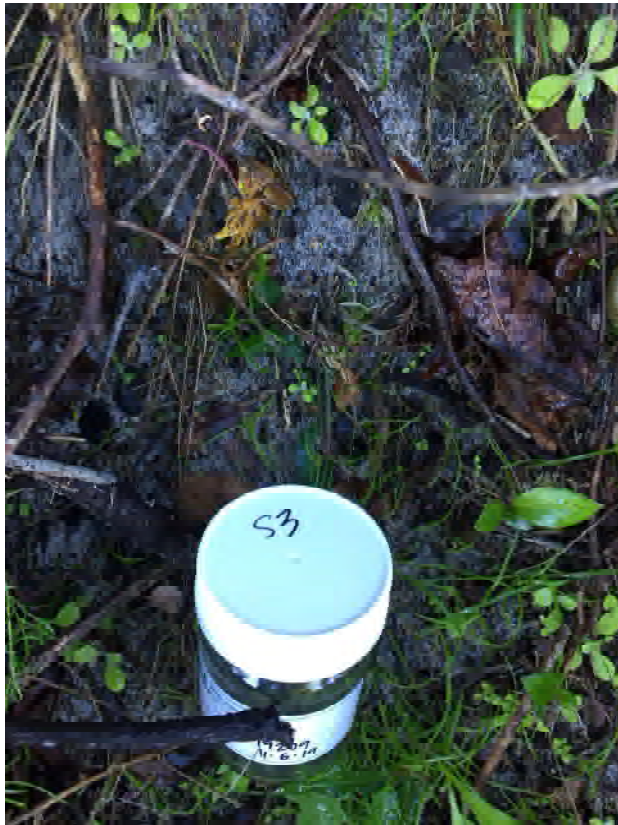
Image 6: An image of where sample 'S3' was collected in the understorey of the rear yard, the fine dune sand is visible beneath the vegetation

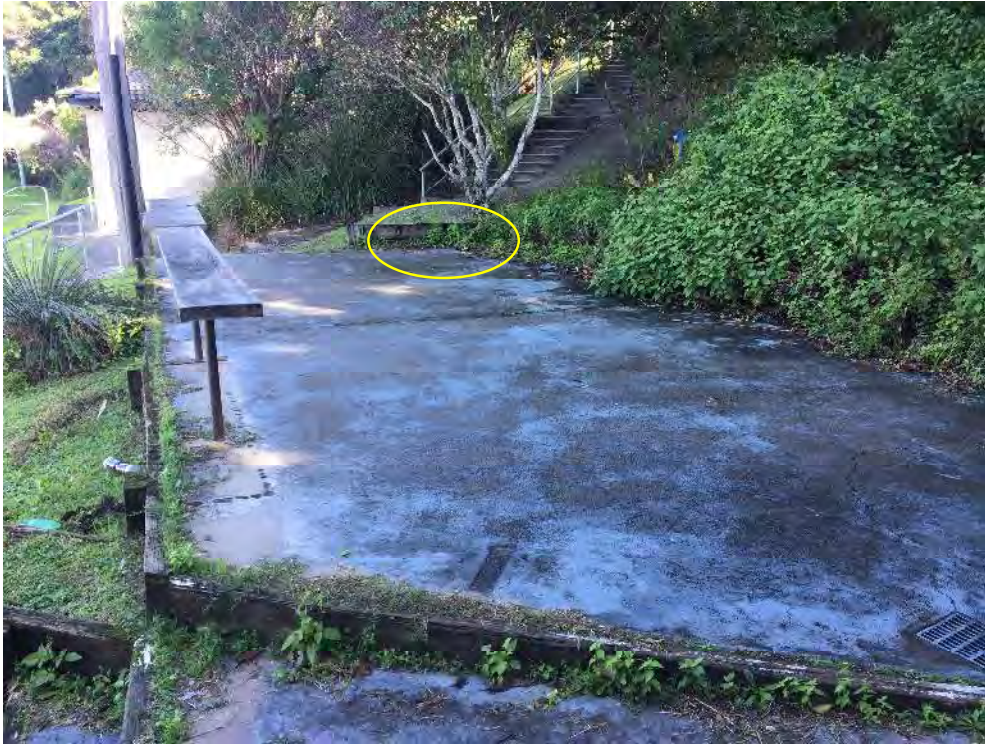
Image 7: An image of the vacant concreted area and garden where 'S8' was collected (Lot 1 DP781542).

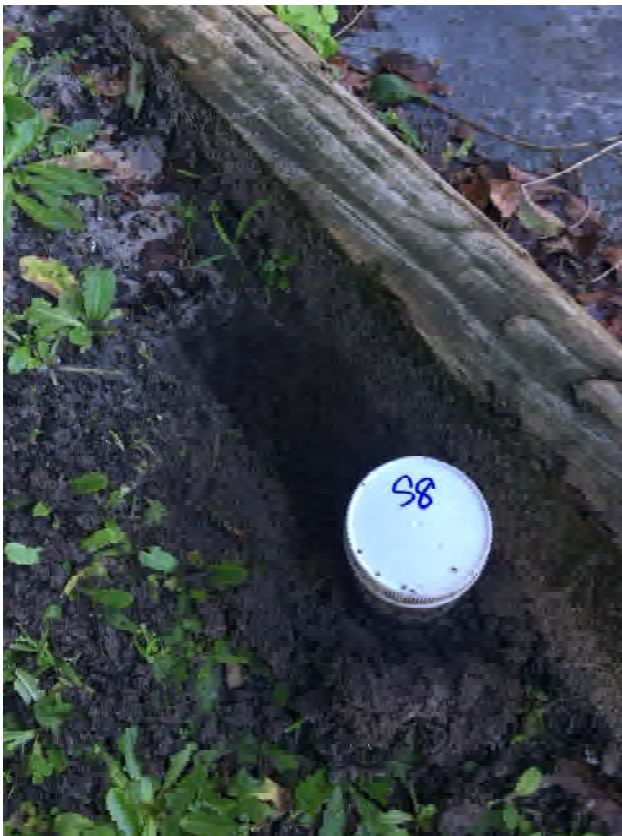
Image 8: An image of where sample 'S8' was collected adjacent to the concrete slab.
