ARBORICULTURAL REPORT

9 Castle Drive Lennox Head

PREPARED FOR:
Mr. Jason Vidler
Shire of Ballina

Re: Arboriculture report on Ficus macrophylla at Castle Drive and Ficus macrophylla at Pine Avenue.

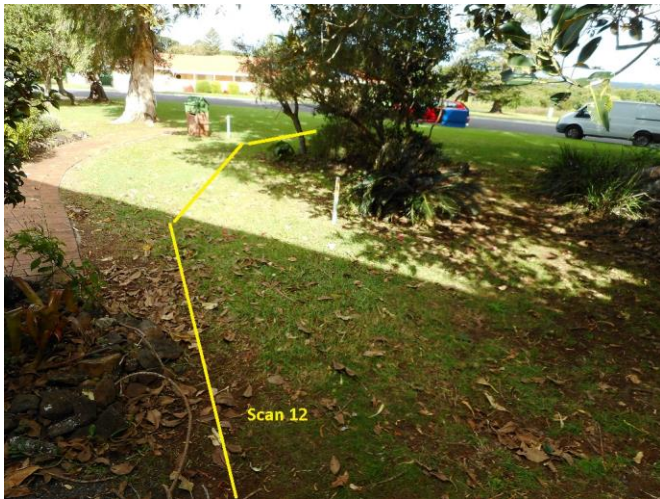
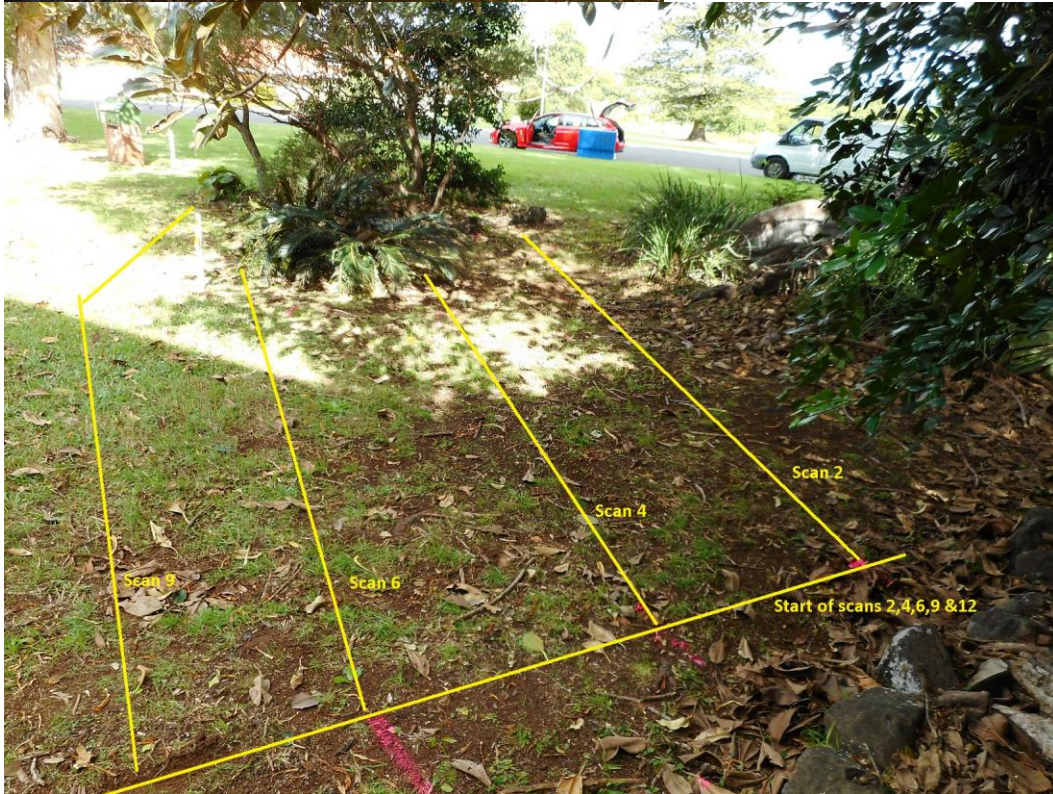
The final graph shows a 3d projected plan of the trees root system. The greater concentration of roots appear to be on the east side of the tree but much of the larger, near surface roots appear on the house side and the scans show a fair amount of roots directly in front of the house.

3d imaging of the projected root system.
