Peter Lucena
& Associates
Pty. Ltd.

19th August 2015

**Re: Report on Subsidence/Tree Root Damage at 7 Castle Dr
Lennox Head**

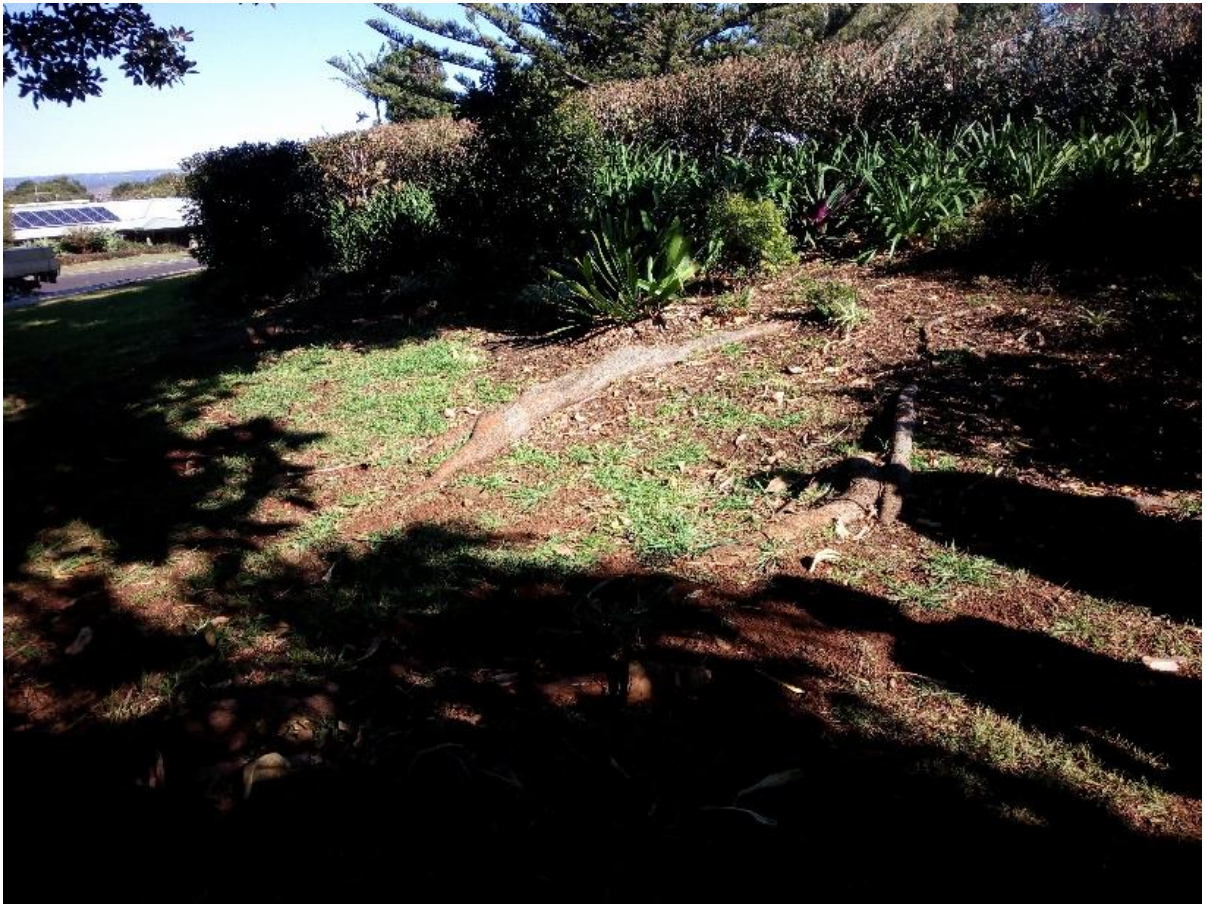
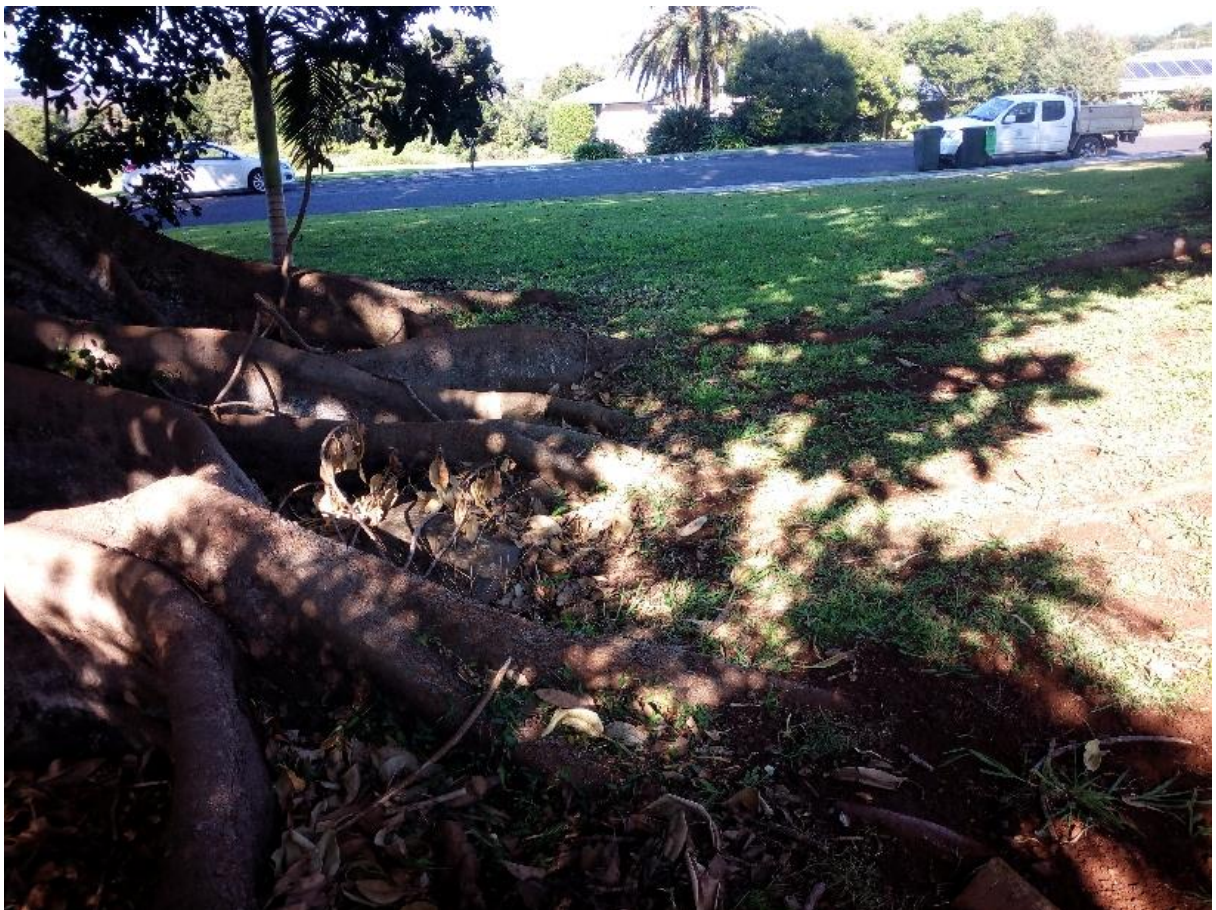
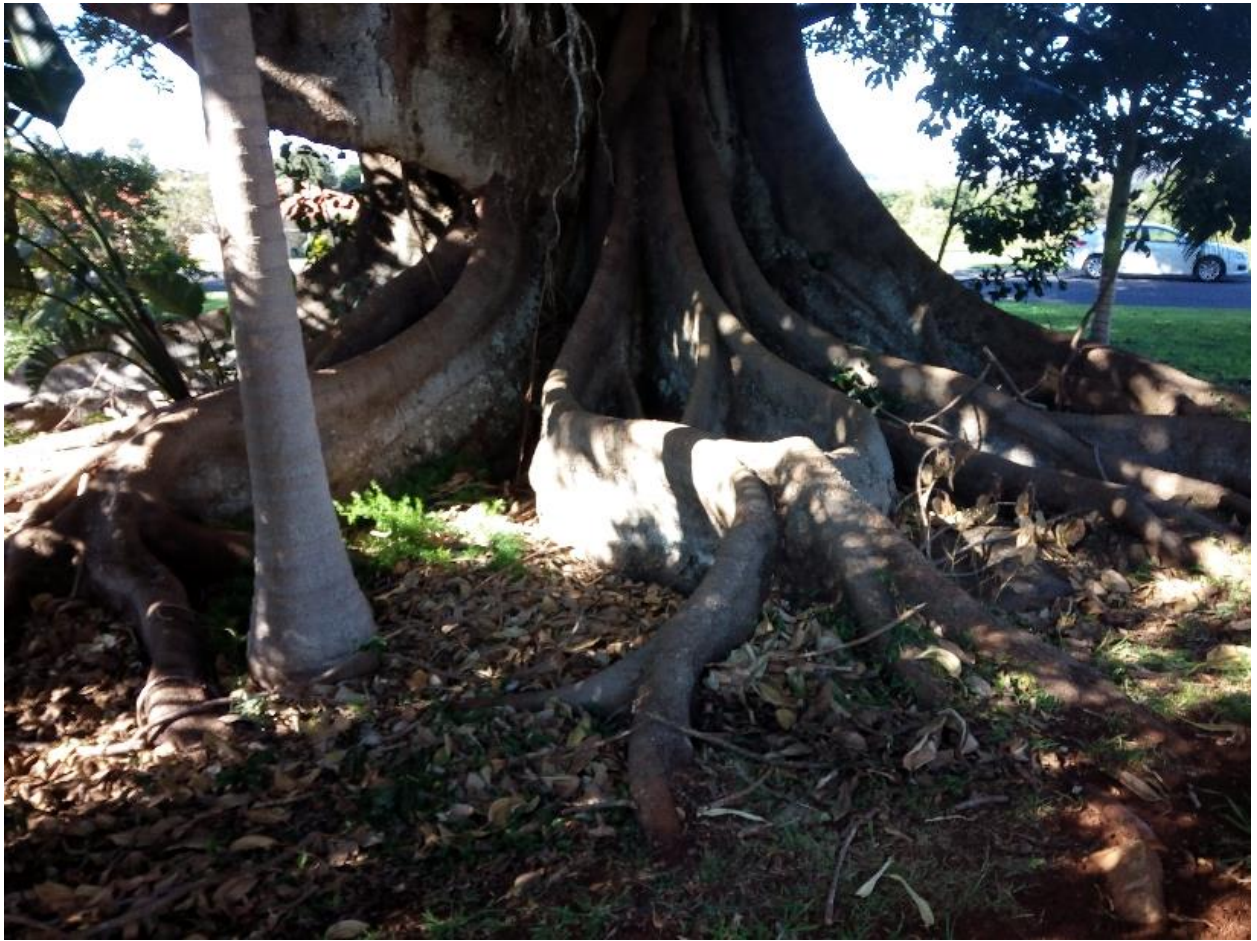
Fig Tree:

We were asked to look at various defects to the building and surrounding driveway / path slabs, and comment on possible causes. We were asked to comment particularly in relation to a large Moreton Bay fig tree that is situated within close proximity of the house. The tree and the land that the tree is located on is owned by Council. We have been provided with anecdotal evidence that the tree roots have been growing and that the damage to the building has worsened recently.
