Arborist's Report

Site: 7-9 Castle Drive
Lennox Head NSW 2478

Client: Ballina Shire Council

Date: 9 March 2018

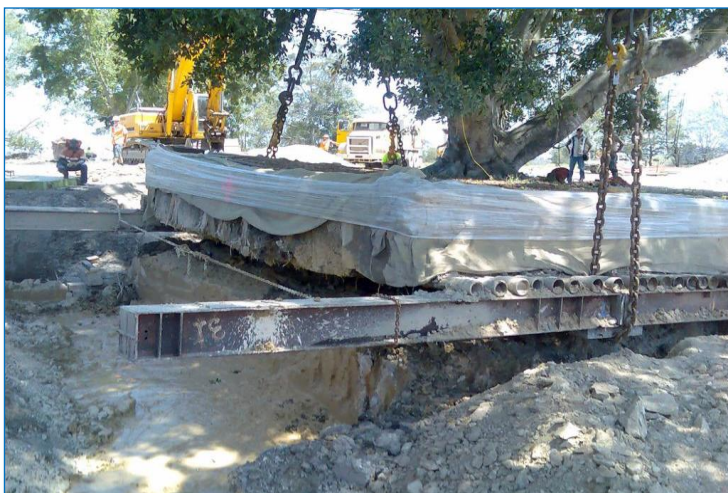
Figure 15. Lifting a very large *Ficus microcarpa* var 'Hillii' using a pipe raft, under beams and heavy lift cranes.

Whilst figs may be moved cold, i.e. without pre-transplant root pruning and maintenance, it is preferred that transplant preparation is performed. A minimum of 6 months preparation is advisable or longer, if possible. With correct pre-transplant preparation, tree survival is better than 99%. In this instance, root pruning, mulching and regular irrigation would be required.

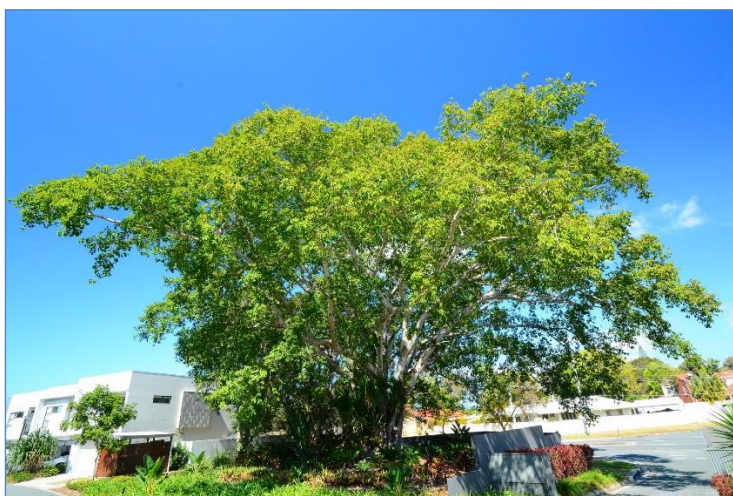
Figure 16. A very large white fig relocated in 2005 to allow construction of an apartment complex, 'Allisee' in Hollywell, Gold Coast region.

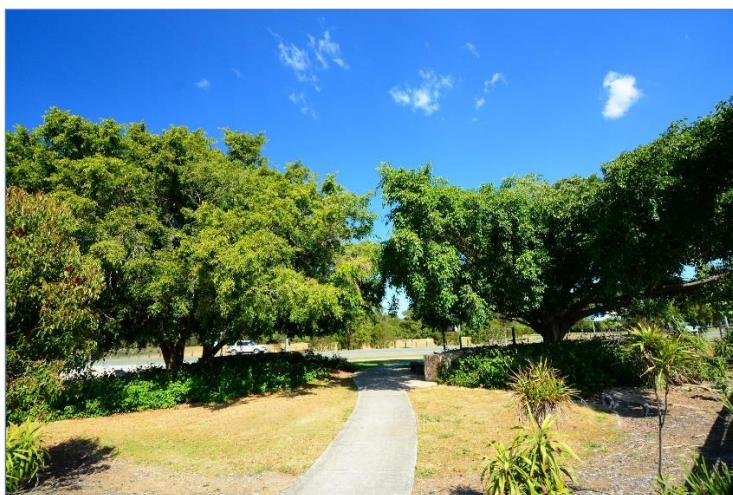
Figure 17. Three weeping figs relocated in 2007 to allow road construction at 'Riverstone Crossing' in Coomera, Gold Coast region.

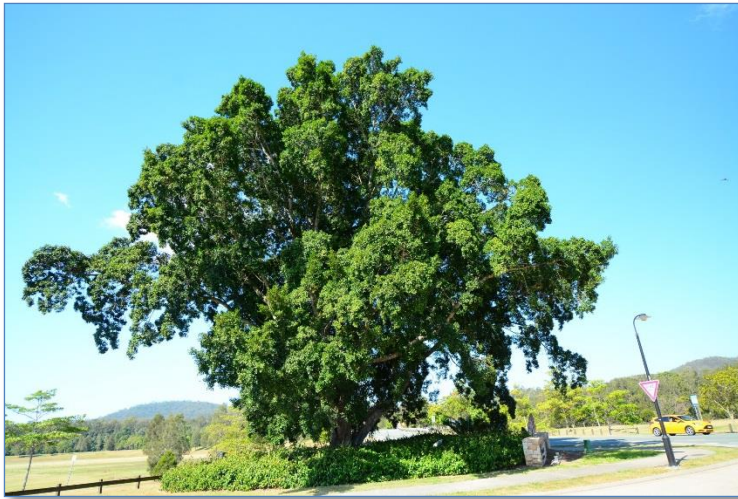
Figure 18. A large Hill's weeping fig relocated in 2007 to allow residential construction at 'Riverstone Crossing' in Coomera.
(Transplant in progress is also shown in Figure 15).

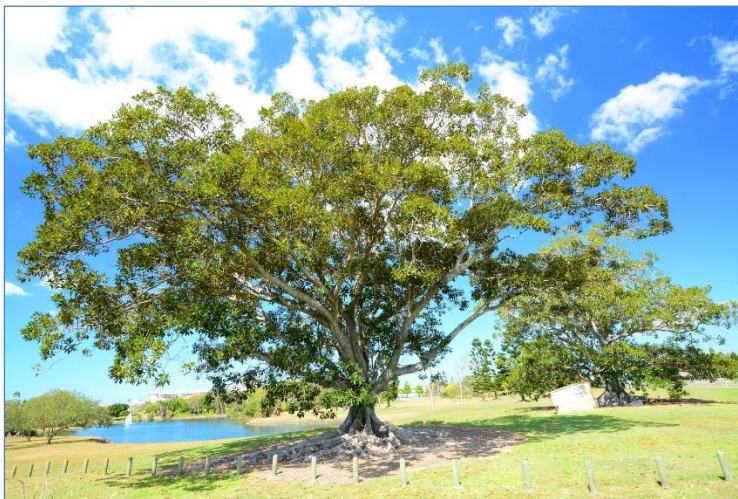
Figure 19. Two very large Moreton Bay figs relocated in 2001 to allow road construction at 'Emerald Lakes' in Carrara, Gold Coast region.
