Lot 3 DP525783 Compton Drive, Ballina

Geotechnical Assessment for residential use.

Mr Ricky Lau
Slope Hazard Assessment
23 Compton Drive, Ballina

RE: Slope Hazard Assessment: 23 Compton Drive, Ballina

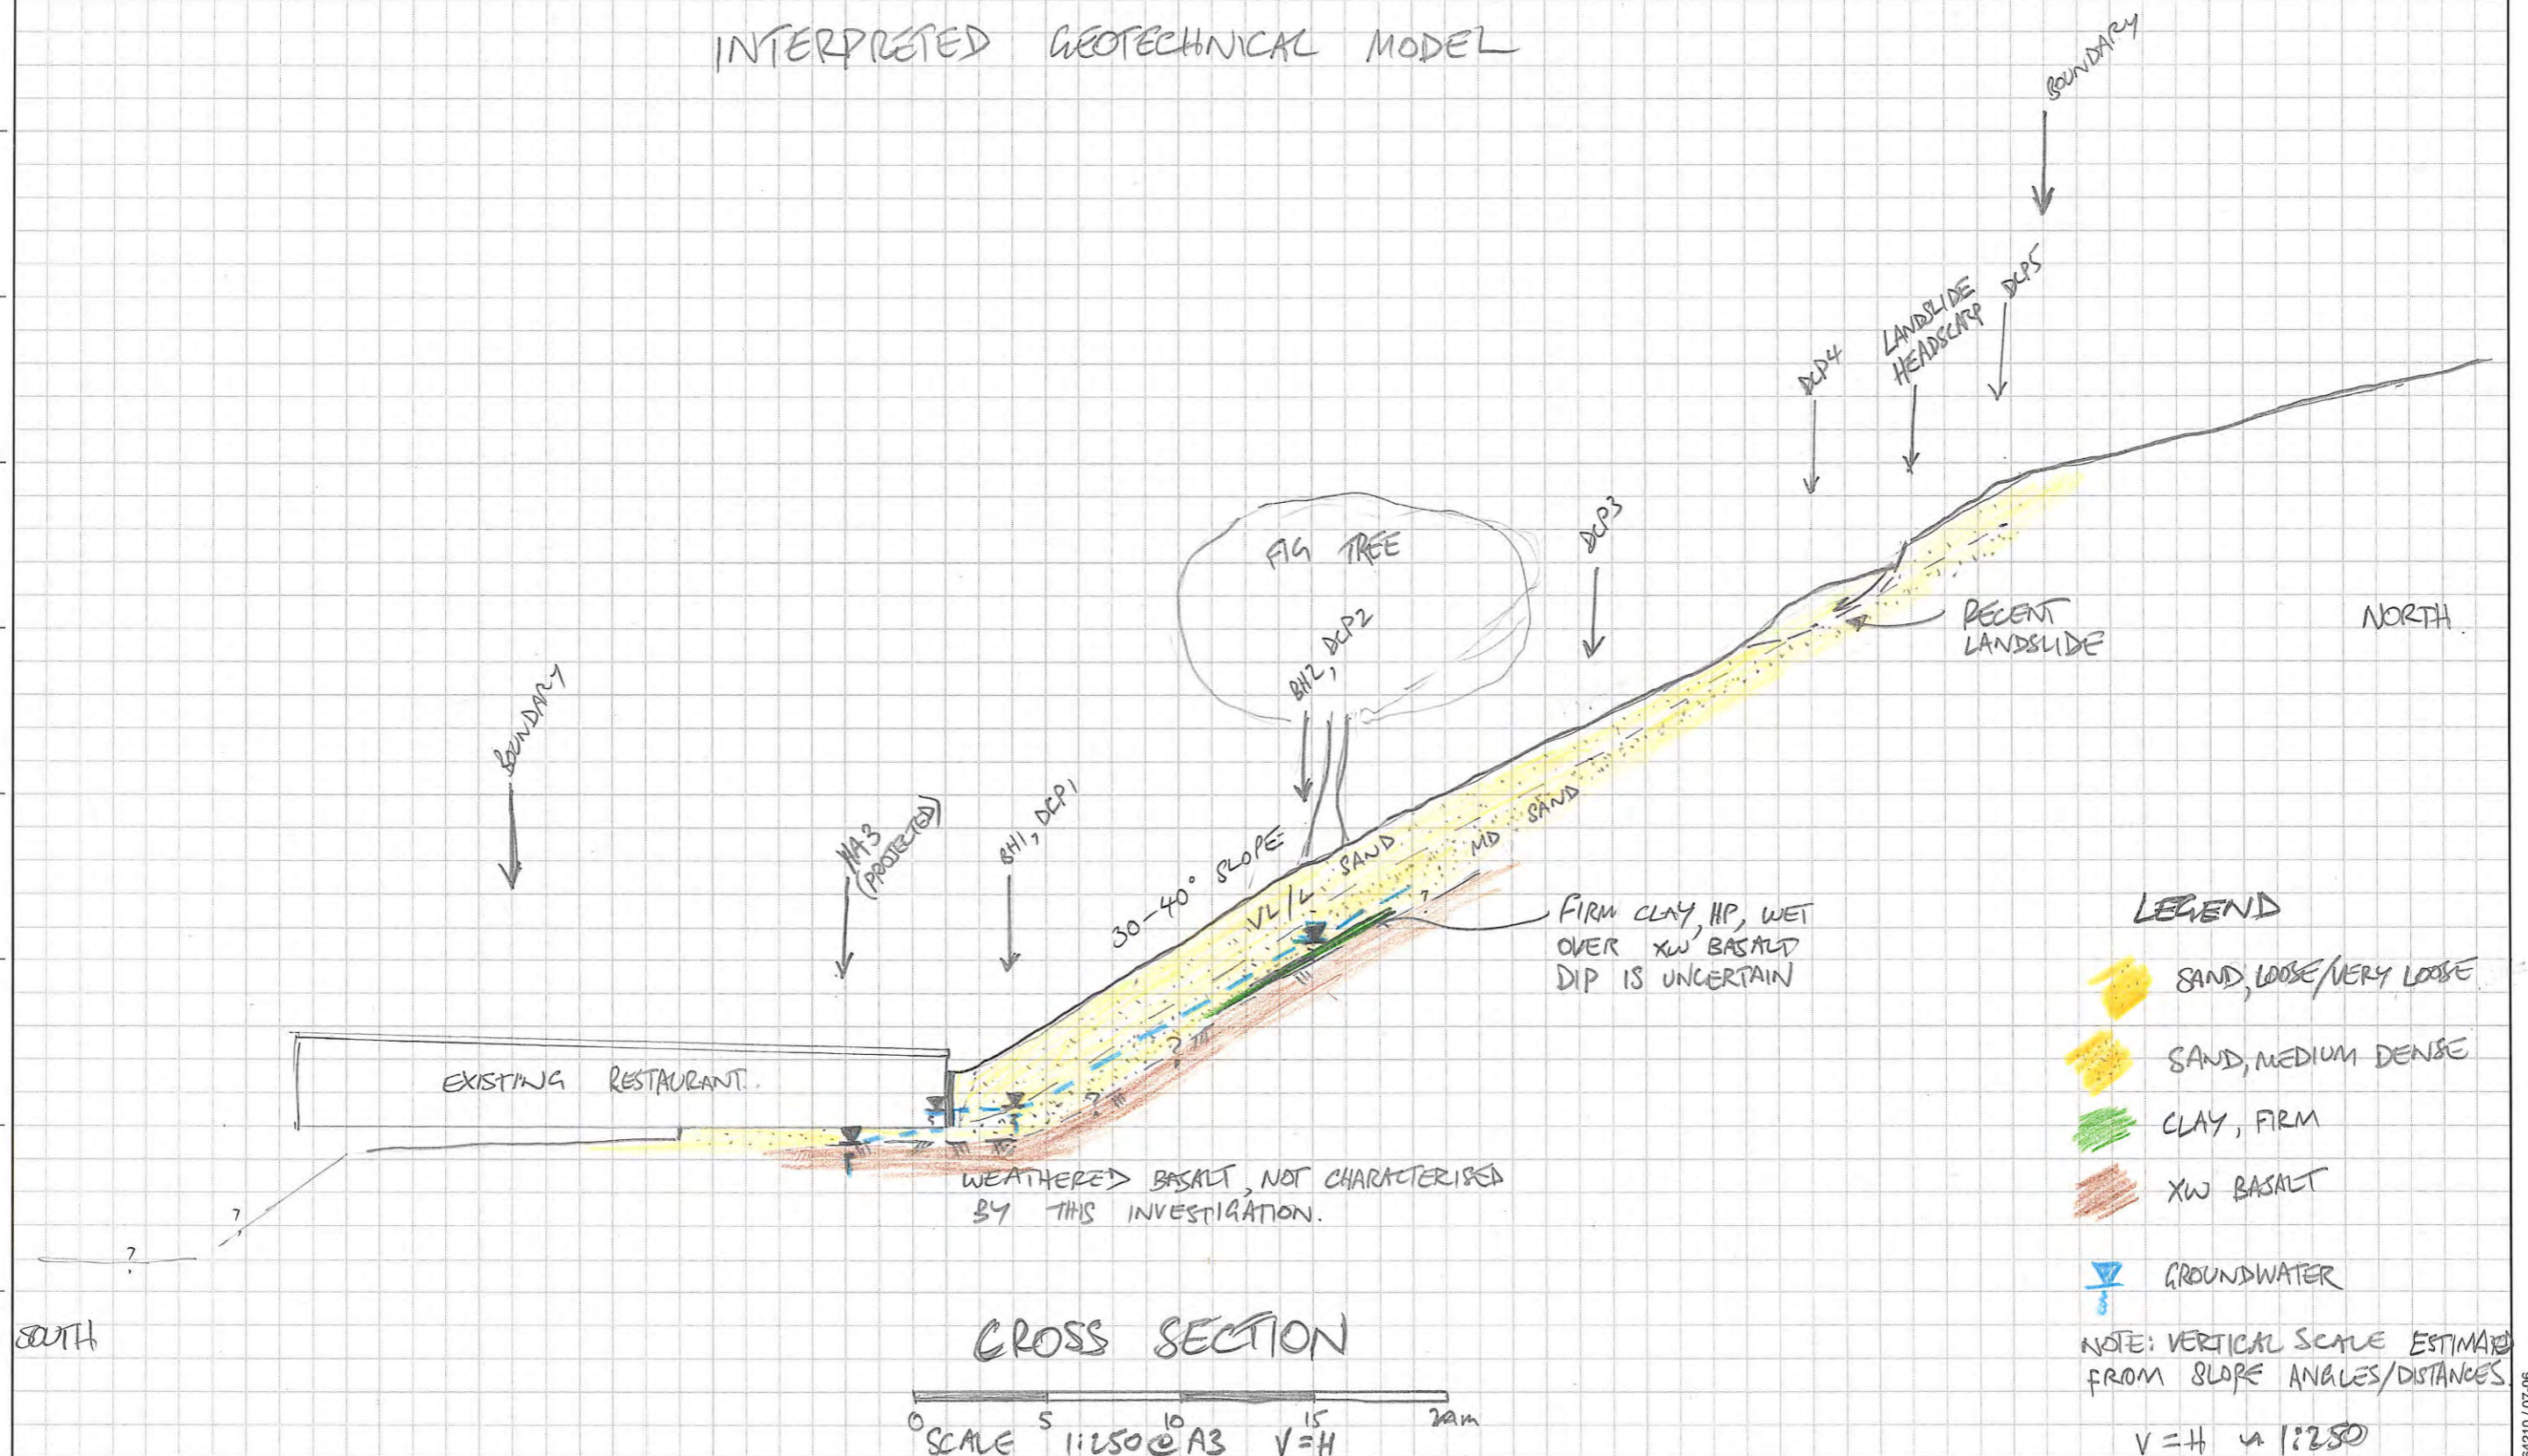
INTERPRETED GEOTECHNICAL MODEL

Our boreholes drilled on the site intersected fill and aeolian dune sand overlying weathered basaltic rock. In one borehole a firm clay of apparent alluvial/marine origin was observed overlying the weathered basalt. This clay could also be a weathered interflow layer from within the basaltic rocks that underlie the site.
